### **Effect of the hot-air lance on the adhesion of sealants used in roadway maintenance**

Masson, J-F.; Lacasse, M. A.

*[Proceedings of the 2nd Conference on Pavement Crack and Joint Sealants for Rigid and Flexible Pavements], pp. 105-124, 1997-07-01*

# **The Effect of the Hot-Air Lance on the Adhesion of Sealants used in Roadway Maintenance**

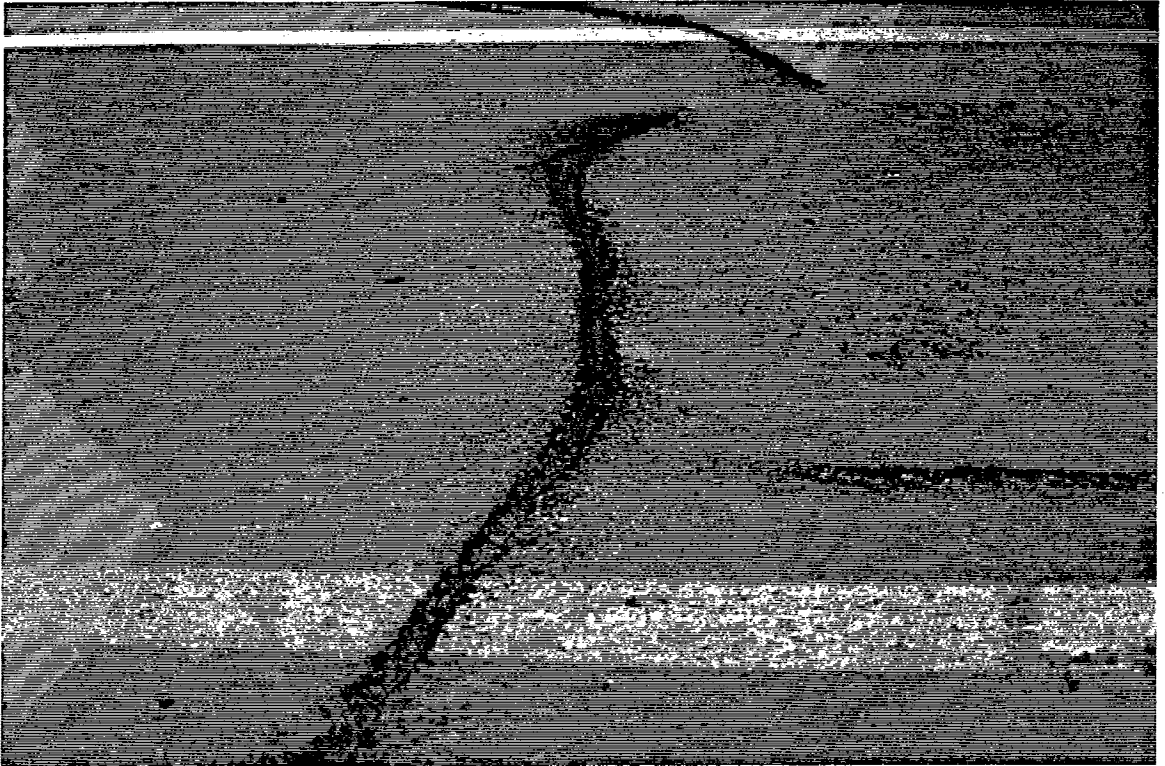
**FIGURE 4**

**Typical blackening of an overheated rout.**

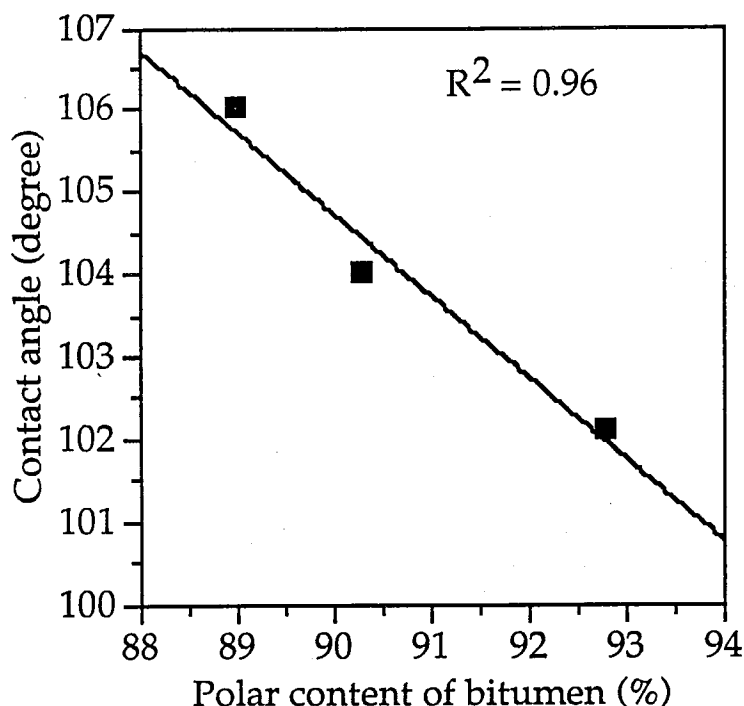
**FIGURE 5**

The contact angle of water onto three bitumens of different polarity. In this instance the polarity is equated to the sum of the aromatics, resins and asphaltene contents in bitumen.

The angle of contact of water onto bitumen provides an indication of its surface polarity. As the polarity increases, the angle of contact decreases. The polarity of bitumen can be increased either by oxidation or by an increase in the concentration of its polar components: aromatics, resins, and asphaltenes [14]. Provided in Figure 5 is an example of the decrease in contact angle of water on three bitumens with different compositions.

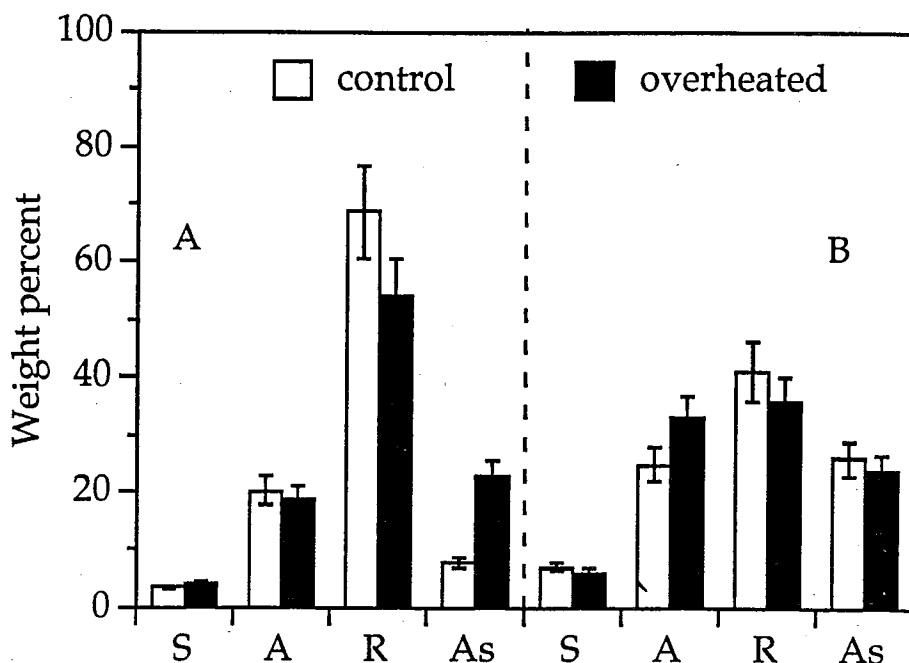
**FIGURE 7**  
**SARAs composition of Bitumen A and B before and after overheating.**

More precisely, the SARAs analysis obtained by chromatography indicates that in Bitumen A, the resins are transformed into asphaltenes (Figure 7). An increase in asphaltene content in bitumen causes its embrittlement [14]. Similarly, Bitumen A is embrittled by the HAL. The same embrittlement is not seen in Bitumen B, however, as the SARAs composition is apparently little affected by heat (Figure 7).

The results in Figures 6 and 7 show that the HAL can embrittle various bitumens to different extents. Moreover, they show that this embrittlement is restricted to the surface. That embrittlement is a surface effect can be recognized by considering that infrared spectroscopy characterizes the bitumen surface to a depth of 0.5 to 5 mm [18] whereas for thin-layer chromatography, the bitumen surface must be sampled with a blade, the sampling depth being a fraction of a millimeter. Accordingly, the sampling depth for chromatography is one hundred times greater than that for spectroscopy (0.5 mm). The constant SARAs composition of bitumen B upon heating thus indicates that the effect of the HAL is limited to a fraction of a millimeter. Despite the shallowness of the embrittled layer, it may nonetheless affect sealant adhesion and performance because it is at the sealant-AC interface.
