**Measurement of Airborne Sound Insulation
of 8 Wall Assemblies
Measurement of Airborne and Impact
Sound Insulation of 29 Floor Assemblies**

Nordic Engineered Wood

Report No. A1-006070.10

July 23, 2015

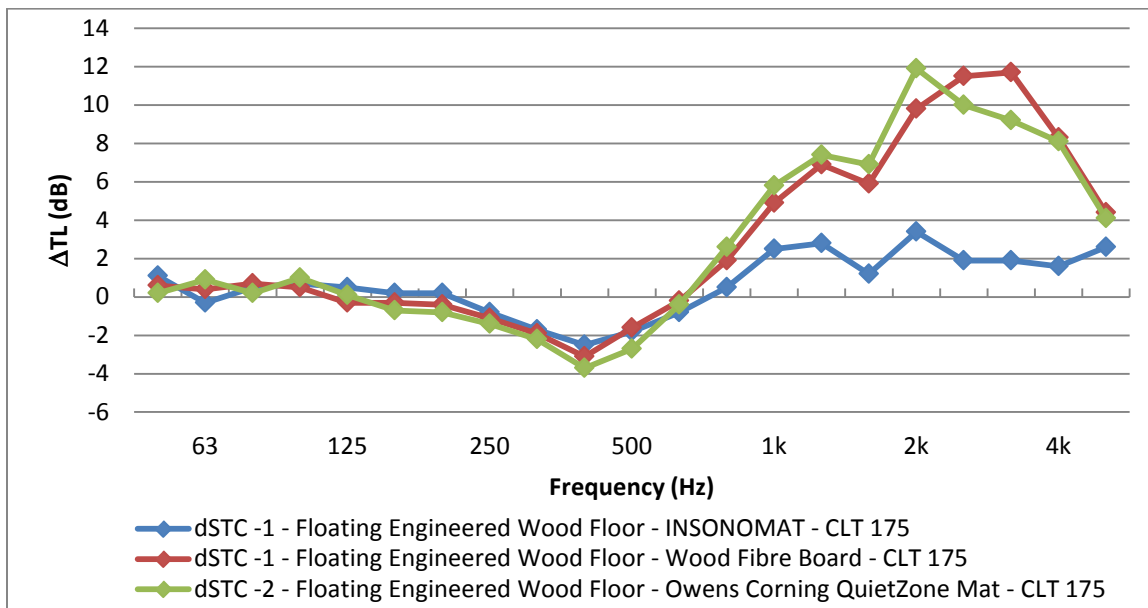
Figure 10 – Floating Engineered Wood Flooring Installed on 175 mm CLT

In most cases, floor coverings have a beneficial effect on the sound insulation performance of a floor assembly. However, they can also have a degrading effect in some cases. The addition of a floating engineered wood floor on CLT 175 mm assemblies leads to a decrease in STC by -1 to -2 points (Figure 10). The worsening is due to the introduction of a mass-spring-mass resonance at 400 Hz which directly affects the STC rating. For the poured concrete assembly on tar board, the addition of a covering decreases the STC rating from STC 47 to STC 42 for the same reason.

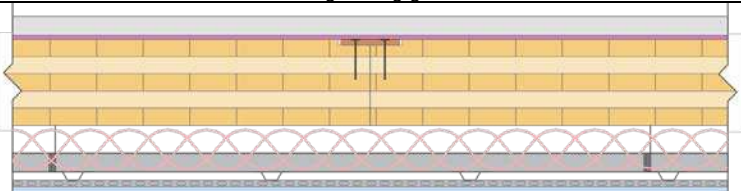
A1-006070-14F

<p>38 mm (1-1/2") precast concrete slab on 9 mm closed cell foam placed on top of a CLT 5 ply (175 mm) with two layers of 13 mm Type C gypsum board installed on a hung ceiling grid with resilient channels.</p>	73	66	88
