**FIELD STUDIES OF A SULPHUR/ASPHALT COMPOSITE
POTHOLE REPAIR SYSTEM**

by J.J. Beaudoin and P.J. Sereda

DBR Paper No. 1156
Division of Building Research

The results of two field studies on the performance of a novel sulphur/asphalt composite pothole repair system are described, as well as the material properties and equipment development. More than 100 potholes at each location (Ville St-Laurent, Quebec, and Winnipeg, Manitoba) were repaired under both summer and winter conditions. Control patches using conventional cold patch material were made whenever possible. Road types repaired included concrete pavement with and without asphalt overlays and asphalt pavement on a granular base. The potholes were prepared using various methods of cleaning and preheating, tack coat, wire mesh reinforcement, crushed stone filler and edge cutting. The composite system performed better, by far, than the conventional cold patch material.

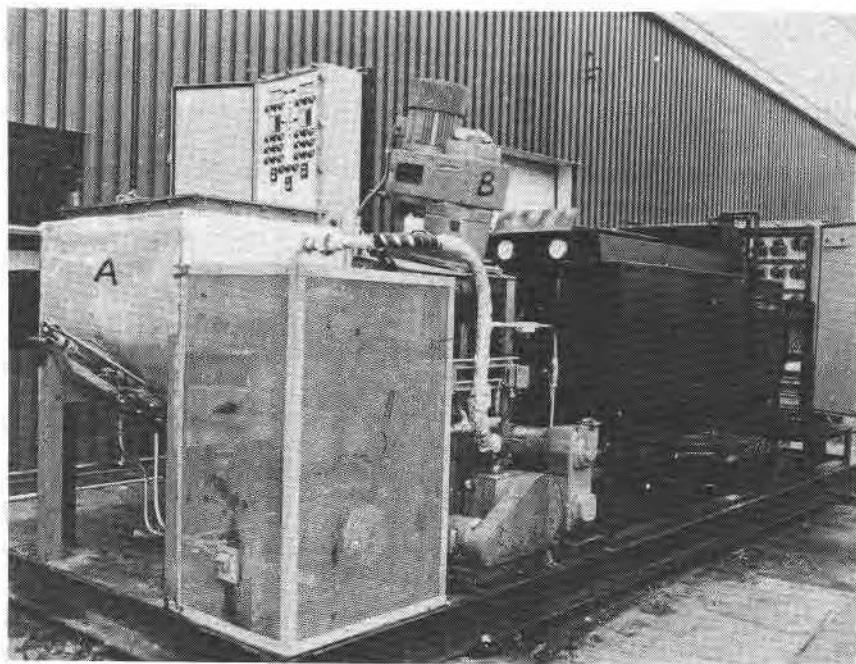
Fig. 3. Prototype production equipment designed to produce NRCC sulphur/asphalt composite pothole repair material: A — Aggregate blender, B — High-speed shear mixer, C — Heating kettles for sulphur and asphalt.

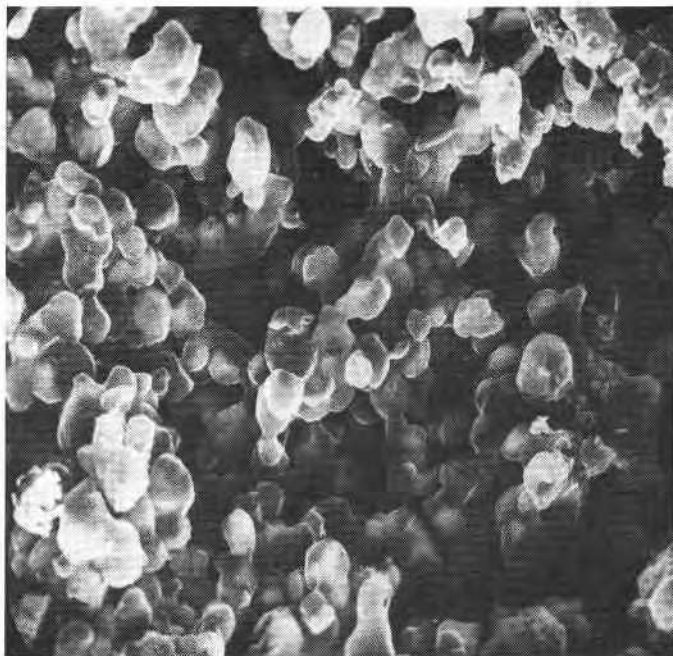
A SEM photomicrograph, illustrating the continuous sulphur network in the SAC is presented in Fig. 4. Mechanical properties of the SAC have been determined and reported previously (Beaudoin and Sereda, 1979). Two important characteristics are the relatively short set time and the ability of the material to be remelted without segregation. Five simple tests were used to determine the quality of the binder: appearance and colour, density, stability (sulphur separation), hardness (cone penetration) and compressive strength (Sereda and Beaudoin, 1980). Hardness perhaps indicates best the quality of the final product since its value decreases by a factor of more than 2 when the sulphur is not continuous.

Fig. 4. Continuous sulphur network revealed by leaching continuous asphalt phase from NRCC sulphur/asphalt material. Sulphur nodules are approximately 5 μm .

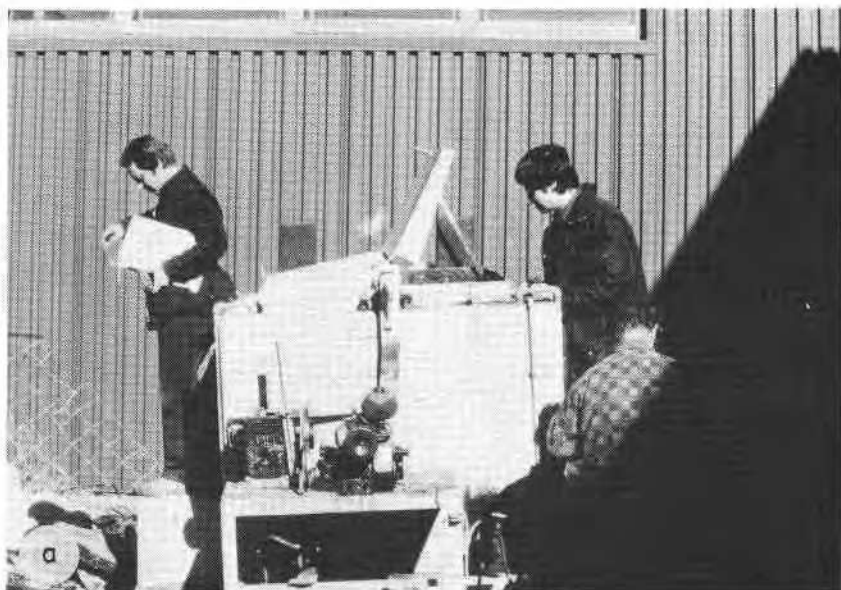
The melter used by Asphalt Labs Ltée consisted of a 1 m³ oil-jacketed container mounted on wheels. It was equipped with a sliding-type, stirring apparatus and could be towed by truck. The operating temperature was maintained between 150 and 160°C (see Fig. 5(a)).

Fig. 5. (a) Melter used to remelt NRCC pothole repair material at Ville St-Laurent, Quebec; (b) Melter used to remelt NRCC pothole repair material at Winnipeg, Manitoba.

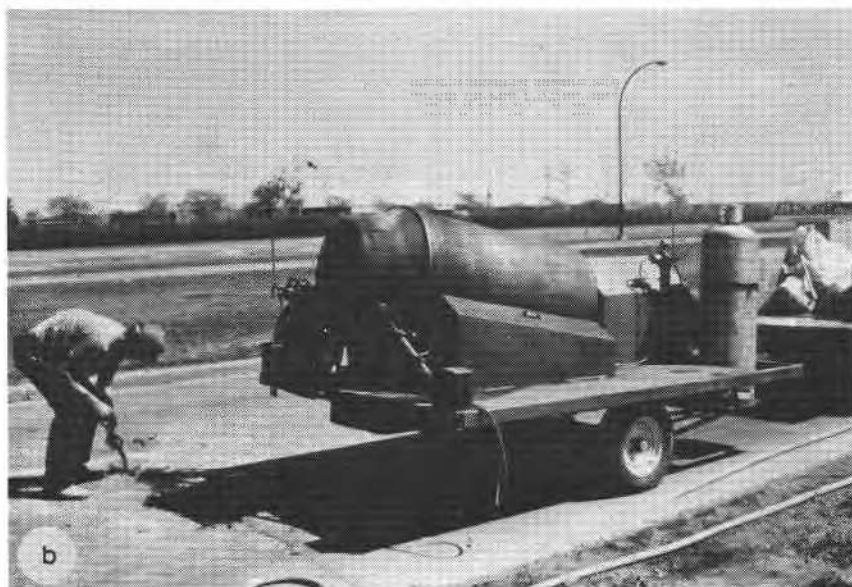
The melter designed and used by I.D. Engineering Ltd. (Fig. 5(b)) was not oil-jacketed. It was a rotating drum with spiral ribs inside, and was heated by direct flame against the rear wall. It had a charge capacity of 360 kg and took about 2 hours to melt the charge. The material was discharged from the drum by reverse rotation of the mixer, then directed into the pothole by means of a chute.
