The Collapse of WTC7

**The Collapse of WT7 : a Canadian researcher who
studied the World Trade Center disaster reports on
the collapse of a building beside the twin towers**

Fire Resistance Issues in the Collapse of Building WTC 7

By V.K.R. Kodur, Ph.D., P.Eng

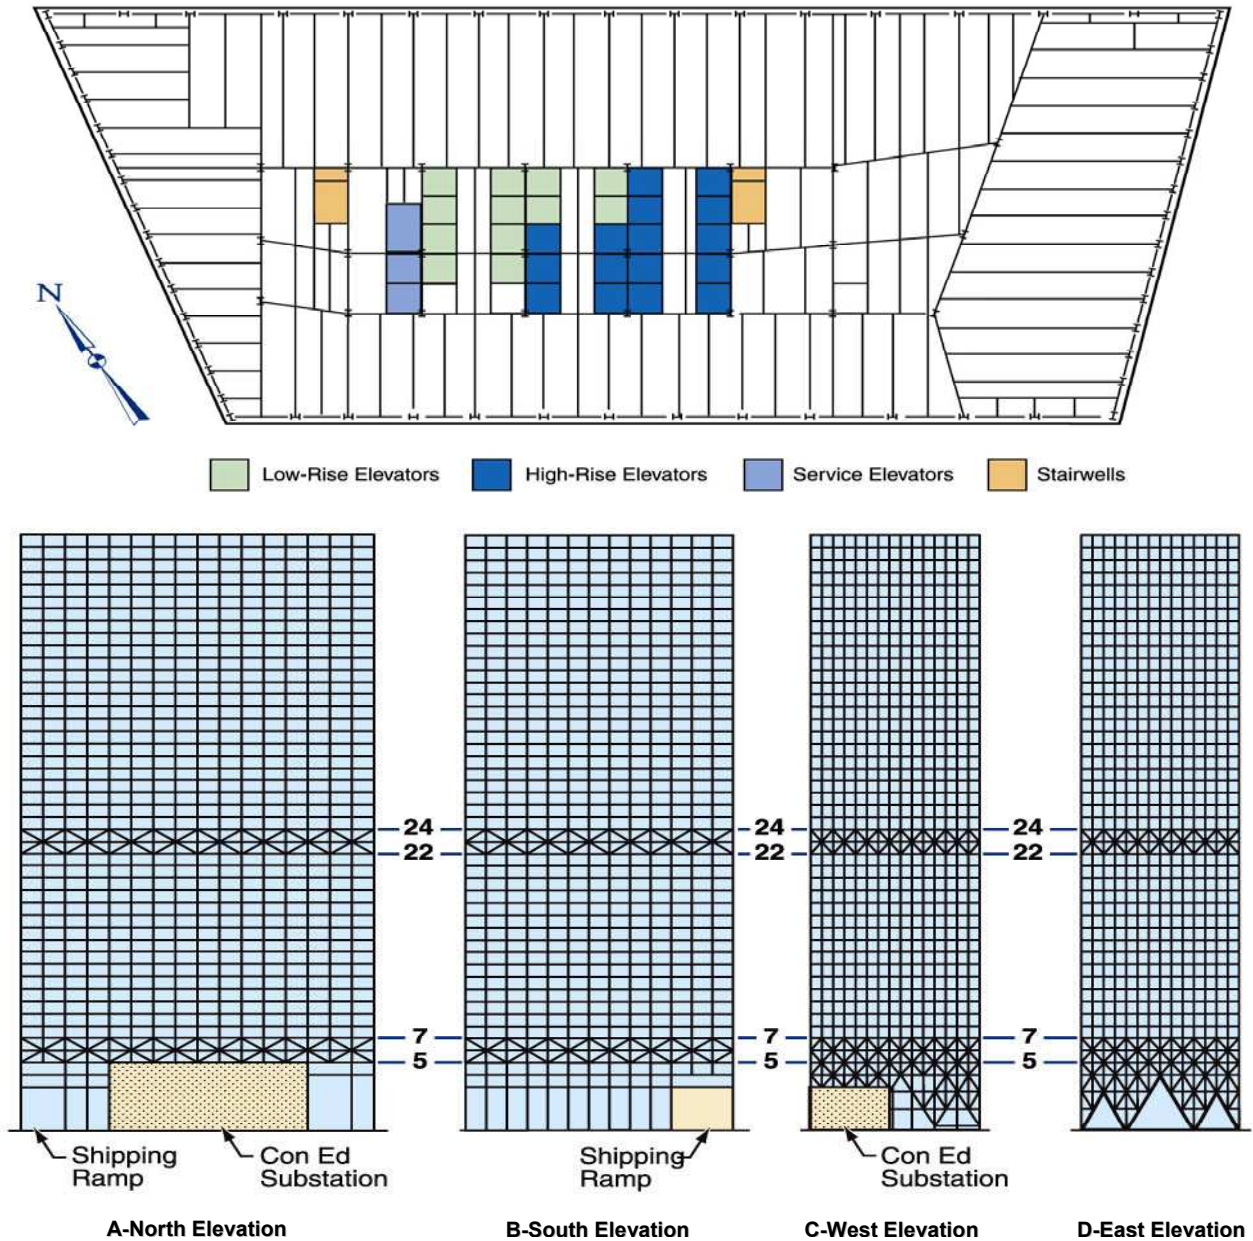
WTC 7 was a 47-storey steel-frame building and was constructed in 1984. It was 635 feet high and had a trapezoidal-shaped floor plate (Figure 1). The typical floors had an area of approximately 42,000 square feet, with a total of 1,868,000 square feet of office space. WTC 7 housed a Consolidated Edison substation located on the lower four floors, and fuel storage tanks (3,000 - 6,000 gallons and 2,000 - 12,000 gallons) located at ground level. The 7th floor housed generators and day-storage fuel tanks. The next three levels above contained switchgear and emergency generators, and the top 40 stories were office space. WTC 7 was linked to the World Trade Center plaza by two pedestrian bridges.

Figure 1. Typical floor layout and elevation for WTC 7

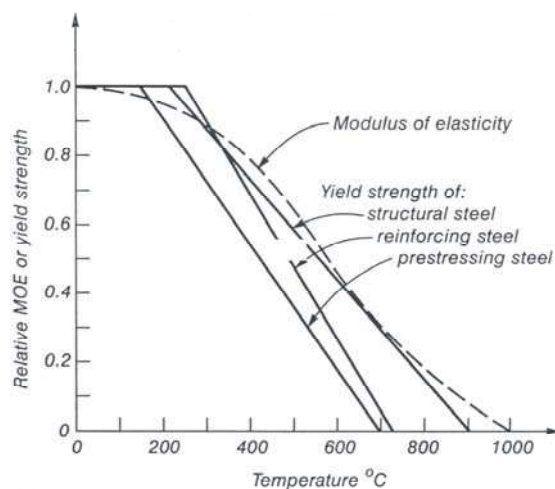
Steel loses its load-carrying capacity (or about 50 percent of its original strength) at 538°C (1,000°F) when exposed to an ASTM E-119 standard fire that is often used as a benchmark for building fires. External fire protection (fireproofing) is applied to the steel structural members to provide the required fire resistance ratings. Figure 3 shows the variation of strength and stiffness in steel as a function of temperature. The WTC fires, burning on multiple floors simultaneously, may have been more severe than the ASTM E-119 standard fire.

Figure 3. Variation of strength and modulus of elasticity of steel with temperature
