APPLICATIONS OF INFRARED THERMOGRAPHY IN LOCATING AND IDENTIFYING BUILDING FAULTS

by Kenneth N. Burn and G.D. Schuyler

Reprinted from
**Journal of the International Institute for
Conservation — Canadian Group**
Vol. 4, No. 2, Spring 1979
p. 3 - 14

DBR Paper No. 964
Division of Building Research

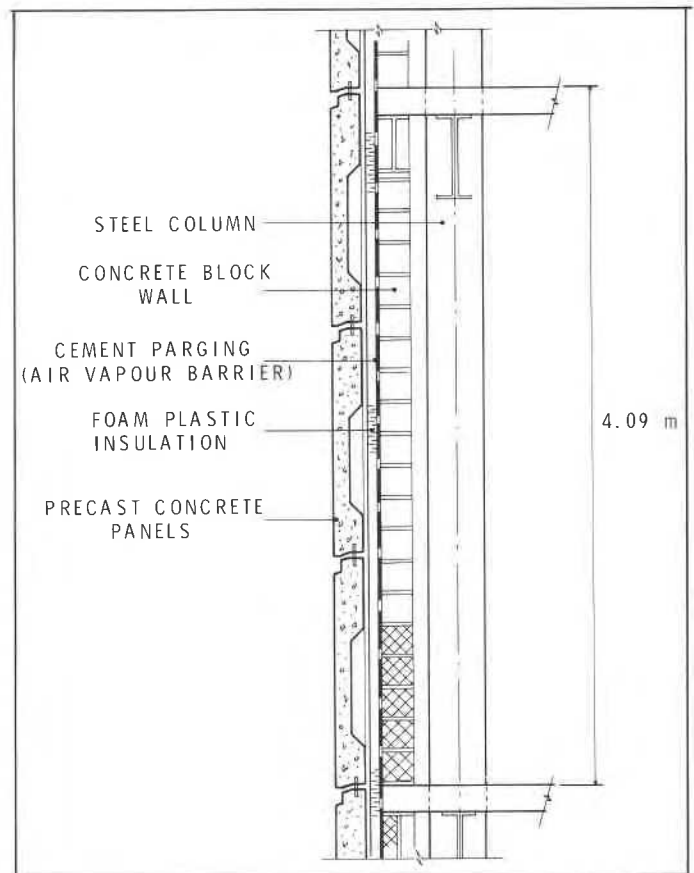
Figure 9. Typical wall construction used in highrise art gallery.

The structural frame of the building is of steel and the original cladding was of gray limestone and brown granite. These finish materials were replaced by precast concrete and porcelain enamel panels simulating the original texture and colour. Construction details of the new envelope vary from place to place throughout, but the general design approach is represented by a sketch of the wall section shown in Figure 9.

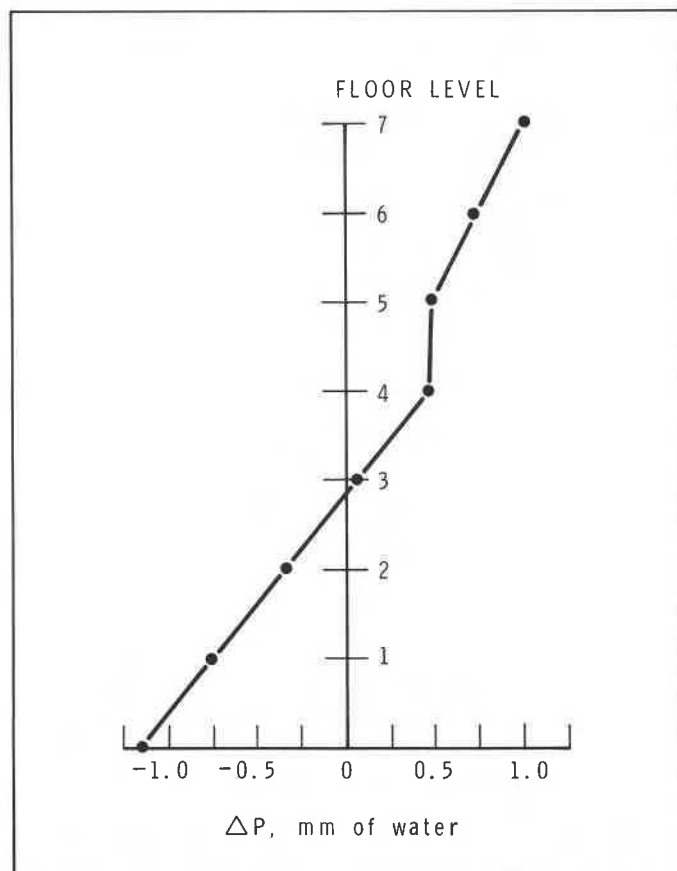
Figure 10. Air pressure inside building with reference to external pressure.

The pressure differences shown in **Figure 10** were measured at about the same time as the thermograms were taken. The maximum positive and negative pressures, equivalent to about 1.0 mm of water, had occurred at top and bottom, and the point at which the pressure difference was zero occurred at the third floor level. The fact that the slope of the curve is not constant indicates that there is some variation in air tightness from floor to floor.

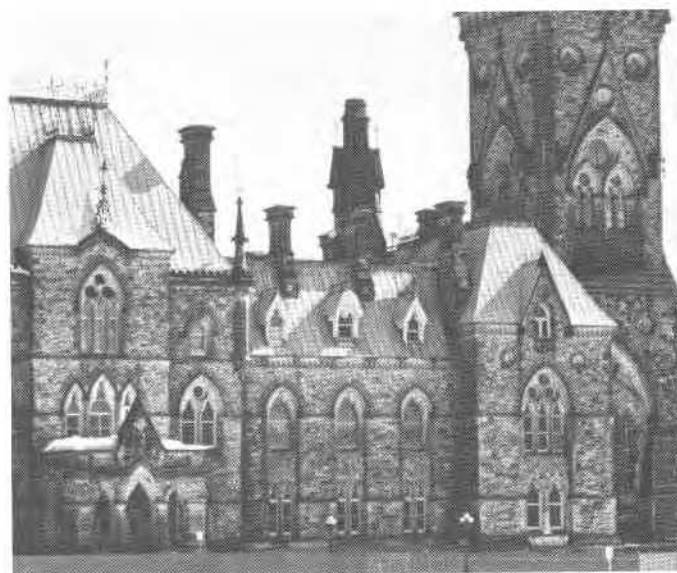
Figure 13. Photograph of East Block, Parliament Buildings.

Figure 13 is a photograph of the East Block of the Canadian Parliament Buildings in Ottawa, which has now been retrofitted. The stone structure is surmounted by a complex mansard roof with dormers protruding through the lower, steeper section. **Figure 14** shows part of the roof framing and timber supports in the attic space and illustrates the extreme difficulty of installing a continuous air barrier under such conditions.
