DESIGN CHANGE BENEFICIAL IN REDUCING DOMESTIC HOT WATER TANK CORROSION

by
P. J. SEREDA

RESEARCH PAPER NO. 122
of the
DIVISION OF BUILDING RESEARCH

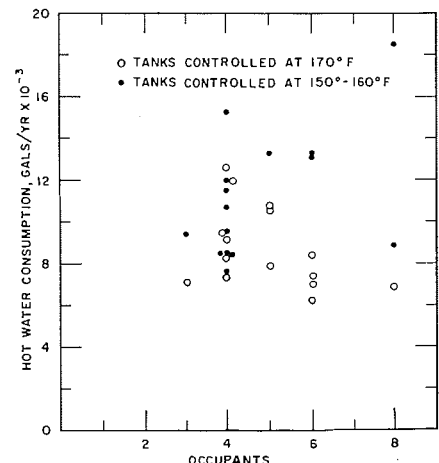
4. Rate of consumption of hot water varied threefold when considering all the units and twofold when considering houses with the same number of occupants. This factor did not seem to influence the corrosion rate. This also was found by Weast.⁴ When consumption of hot water from units controlled at 170 F was plotted against the number of occupants in the house (Figure 3), there seemed to be a trend indicating a decrease in the consumption per house as the number of occupants increased. This was a surprising result.

Figure 3—Rate of hot water consumption as related to number of occupants in the household. (Taken from Brantford, Belleville and Peterborough Projects)
