### Shattering of unreinforced PVC roof membranes: problem phenomenon, causes and prevention

Paroli, R. M.; Smith, T. L.; Whelan, B. J.

*Building Better Roofs - IRC Technical Seminar, pp. 93-107, 1996-09-01*

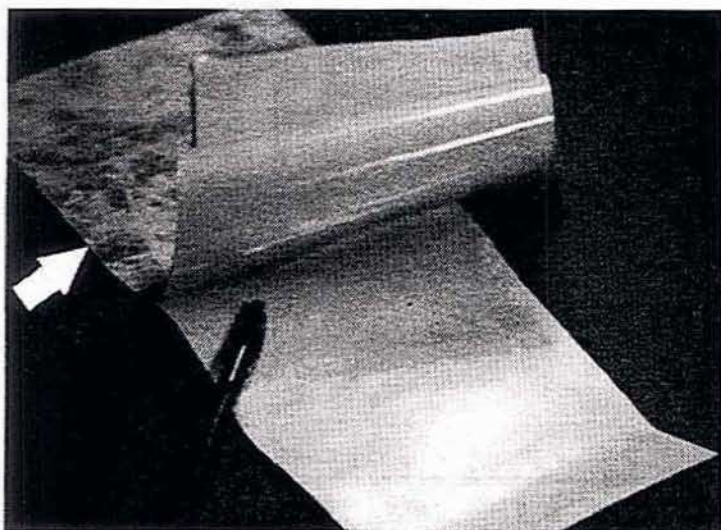
Figure 6 View of an "unbonded flap." The seam occurs where indicated by the arrow. The ink pen is laying on the unbonded flap, which extended underneath the membrane for several inches beyond the lap.
