FROST HEAVE DURING WINTER CONSTRUCTION OF A BUILDING IN OTTAWA, CANADA

by K.N. Burn and R.K. Beach

Reprinted, from
Proceedings, International Symposium on Frost Action in Soils
held at U. of Lulea, Sweden, February 1978
Vol. 1, p. 185 - 194

DBR Paper No. 763
Division of Building Research

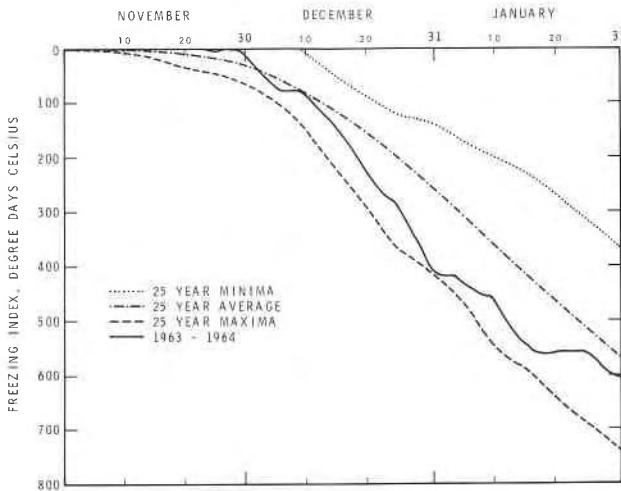
Fig. 1. Freezing Index at Ottawa, November 1963 to January 1964

In 1963, November was mild right to the end of the month, but unusually cold conditions followed when the temperatures plummeted, producing a cumulative 410 degree-days of freezing by the end of December which came close to equalling the 25-year maximum value. It was during most of this critical period that the building was open and unheated.

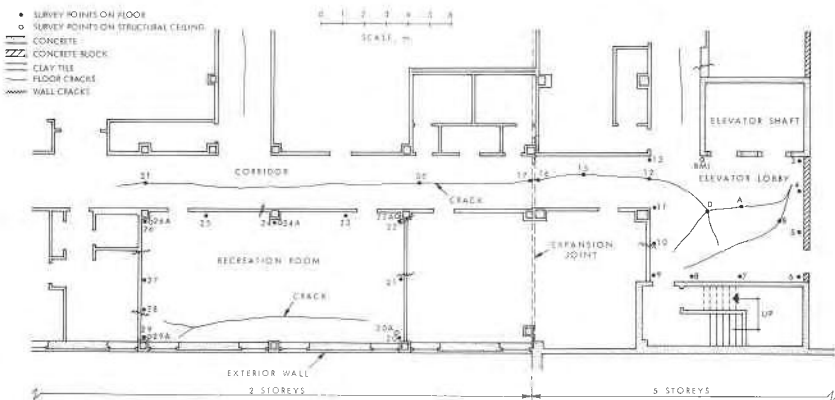
Fig. 2. Partial plan of building showing location of points for heave measurements

The first location was a two-bay recreation room, where severe cracking was observed in the tile partitions. Measurements of movements of the concrete structural ceiling were also made at the columns to determine whether there had been any differential movement of the structural frame of the building. The second area was the elevator lobby where the heave was obvious and several cracks had appeared in the floor. The third area was a corridor running from the elevator lobby past the recreation room. It had a longitudinal crack running almost the full length of the corridor.

The points at which levels were taken are shown in Figure 2. Positions of floor cracks and vertical cracks in the partitions are

also shown. The results of the surveys are shown graphically in Figure 3.
