The facts and the lessons of Listowel: a study of the factors relating to the collapse of Listowel arena and the lessons to be drawn from the tragedy in the interests of public safety

Canadian Consulting Engineer, 2, 5, pp. 36-47, 1960-05-01

The Collapse of the Listowel Arena

Technical Paper No. 97
of the
Division of Building Research

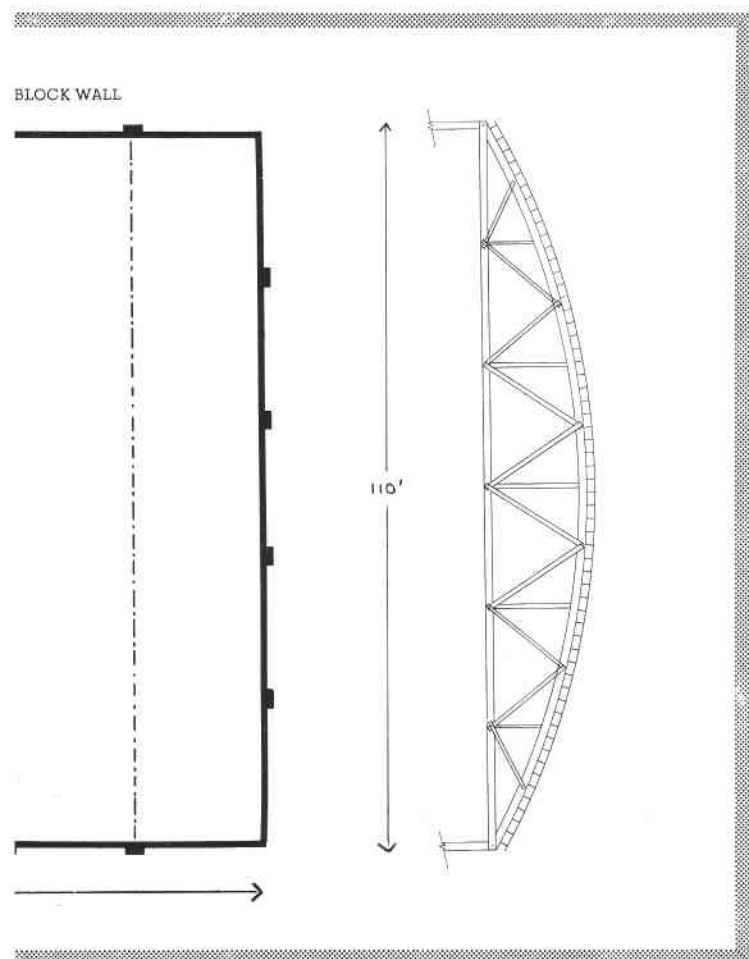
Fig. 3. A drawing of one of the trusses as originally designed

(5) An unsymmetrical distribution of snow load may occur and this condition must also be considered in the design of the truss members. Each diagonal web-member shown on the design drawing and used in these trusses was connected to one face only of each chord. This arrangement is undesirable because the effect of forces in the web-members connected eccentrically is to apply a torque to the chord and, as a consequence, to cause serious second-

ary stresses. This eccentric joint arrangement is shown in Sect. A-A of Fig. 3.
