## **Protection of foam plastic thermal insulation in low sloped roofing systems**

**Booth, R.J.; DeRushie, C.; Liu, K.K.Y.**

**NRCC-45712**

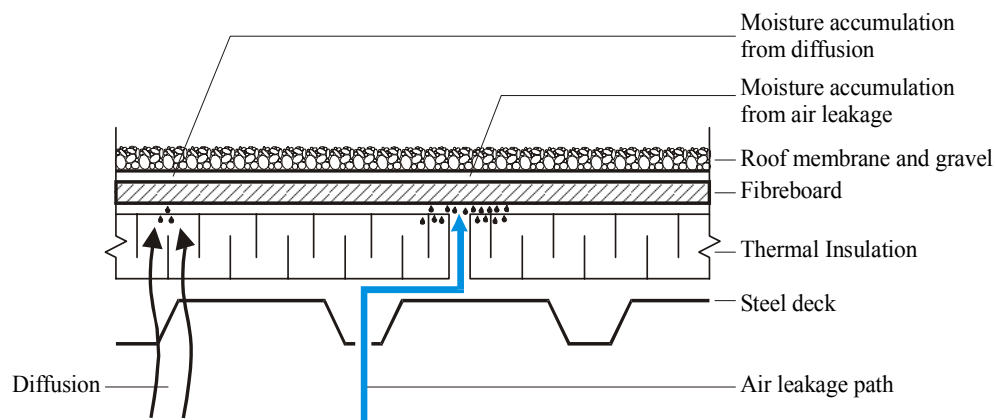
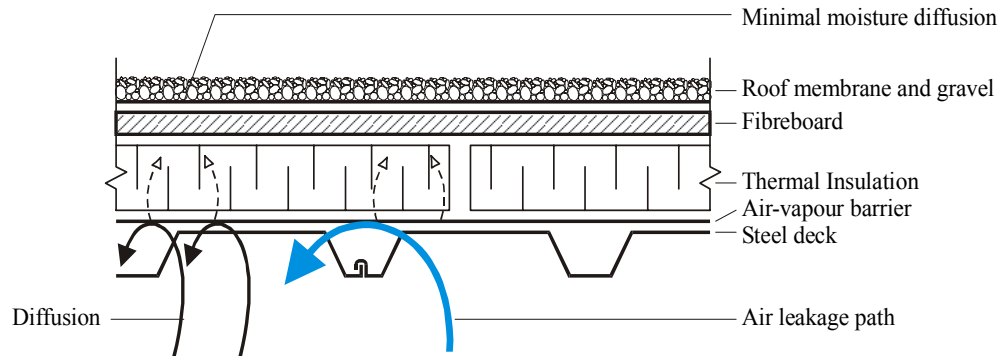
Substitute glass fibre with phenolic or other plastic foam insulation and essentially no air will enter the insulation, instead moist air enters the network of insulation joints and, in winter, water will condense on or in the cold (membrane or overlay) surface over the joints between the insulation boards. Board joints are about 1% of the area of insulation boards in a roof, depending upon board sizes and board gaps. Condensation is concentrated between the insulation boards and this can result in "pencil line" corrosion on steel deck below foam insulation joints. [Figures 4(a) and 4(b)].

Roofs with air-vapour barriers are protected from condensation and "pencil line"

corrosion has not been seen in such roofs.

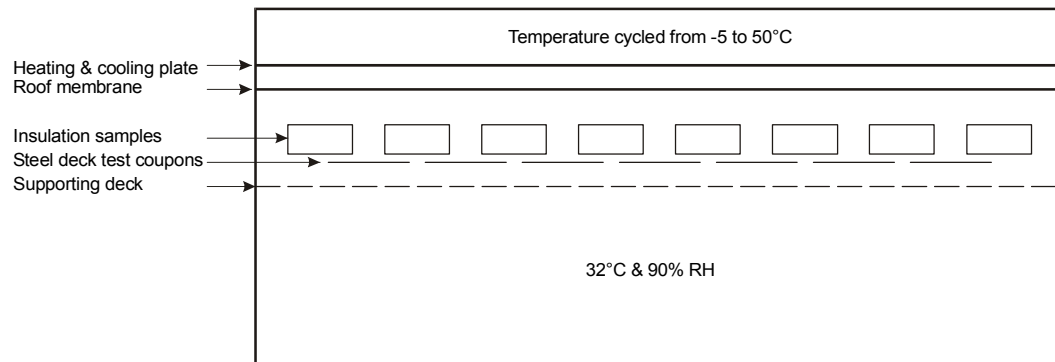
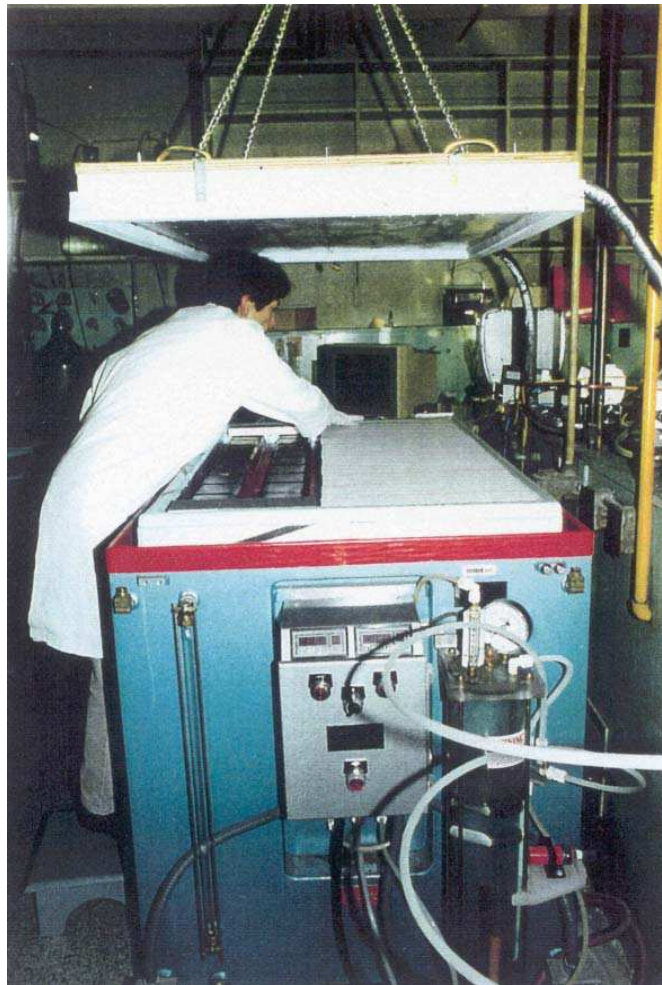
*The amount of steel deck corrosion was inspected visually after 4, 10, 18, 26 and 34 weeks of exposure. After 34 weeks of exposure to these conditions the pH of leachates indicated that 99% of the acid in the phenolic insulation samples had been removed. The amount of corrosion observed on the steel deck under both insulation types was superficial [Figure 6]. The rate and severity of corrosion was slightly worse underneath the polyisocyanurate insulation than underneath the phenolic insulation. Lines of discolouration were visible on the steel deck underneath the joints between insulation samples, this phenomenon has been seen in commercial sized roofs that have inadequate condensation protection.*

Figure 5 The apparatus used to simulate a low sloped industrial roof undergoing repeated cycles of condensation followed by drying (a) cross-section and (b) photo.
