LANDSLIDE AT ORLEANS, ONTARIO

by W. J. Eden and P. M. Jarrett

Technical Paper No. 321
of the
Division of Building Research

Ottawa
March 1971

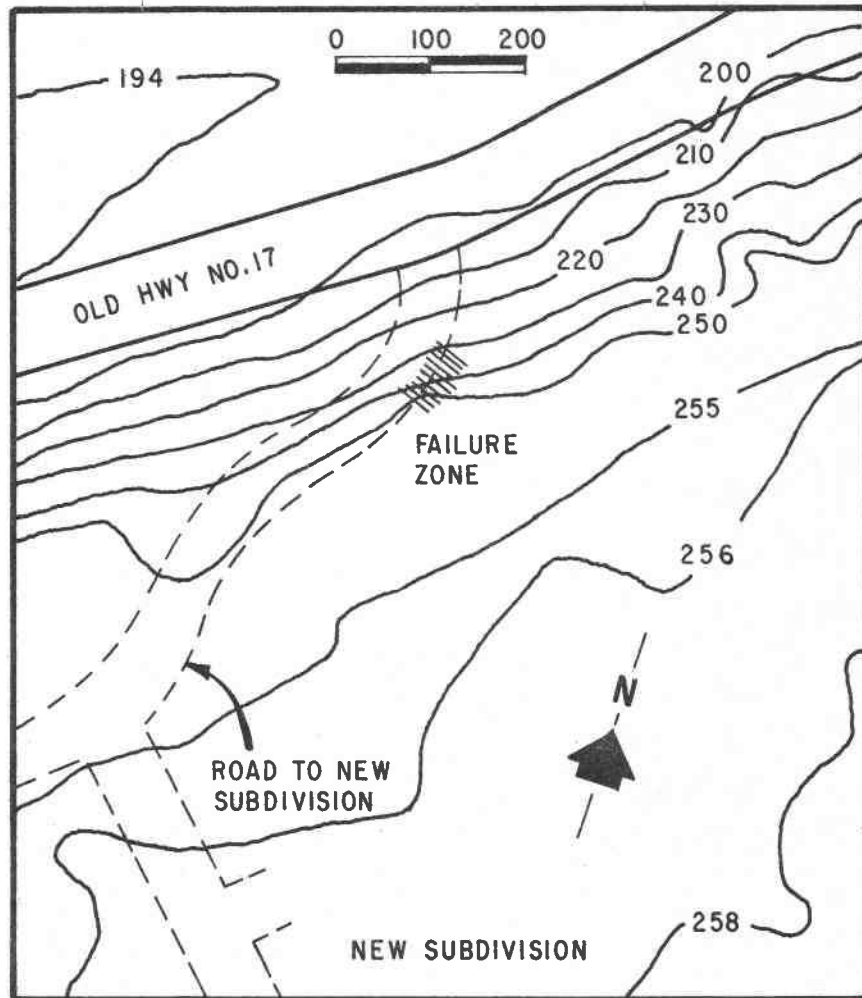
FIGURE 1
SLIDE AREA BEFORE THE DEVELOPMENT

On 10 October 1965, a small landslide occurred in the side hill cut of a road from a housing subdivision at Orleans, Ontario. The road descended from a 50-ft high clay terrace to the former route of Highway 17 at the toe of the slope. Figure 1 is a plan of the area showing the terrace and the alignment of the road, which was constructed in 1960. To achieve a maximum gradient of 10%, a side hill cut of varying depth was necessary. The slopes of the side hill cut were a constant source of trouble due to surface sloughing. At the location of the landslide, the cut slope was inclined at nearly 35° .
