VISIT TO THE CONSTRUCTION SITE OF A HOUSING PROJECT
IN PANGNIRTUNG, BAFFIN ISLAND, N.W.T.

R.L. Quirouette

Ottawa
January 1980

DBR INTERNAL REPORT NO. 459

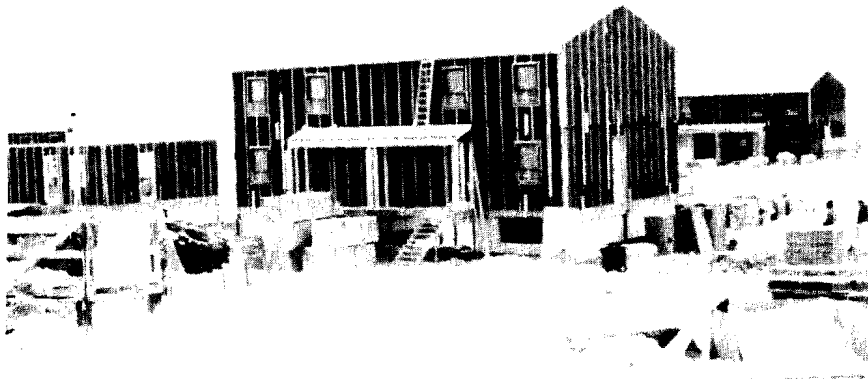
Sixteen housing units are being constructed in Pangnirtung for the government of the Northwest Territories. These new units constitute eight separate buildings of two dwelling units each. Units have either two or four bedrooms, built in 38 × 140 mm (2 × 6) wood-frame construction. They sit just above grade on light steel piles placed in slurry backfilled augered holes in the bedrock. The buildings appear to be sited in a loop with almost all buildings facing an inner court, itself the site of two buildings (Fig. 2B).

Fig. 2. Typical 2-unit, 4-bedroom house
(A) - anchor cable; (B) - front view of unit
