### Condensation in flat roofs, II Kuester, G. H.

CONDENSATION IN FLAT ROOFS, II

Internal Report No. 387

## REPORT OF TEST HUT, 1969-1970

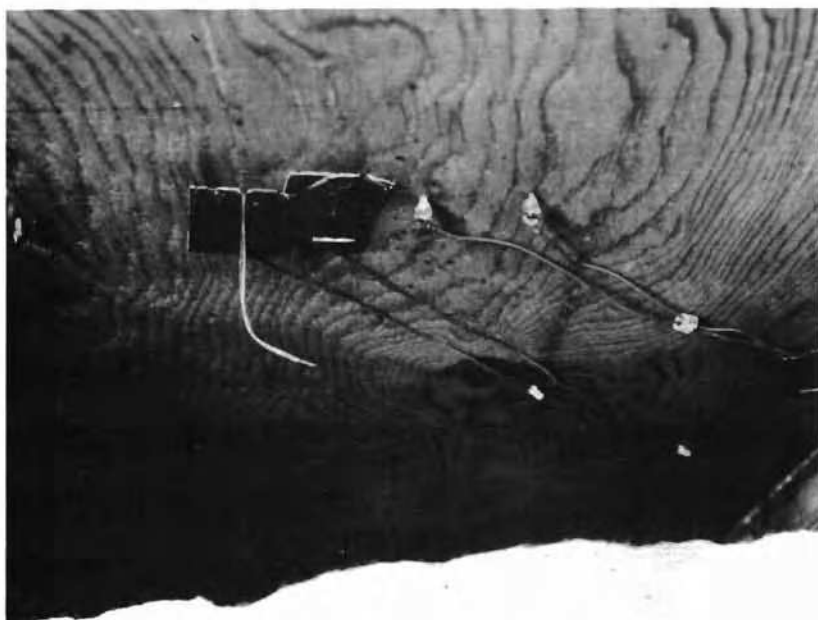
Figure 22  
Panel D, space 11. Fungus on  
wet roof deck.

Fungi or mold was observed near the south end of the test panel (Figure 22) and subsequently analyzed to be of a kind known not to deteriorate wood (coadostorium species).
