Investigation of vibrations through soil caused by heavy vehicles in Winnipeg Sutherland, H. B.

Report (National Research Council of Canada. Division of Building Research); no. DBR-R-15, 1949-10-01

AN INVESTIGATION OF VIBRATIONS THROUGH SOIL
CAUSED BY HEAVY VEHICLES IN WINNIPEG

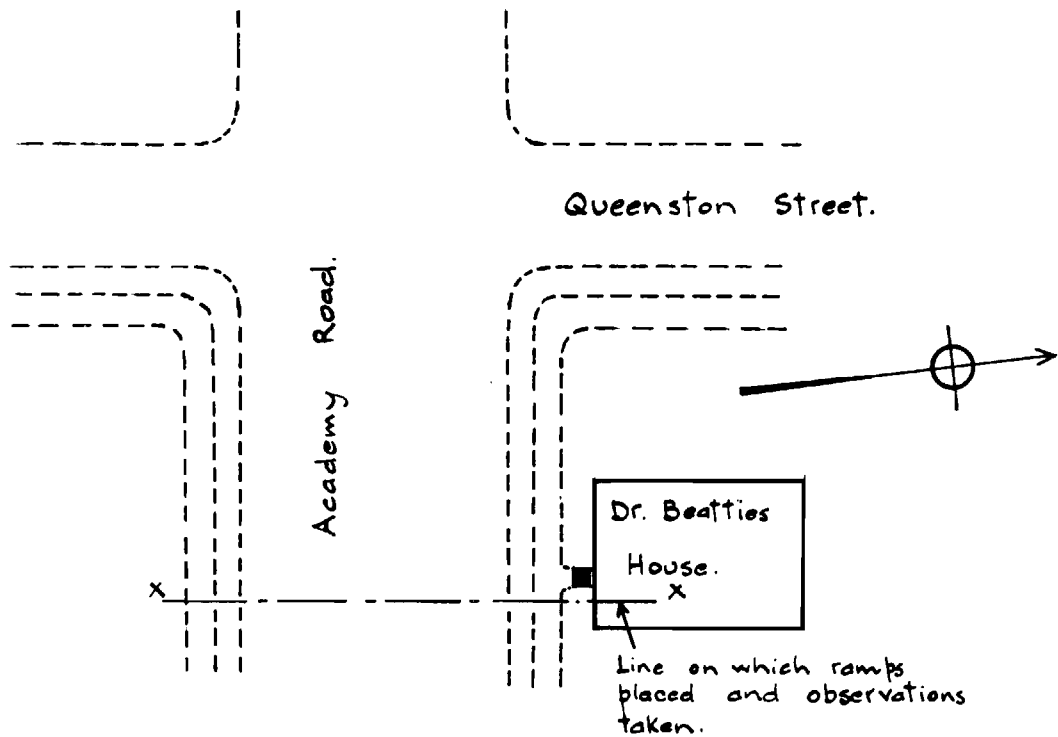
FIG. 1. scale: 1" = 30'

purpose. Its position is shown in plan in Figure 1 of Sheet 1, and a view of the house is shown in Figure 6, Sheet 3. The main observation point was downstairs, the seismograph being set up close to window 1 in Figure 3. The remote control switch was operated from outside this window. A second observation point upstairs was established close to window 2. All the recordings, apart from two, were taken at these two observation points in Dr. Beattie's house. The other two recordings were taken in a house close to Academy Road.

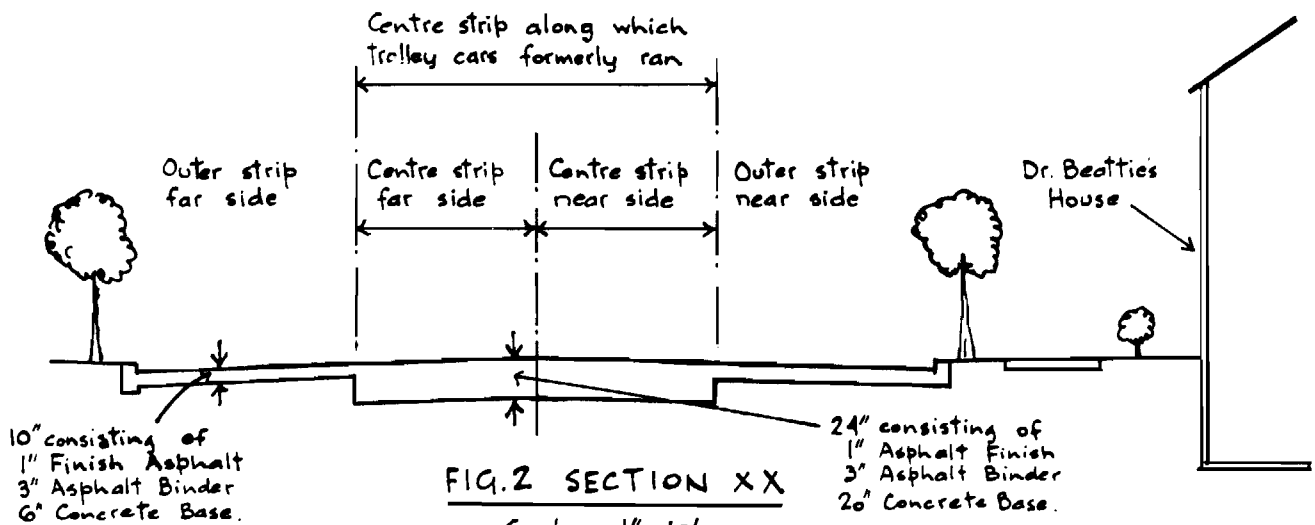
FIG. 2 SECTION XX

- (a) Before the introduction of trolley buses, street cars ran down the centre strip of Academy Road. This centre strip is approximately 21 feet wide. The construction and maintenance of the centre strip was the responsibility of the Winnipeg Electric Company while the street cars were in operation. To accommodate the ties and rails and provide a suitable base, a total thickness of approximately 24 inches of concrete was provided in the centre strip. Between this centre strip and the curbs on each side, the City of Winnipeg had provided a road approximately 10 inches thick. When the street cars stopped operating, the rails were removed and the complete width of carriage-way re-surfaced with asphalt. A cross section of the roadway is shown in Sheet 1, Figure 2.

As previously described, and as shown in Figure 2 of Sheet 1, Academy Road has two road bed constructions, an approximately 24-inch thickness in the centre strip and a 10-inch construction in the outer strips. Running the vehicles on these various tracks gives control over factor (e).

For purposes of testing, Academy Road was divided into four strips, as shown in Figure 2, Sheet 1. The strips were described as follows:

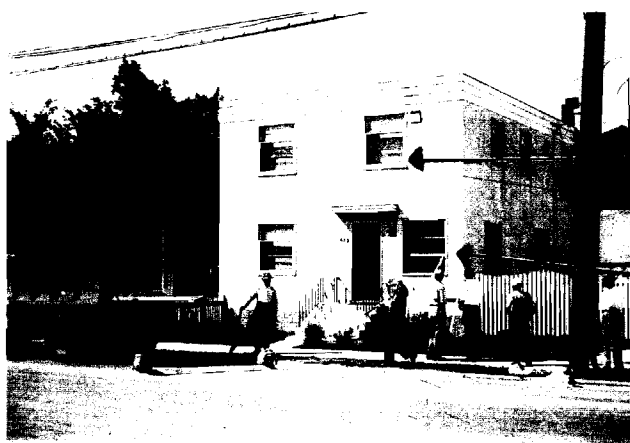
FIG. 6 DR. BEATTIE'S HOUSE SHOWING
UPSTAIRS AND DOWNSTAIRS
OBSERVATION POINTS.
