An Attic Condensation Problem Robson, D. R.

441

TECHNICAL NOTE

SUBJECT AN ATTIC CONDENSATION PROBLEM

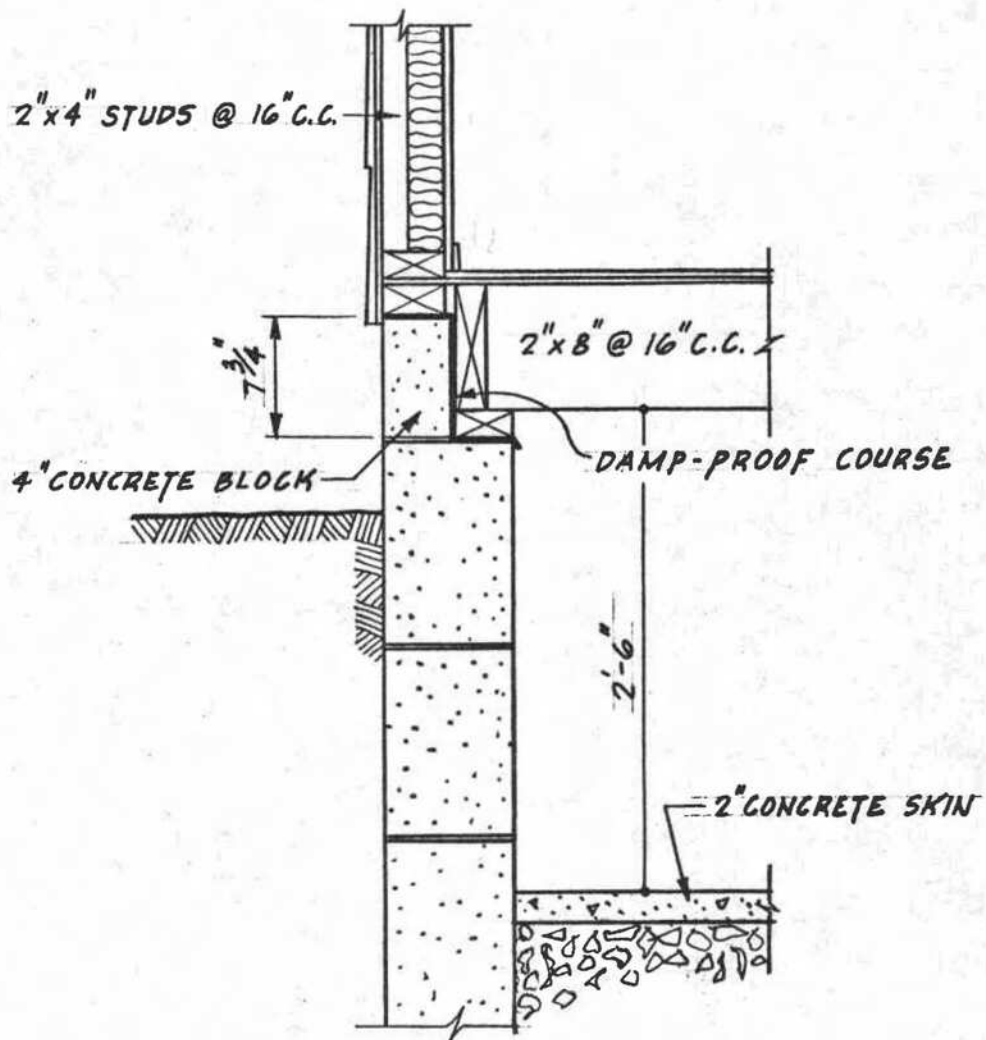
FIGURE 2

were not such as to make an apparent contribution to the moisture problem under investigation. The block walls of the crawl space were uninsulated, and the ground surface was covered with a thin layer of concrete and no vapour barrier was used under the concrete skin. The addition of a light skin of concrete over the crawl space fill has the advantage of making the crawl space much more usable as storage space (Figure 2). Access to the crawl space is conveniently located in the floor of the closet serving the main entrance. Heat is introduced to the crawl space by outlets taken from the main plenum. Figure 3 (AR-531) illustrates the position of the house relative to the surrounding area.
