NHBA EXPERIMENTAL PROJECT MARK II,
FOREST LAWN, ALBERTA

by
G. O. Handegord

Internal Report No. 244
of the
Division of Building Research

OTTAWA
January 1962

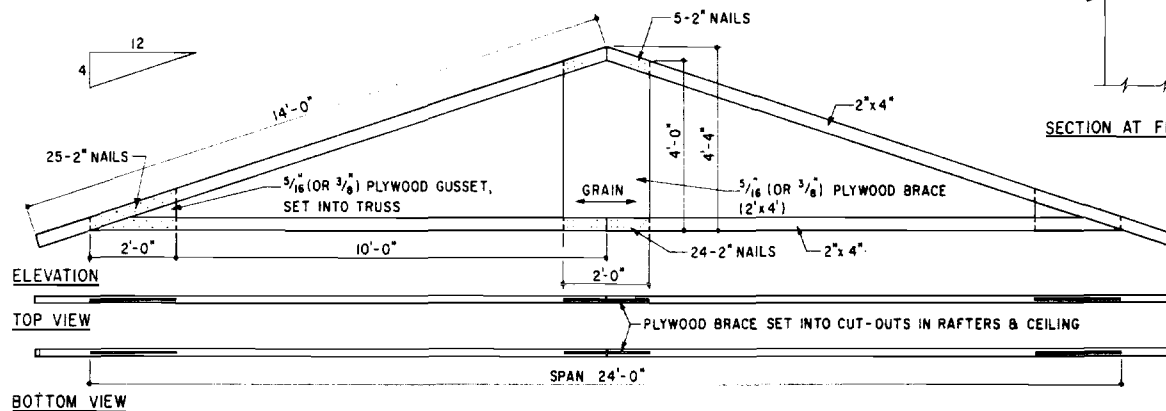
ROOF TRUSS DETAILS

A special type of king post truss spaced at 2-foot centres was employed as the basic roof structure, (Fig. 2) and this system appeared to have performed satisfactorily. Roof sheathing consisted of 3/8-inch cross-grained plywood, 14 feet in length, applied so as to extend from ridge to eave without horizontal joints. No reinforcing was used at the joints between the plywood roof sheets; these were simply caulked and painted. The roofing used was a special liquid coating called "Permaclad", and was applied according to the suppliers' directions.

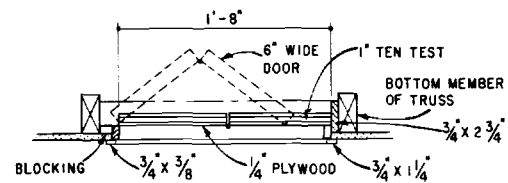
CEILING VENT DETAIL

Ventilation was provided for in the design with two ducts formed in the ceiling joist spaces and extending from the furnace plenum to the eaves at the front and rear of the house. These ducts were installed as shown in the detail in Fig. 2. Both ducts were equipped with manually operated dampers for control of the amount of ventilation. The exhaust of air from the house was provided for by a bathroom exhaust fan and by two ceiling vents, one in the master bedroom and one in the living room, which were equipped with manually operated doors as shown in Fig. 3 and connected by ducts to the outside. It was intended that the outside air intakes and ceiling vents could be opened in winter to provide a means for moisture removal and could be opened in winter to provide a means for moisture removal and could similarly be employed in summer to gain the benefits of night cooling. In winter, except for a short period after occupancy, only the vent in the master bedroom was kept open. This was found necessary because of the discomfort from cold down drafts from the vents, presumably during "off" periods of the fan or under certain wind conditions. The tenant preferred
