PAINT PERFORMANCE ON HOUSES IN AMHERST, N.S.

Internal Report No. 327  
of the  
Division of Building Research

Ottawa  
May 1966

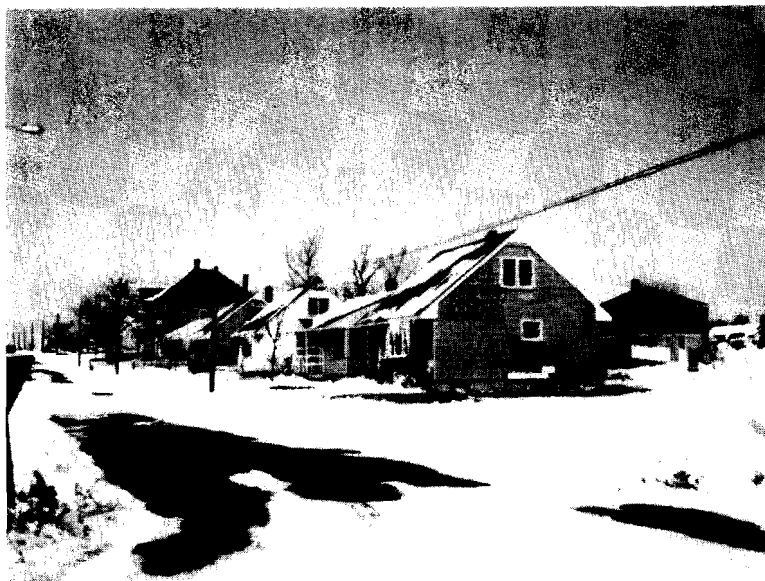
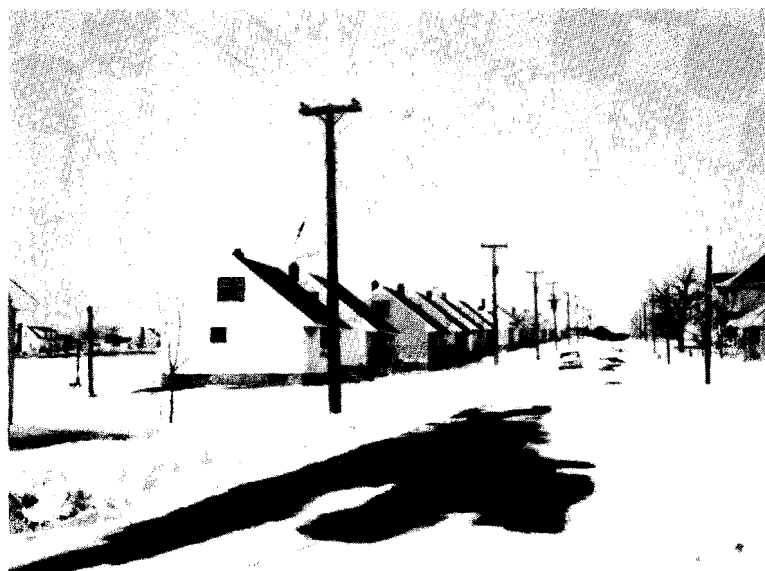
Figure 1 Looking North from Spring St. on Westminster Ave. C.M.H.C. Houses, Amherst, Nova Scotia

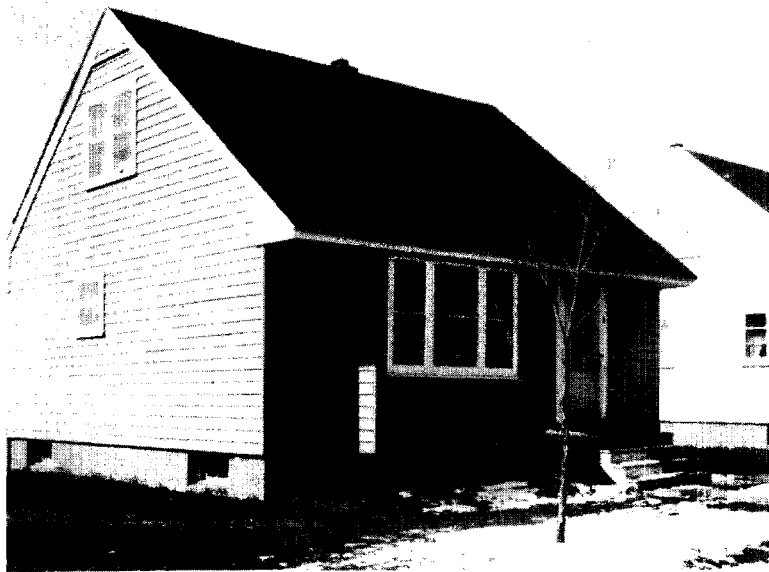
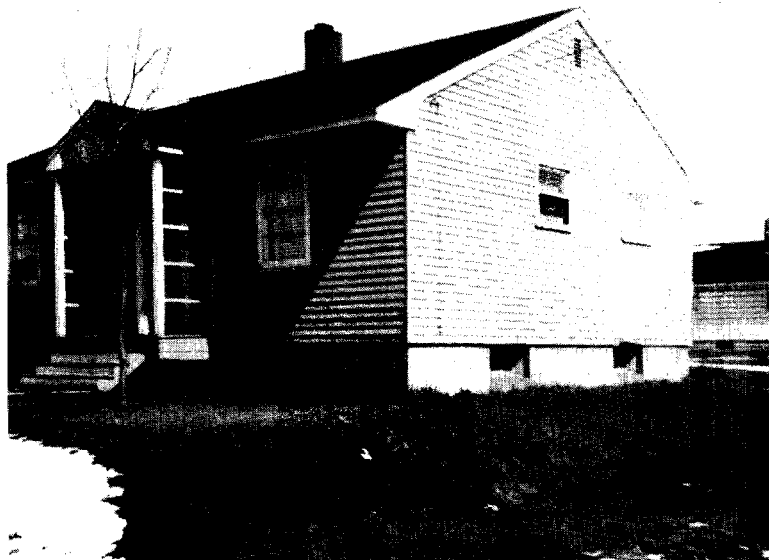
Figure 4  $1\frac{1}{2}$ -Storey House with Asbestos Siding on  
All Exterior Wall Surfaces

Figure 3 Bevelled Wood Siding on all Exterior Wall Surfaces
