PERFORMANCE OF "T. T. W." BRICK BUILDINGS
by

Internal Report No. 380
of the
Division of Building Research

OTTAWA
November 1970

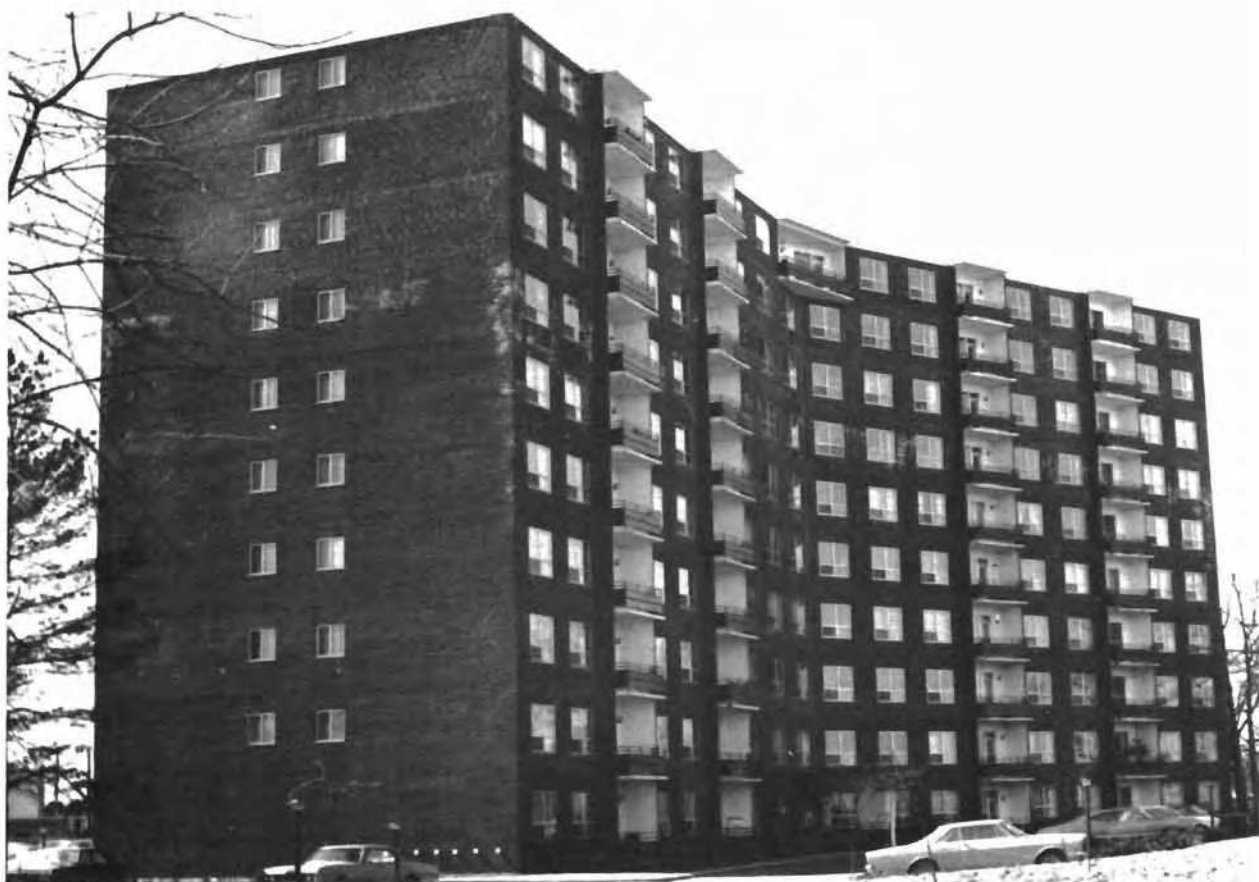
Cracking of interior walls was reported to have occurred in some buildings, particularly where cross-walls of concrete block masonry adjoined the exterior walls. The large apartment building in Sarnia, pictured in Figure 1, showed step-cracking of a concrete wall of the top storey (Figure 11), but the caretaker stated that such cracking was not extensive in the building.

Figure 1 - 10-storey, 112-suite, "Fairway Towers" apartment building, Sarnia, erected in 1967; described in the Daily Commercial News as "Canada's first high rise engineered clay masonry bearing wall apartment house ..."

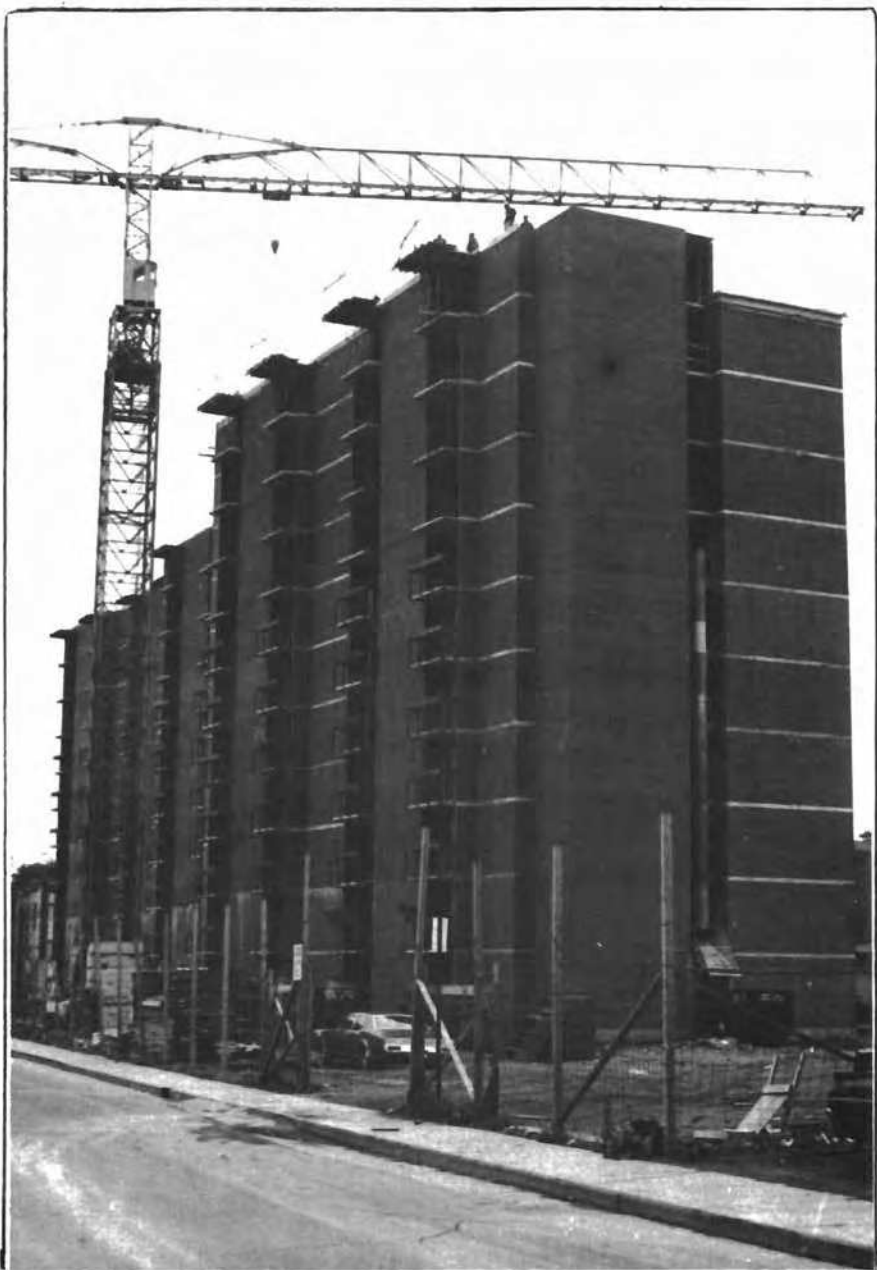
A 10-storey apartment structure 300 feet in length (Figure 2), that was under construction in Hamilton when examined during the survey, provides an example of the T. T. W. building system. Each storey of this building, according to the construction superintendent, made use of 52,000 T. T. W. bricks; the more than half-million bricks in the building were laid by 9 bricklayers, with the assistance of 4 labourers and the mortar-mixer operator. The rate of construction was such that each storey of the building (walls and floor slab) was completed within 10 days, even though much of the wall construction on this particular building was carried out in the winter months by bricklayers who had not previously laid T. T. W. bricks.

Figure 2 - 10-storey building of load-bearing "T. T. W." brick walls, under construction in June, 1970.

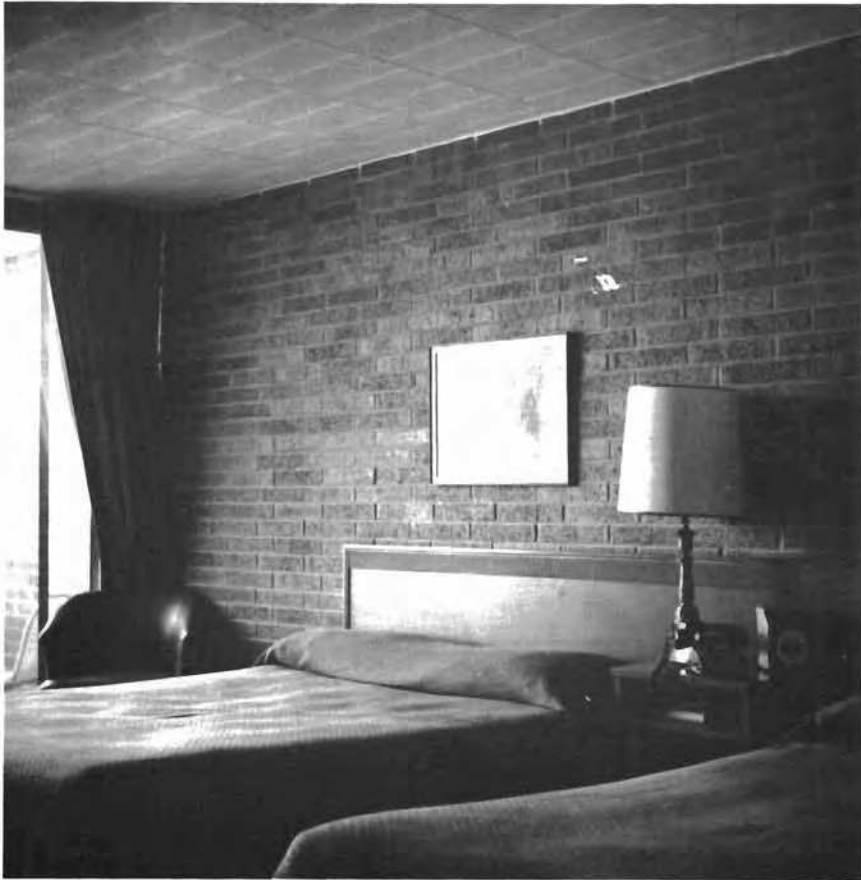
Figure 4 - Brick-finished, load-bearing interior wall of a motel in Niagara Falls; the floors consist of post-tensioned beams made up of concrete blocks, the rough-textured faces of which form the ceiling surface. An external view of this building is given in Figure 7.

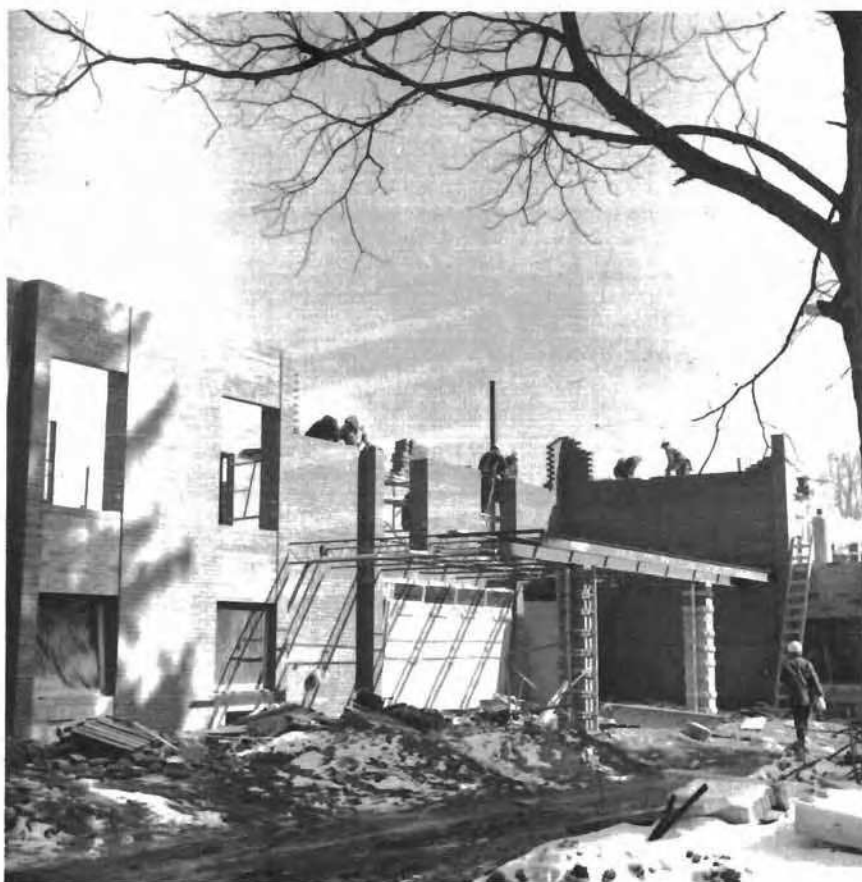
Figure 6 - "Toothing" of walls during construction.
