*American Society of Civil Engineering International Pipelines Conference 2008
[Proceedings], 2008-07-22*

Instrumentation of a Section of AC Pipe in Expansive Soil

Yafei Hu¹; Hung Q. Vu² and Kaveh Lotfian¹

Field instrumentation was successfully installed to monitor the performance of a replacement section of a 150 mm diameter AC water main in south Regina, where failures are frequent, to learn about soil behaviour and its interaction with this type of pipe. The instrumentation included sensors to measure pipe wall strains, *in situ* soil water content, soil movement, soil stress and temperature. Measurements were made in the pipe trench backfill and in the native soil around the backfill. This paper presents the first year monitoring data of the test section.

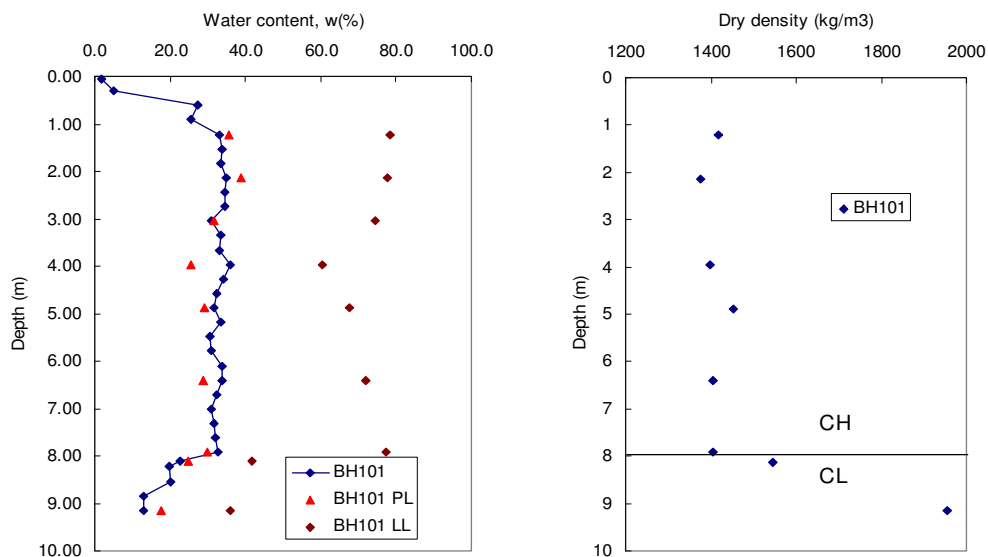
Figure 2. Soil profile, index properties, and dry density at the test site

Four boreholes were drilled to the depth of 9.5 m. One borehole was located on the street, about 0.8 m south of the centreline of the pipe. The other three boreholes were located in the Park, approximately 2.0, 5.0, and 12.1 m away from the pipe, respectively (The boreholes were later used for the installation of rod extensometers and other sensors). The stratigraphy of the site consists of approximately 8.0 m of highly plastic clay, 1.5 m of silty clay and glacial till. Figure 2 shows the soil profile, index properties, and dry density at the borehole on the street.

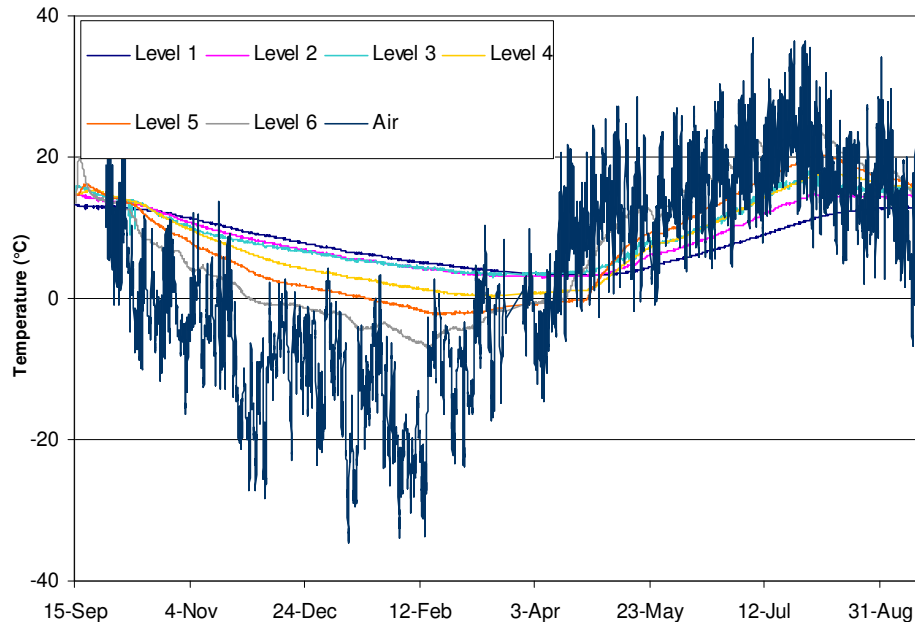
Figure 4. Temperature versus time at different levels in the trench

Figure 4 shows the average temperatures from representative levels (i.e., depths). It can be seen from this figure that, above the pipe level (Level 3), the closer to the ground surface, the more variable the temperatures; at and below the pipe level, temperature dropped at a fairly steady rate and has not gone below freezing. The deepest 0°C isotherm has reached about 1.6 m below the pavement surface around mid March for this period.

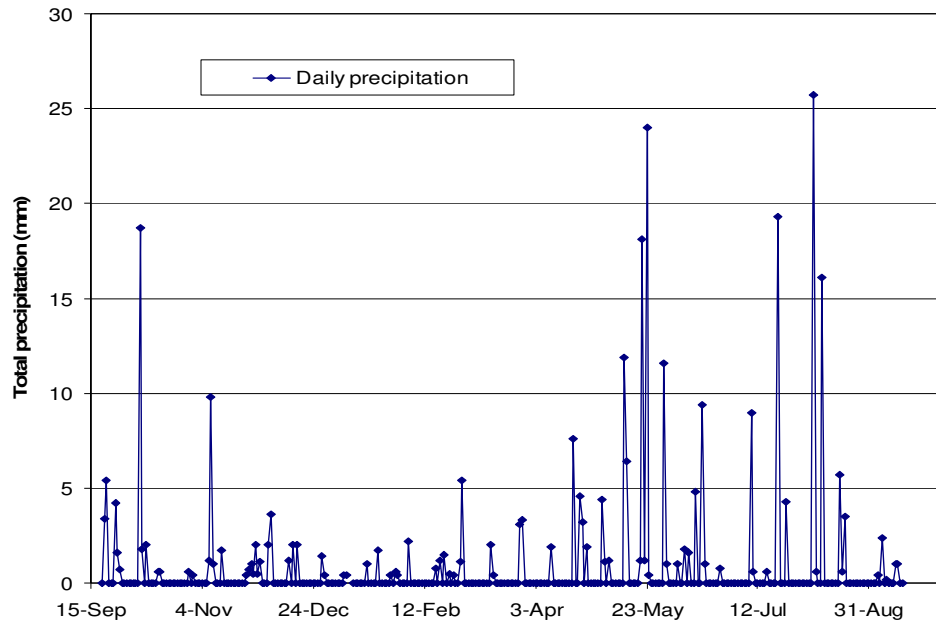
Figure 5. Precipitation for the one year period in the Regina area

Figure 5 shows the precipitation for the one year period in the Regina area. The precipitation data are from the weather station in the Regina International Airport. The total precipitation for the one year period is 312.4 mm, below the normal annual precipitation of 388mm in this area. There are three precipitation peaks: one around early October 2006, one in May and the third in late July and early August. The total precipitation in the winter period (November 2006 to March 2007) was around 60 mm in the form of snow. The snow melt in early April plus the rainfall in May, as it can be seen in the following sections, may change the soil moisture conditions significantly. Although there were significant rainfalls around July and August, the soil water content may not be influenced or even reduced during this period, as this region is defined by a combination of large water deficit and relatively high temperatures (Hamilton, 1981).
