Fire Technology, 36, Nov 4, pp. 236-248, 2000-11-01

Effectiveness of a Photoluminescent Wayguidance System

Guylène Proulx, Brian Kyle and John Creak

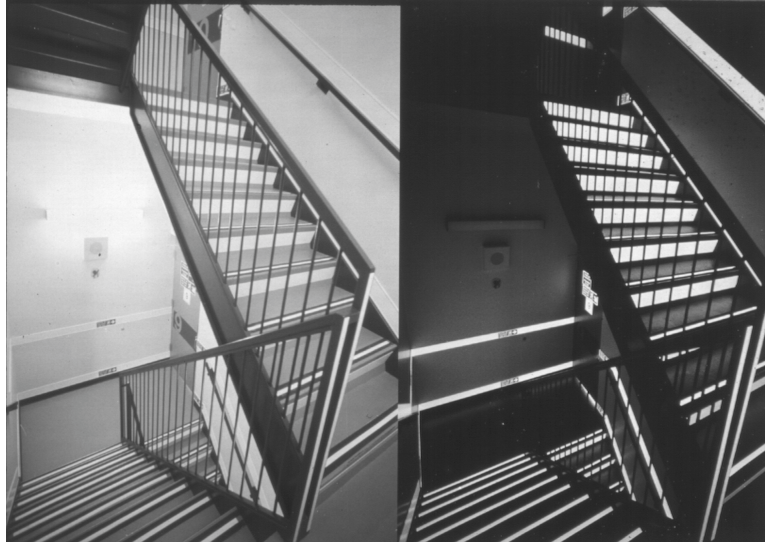
Figure 1: Stairwell C with PLM wayguidance system, lights on and off

Two of the four stairwells were equipped with PLM from the top floor of the building down to the bottom. The installation of the material was according to the Photoluminescent Safety Products Association Standard 002 Part 1 which met the Luminous Class 1 specification (PSPA, 1997). As shown in Figure 1, the stairwell was equipped with two continuous wayguidance lines of 10 cm in width; one line at skirting board and the other 1 m from the floor. Directional signs of 30 cm x 10 cm, were enclosed within these continuous lines. A 2 cm strip was fixed on the tread of each step and a 10 cm piece was positioned on the riser of each step. A sign identifying the floor number was installed on each door, as well as a sign identifying the "Transfer Floors" on Floors 4, 9 and 13. Directional signs were positioned on each door and at mid-landing at 1.7 m from the floor. In accordance with Canadian practice, signs were positioned at the top of each exit door, identifying them as a final exit. The material and installation costs for the stairwells were estimated at \$2,000 CDN/floor.

The typical illumination in the four stairwells prior to the fire alarm activation was 245 lux. When the alarm was activated, lights were switched off to meet the experimental conditions illustrated in Table 1. The material luminance in Stairwell C was 89.1 mcd/m² after 2 min of switch off and 7 mcd/m² after 30 min.
