Assessing the effectiveness of wall-window interface details to manage rainwater - selected results from window installation to a wall sheathed in extruded polystyrene

Journal of ASTM International, 6, 9, pp. 1-43, 2009-10-01

ABSTRACT: The detailing of wall-window interfaces and the consequences of defective installation of windows is an on-going concern in North America. This manuscript concerns laboratory evaluation of the water leakage performance of a select set of window-wall interface details. The details were for windows with mounting flanges installed in wood-frame walls sheathed with rigid extruded polystyrene foam. The tests were performed on a single full scale test assembly in which two identical windows were installed by two similar but nonetheless different means. Each detail included a sill pan intended to collect water that gained entry into the assembly and thus was designed to be robust (tolerant of flaws). Tests were performed over a series of different water loading (spray) rates, and over a series of different air pressure differentials at each spray rate. Air leakage rates through the window opening were monitored; they were controlled by a unique methodolog

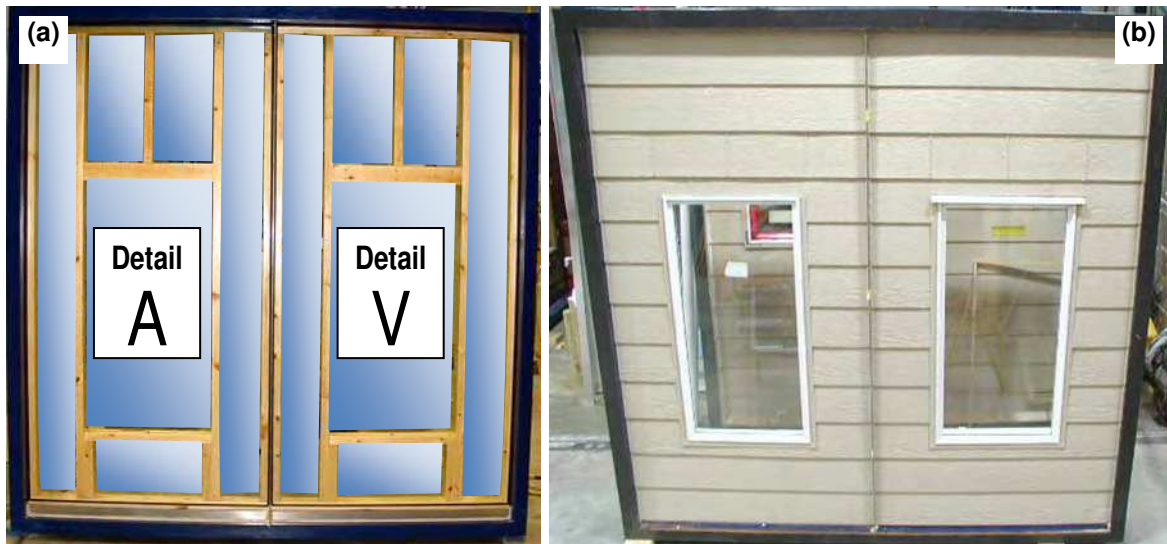
Figure 1 — (a) schematic of front elevation of 2.44-m by 2.44-m (8-ft. by 8-ft.) specimen showing location of 600 mm by 1200 mm (2-ft. by 4-ft.) windows and adjacent wood framing studs. Detail “A” might be representative of installation details used in current practice whereas detail “V” a variation on that practice; (b) photo of a completed specimen clad with hardboard siding

Test specimens were of 2.44-m by 2.44-m (8-ft. by 8-ft.) dimension. A test specimen contained two windows, each measuring 600 mm by 1200 mm window (nominal size: 2-ft. by 4-ft.), installed in an opening measuring 625-mm by 1250-mm (Figure 1). Installation details for the window on the left side of a test specimen differed in one regard from the installation details for the window on the right side of the specimen. Entry of water around either window opening was collected in troughs located beneath the respective sill areas of the openings. Water was also collected at the base of the wall behind the cladding. The window-wall combinations evaluated were determined by the interests of an industry group. Additional details regarding the test specimen configuration are provided below.

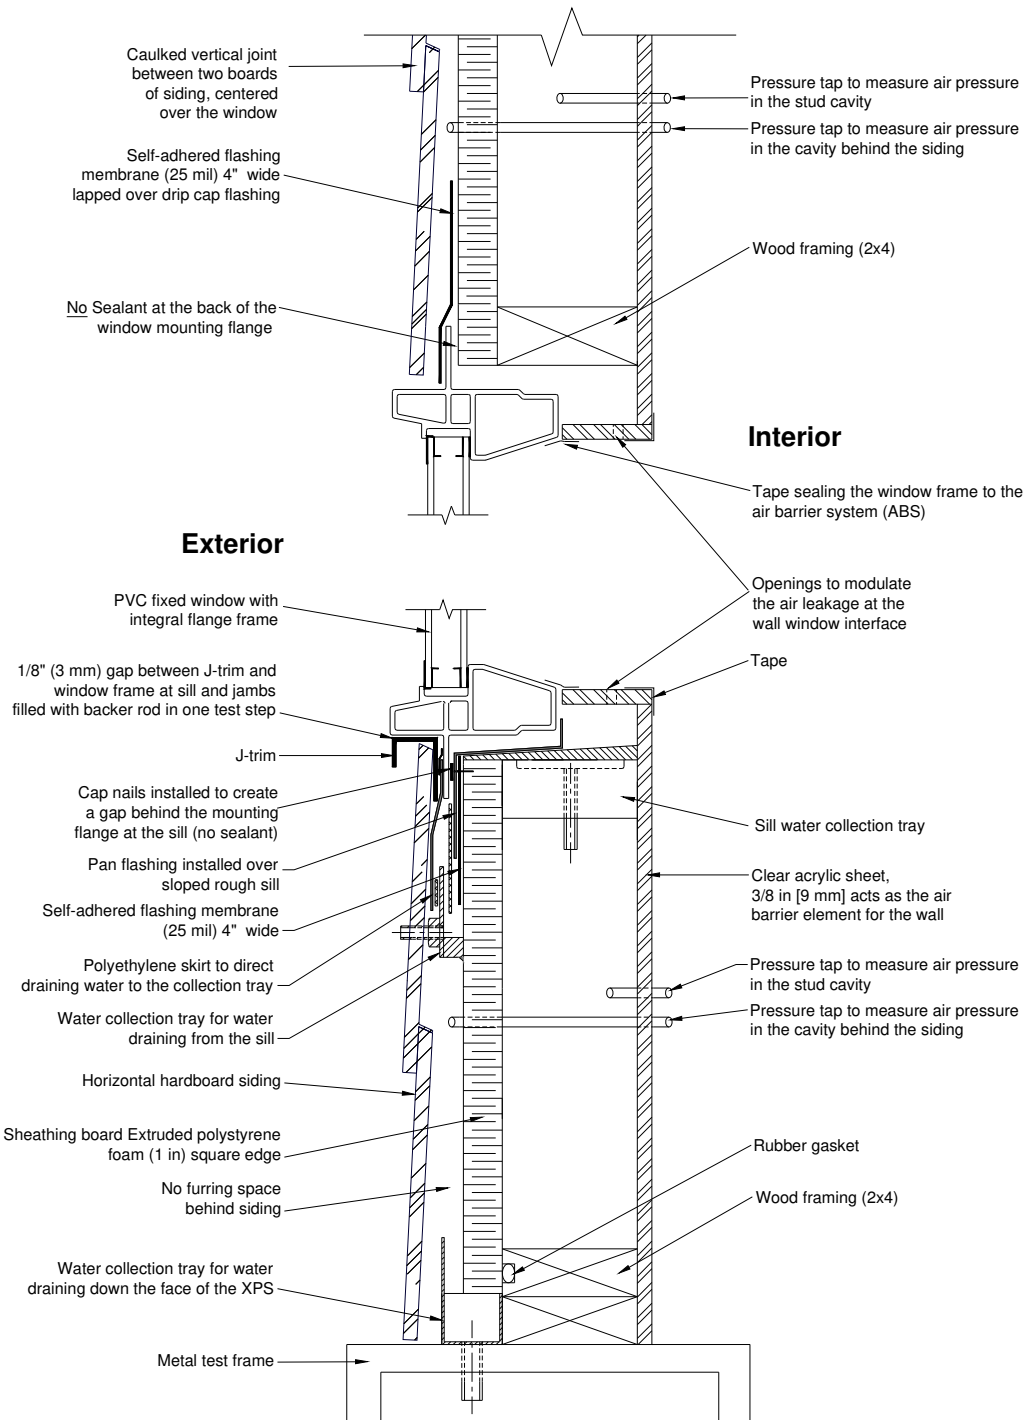
Figure 2 – Schematic drawing of XPSA W3 V-side Vertical Wall Section: without sealant behind the window flange; Note that the drawings are not accurate to the point of providing in depth details of the components; i.e. the size and spacing between components may have been modified to better depict individual items; e.g. the thickness and configuration of the siding edges have been modified as its location in relation to the WRB.

A summary of the construction details for both sides of specimen W3 is presented in Table 1. A vertical sectional view of the V-side of the specimen (without sealant behind flange) is given in Figure 2. Horizontal sectional views of the B- and V-sides are provided in Figure 3 and Figure 4 respectively. Of note is that no sheathing membrane is used in either assembly; the 25-mm (1-in.) thick XPS foam board acts as the water-resistive barrier (WRB).

Of interest as well, is the use of cap nails, as can be seen in Figure 2, to create a gap behind the window mounting flange along the sill such that drainage from the sloped sill can readily be accommodated. Also, no sealant was applied at this location. Following installation of the window, a self-adhered, 200-mm (4-in.) wide flashing membrane was used to seal the fastener heads and flange ends at the head and along the jambs.

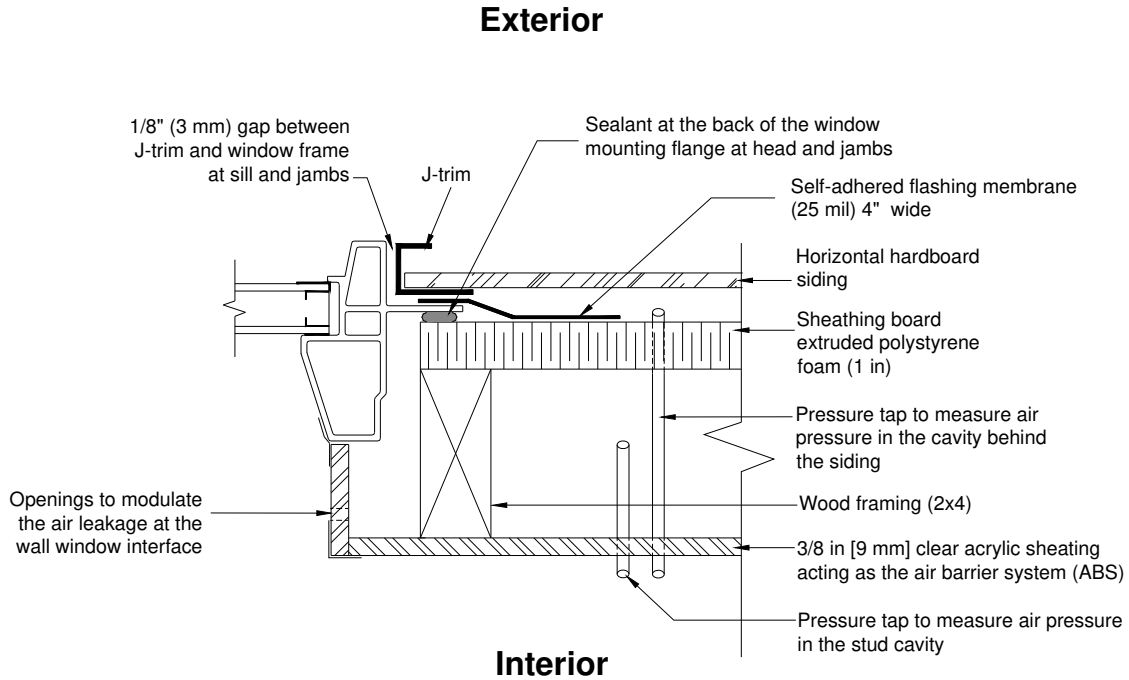
Figure 3- XPSA W3 B-side Horizontal Wall Section, with sealant behind the window flange

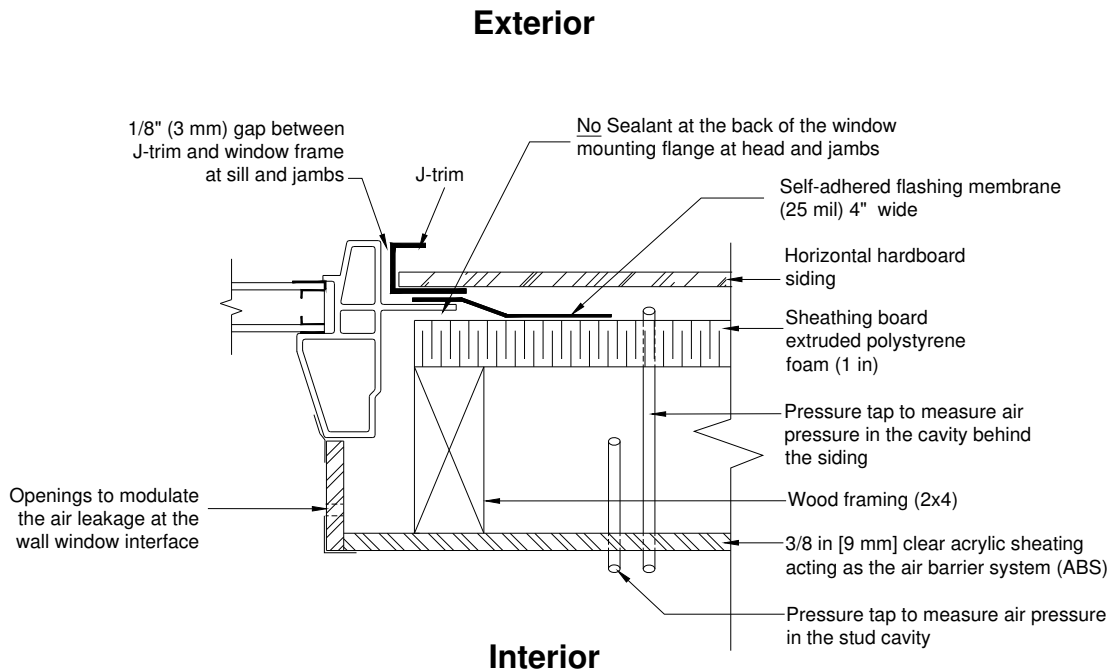
Figure 4 - XPSA W3 V-side Horizontal Wall Section, without sealant behind window flange

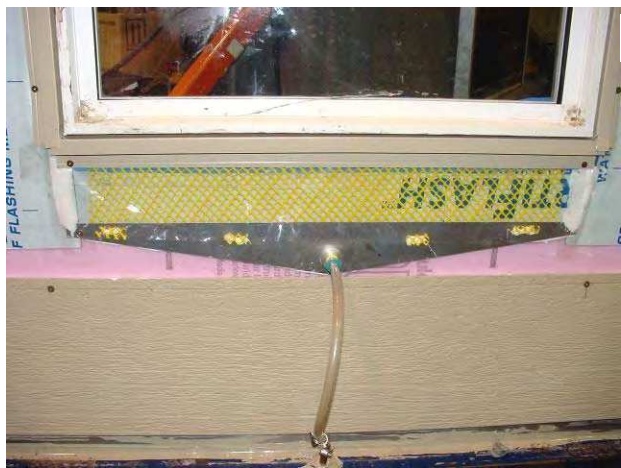
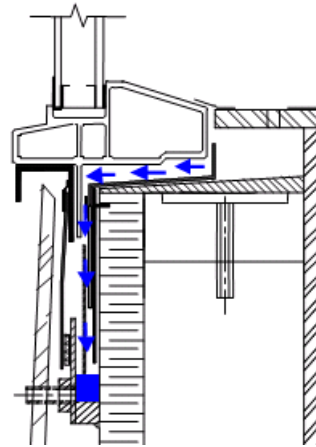
Figure 6 — Photos and related pictorials of collection troughs (a) trough for collection of water that drains from sill (b) trough for collection of water behind cladding at base of wall.

Water collection troughs—Two (2) sets of water collection troughs were used to obtain a measure of water entry behind the cladding and in the sub-sill area: (i) water accumulating in and drained from the sill could be collected in a trough as shown in Figure 6a; (ii) Collection trough at the base of the wall as shown in Figure 6b. The intent of the placing a collection trough at the base of the wall was to collect water that may have passed the cladding and found its way to the WRB and thereafter the base of the wall. Nominally, this permitted quantifying the amount and rate of water entry along these different paths and differentiating the significance between these paths given different test conditions.

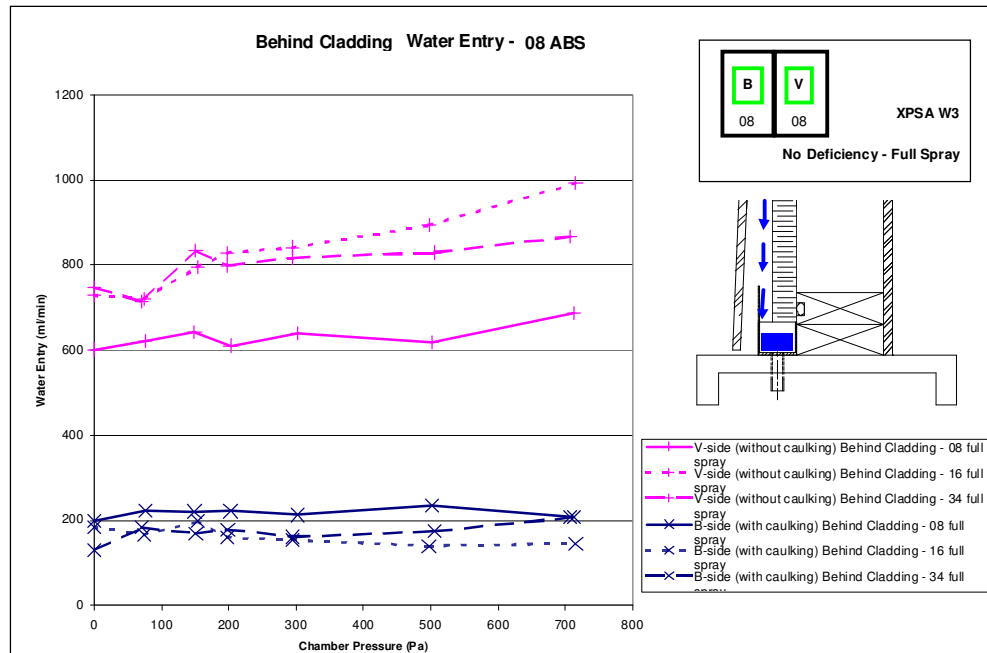
Figure 7 – Water collection rates at base of wall (behind cladding), Trial T1 - No Deficiency; 08 ABS

Collection of water behind cladding—Significant quantities of water evidently passed behind the cladding during this trial (when there were open joints between the cladding system and the window). Significantly greater rates of water collection are observed at the base of the wall than at the trough that collected water from the sill pan. Figure 7, indicates that water collection rates ranged from 170 ml/min to 1000 ml/min; these rates were higher than collection rates from the trough that collected water from the sill pan, even under the most extreme conditions and when defects were introduced into the window frames that resulted in water penetration through them.

Collection of water behind cladding—Comparison of Figures 7 and 12 indicates that there was a significant reduction in the amount of water collected at the base of the wall behind the cladding with the gasket in place. On either side of the specimen, the rate of water collection was reduced to ca. 10% of the nominal rate collected prior to sealing the head and jambs with the gasket.

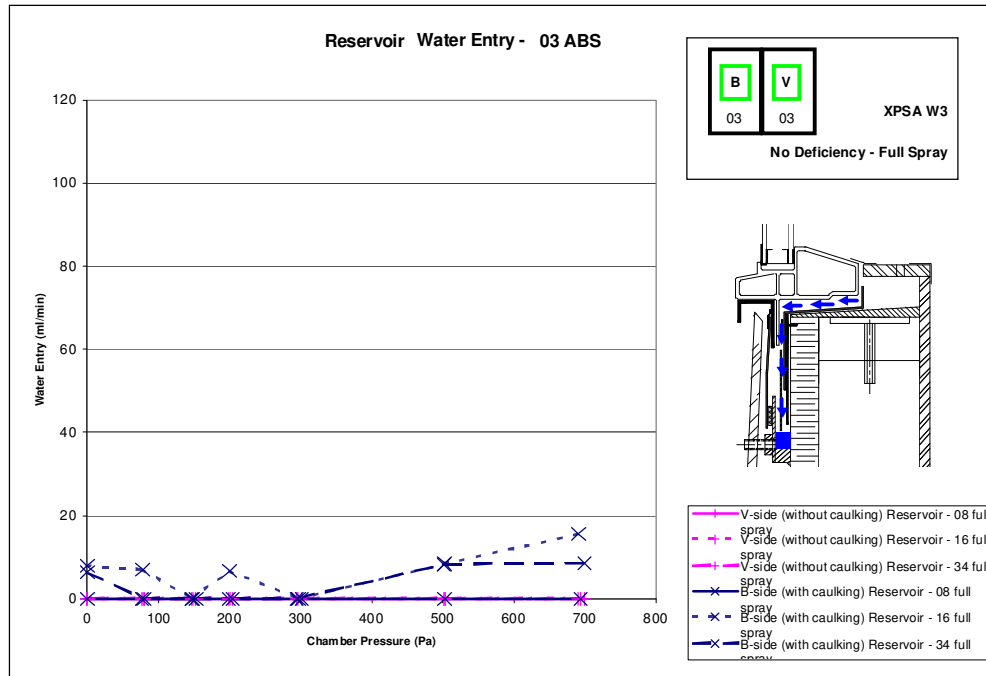
Figure 8 - Water collection rates from sill pan, Trial T1 - No Deficiency, 03 ABS

Drainage from the sill pan - no deficiencies—Smaller rates of water collection (<20 ml/min) were evident for the trough accommodating drainage from the sill pan as compared to rates obtained at the base of the wall behind the cladding (Fig. 8 – No deficiency; 03 ABS). Rates of drainage from the sill pan on the B-side (with sealant behind flanges) were greater than of the V-side (without sealant). This was the case, even when the installations were adjusted to the relatively restrictive air leakage condition (03 ABS) and when no differential air pressure was exerted across the specimen (0 Pa). At the less restrictive air leakage condition (Fig. 9 – No deficiency; 08 ABS), both sides showed small increases in rates of collection of water draining from the sill pan (<20 ml/min).

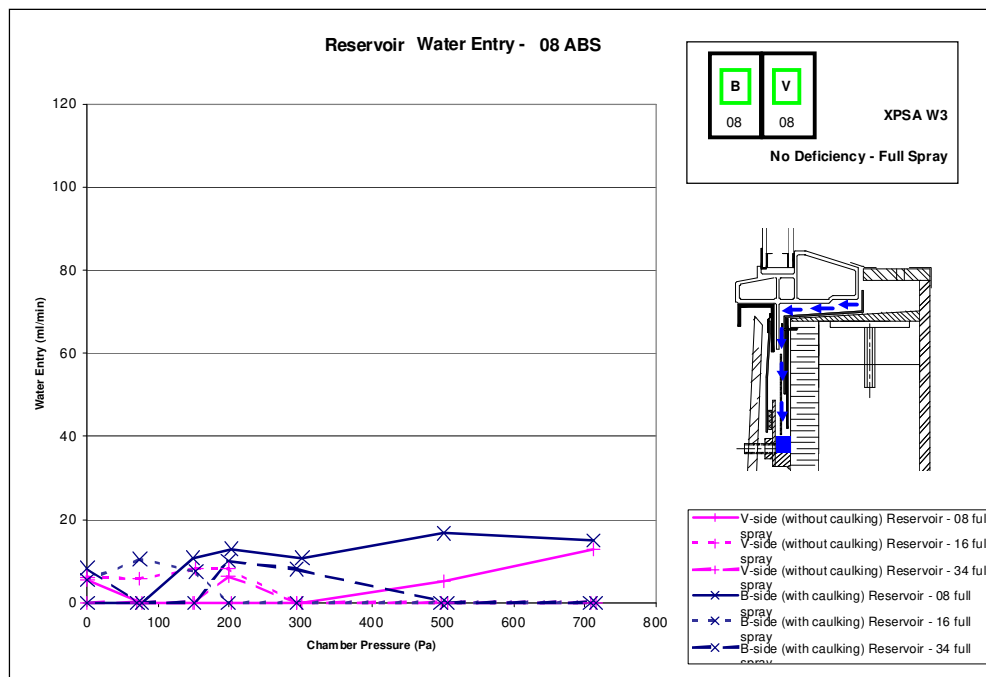
Figure 9 - Water collection rates from sill pan, Trial T1 - No Deficiency, 08 ABS

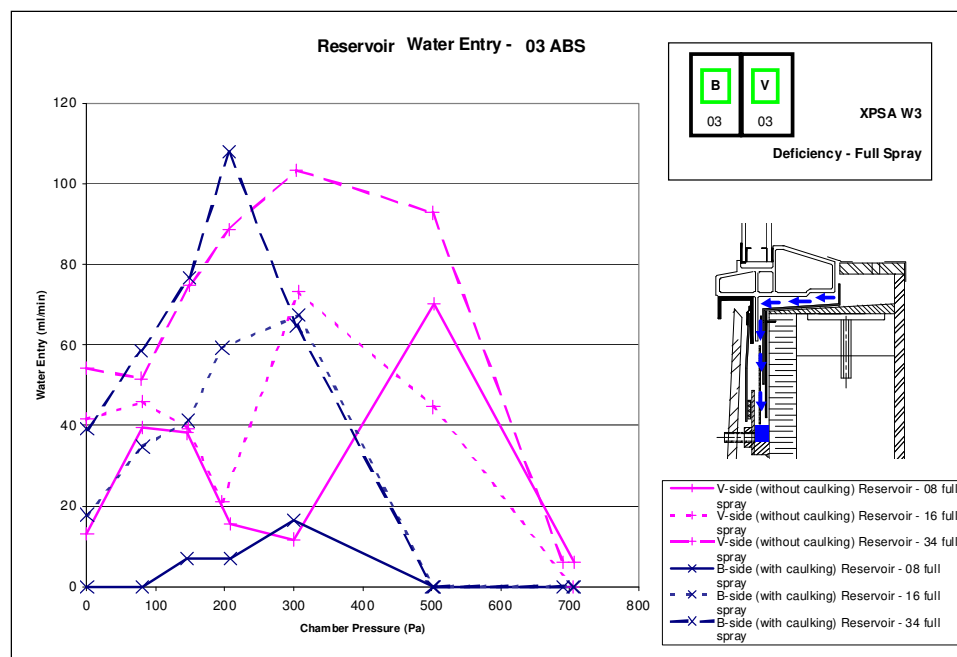
Figure 10 - Water collection rates from sill pan, Trial T1 – Deficiency at window corners, 03 ABS

Drainage from the sill pan - with deficiencies—Higher drainage rates were recorded on both the B-side (with sealant) and V-side (without sealant) of the specimen at pressure differentials up to the 300 Pa as compared to the drainage rates recorded from test sequences with no deficiency (Figure 10 and Figure 11). This was the case regardless of the condition of the ABS. At the 500 Pa pressure level, drainage on the B-side (with sealant) was arrested and water began to accumulate in the sill pan, whereas drainage on the V-side (without sealant) drainage from the sill pan continued, although in some tests the drainage rate was reduced as compared to the rates obtained at lower pressures. At the 700 Pa pressure level, drainage on both sides had ceased and water was observed to overflow the sill pan and enter the stud cavity. As well, drainage from the sill on the B-side was evident at pressures differentials of up to 200 Pa and up to 300 Pa for drainage from the sill on the V-side.

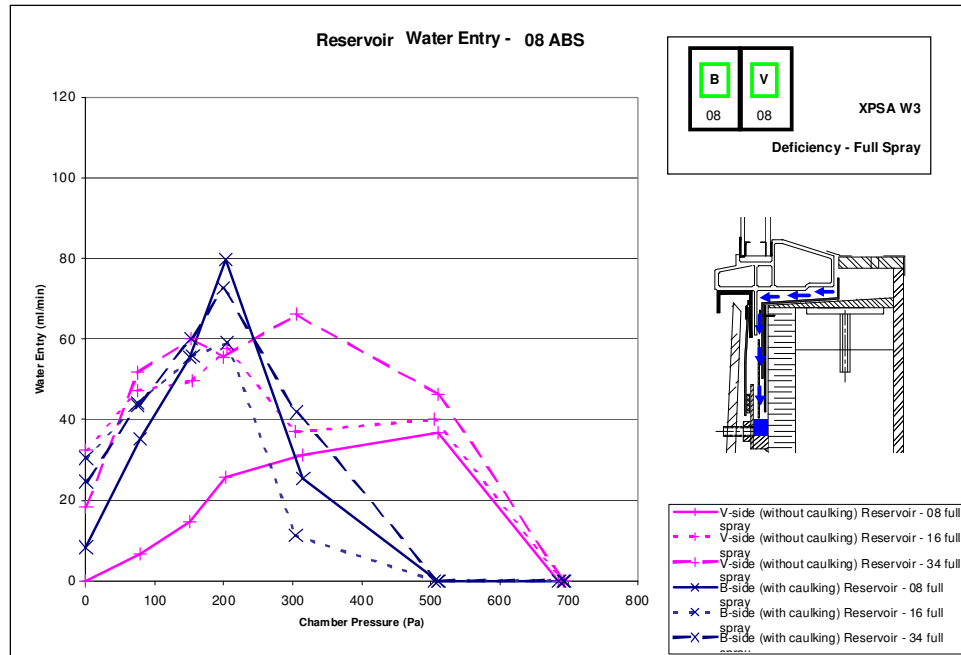
Figure 11 - Water collection rates from sill pan, Trial T1 – Deficiency at window corners, 08 ABS

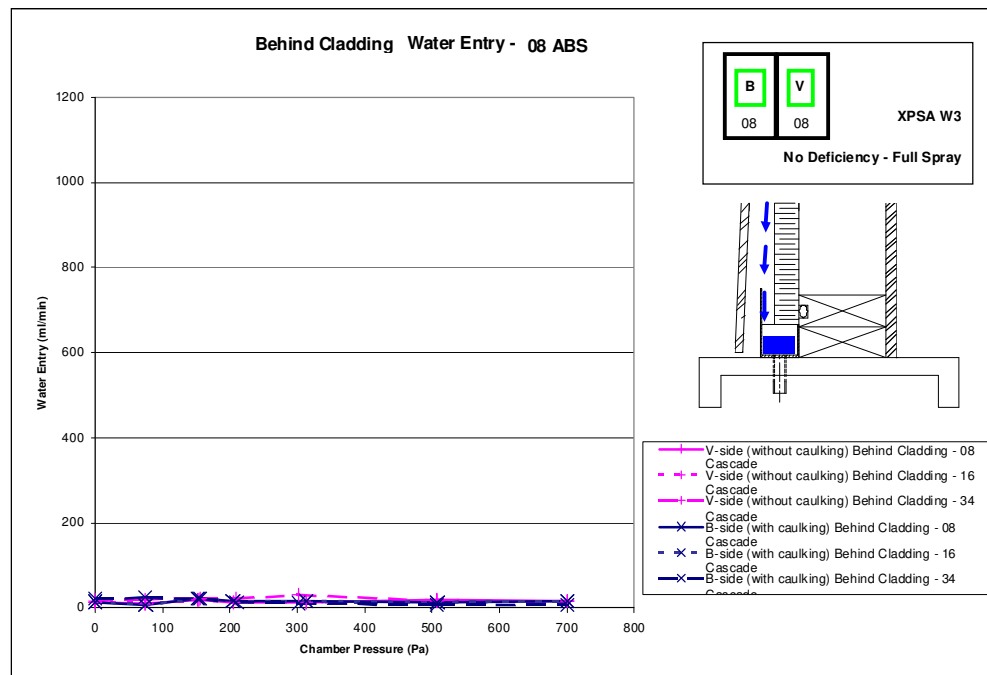
Figure 12 - Water collection rates at base of wall (behind cladding) Trial T2 - with rubber gasket;

No Deficiency; 08 ABS

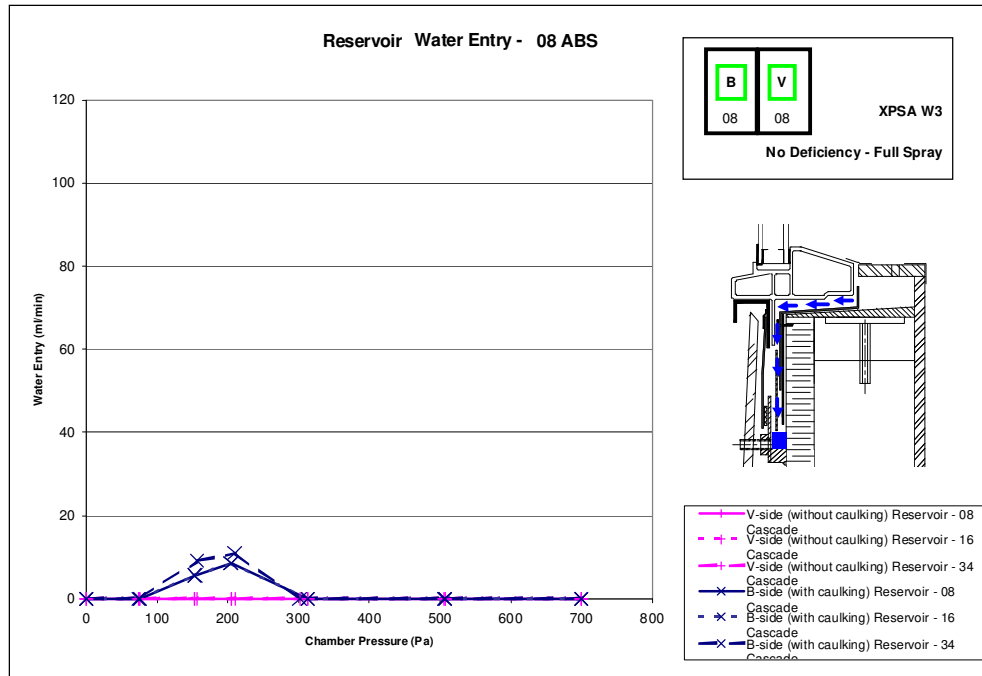
Figure 13 - Water collection rates from sill pan, Trial 2 with Rubber Gasket - No Deficiency; 08 ABS

Drainage from the sill pan—There was little change in the amount of water reaching the sill pan and which subsequently drained to the collection trough in this test trial as compared to Test Trial Set T1. Collection rates and visual observations closely resembled those from the initial test trials that did not incorporate a rubber gasket along the perimeter joint between the cladding and window frame. Without deficiencies (Figure 13) very small rates of water were collected (< 20 ml/min) in the trough that collected water from the sill pan. However, with deficiencies at the window corners (Figure 14), water readily penetrated to the sill pan; pan drainage at a rate of up to 71 ml/min (B-side at 03 ABS) was recorded. At pressures levels above 300 Pa (6.27 psf), drainage rates diminished, and water was seen to accumulate in the sill pan. At 700 Pa (14.62 psf), drainage was completely arrested and eventually

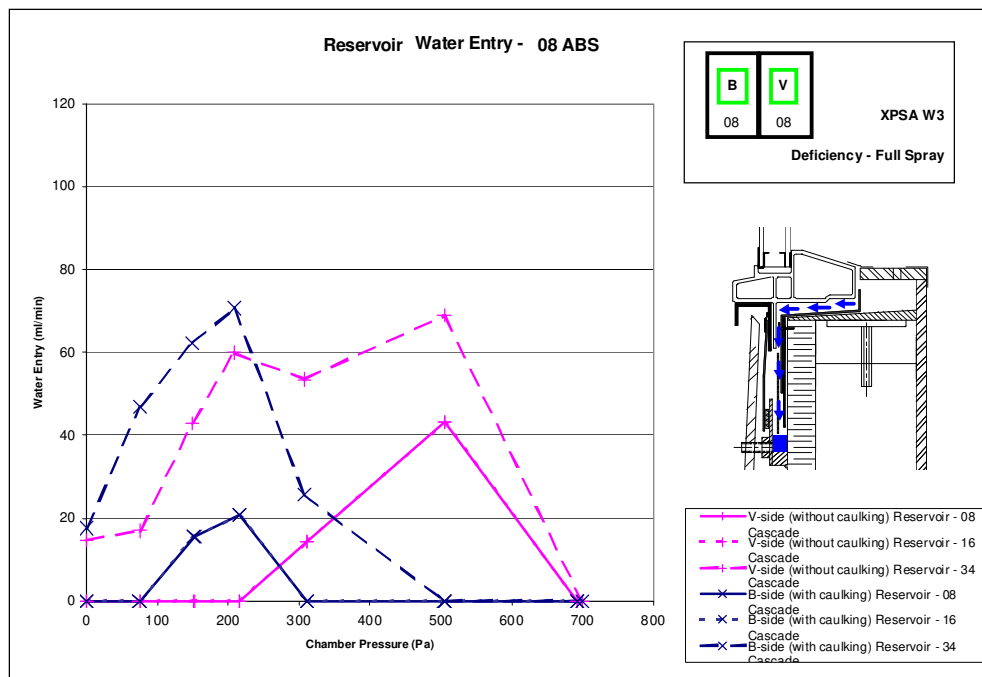
Figure 14 - Water collection rates from sill pan, Trial 2 with Rubber Gasket;
Deficiency at window corners; 08 ABS

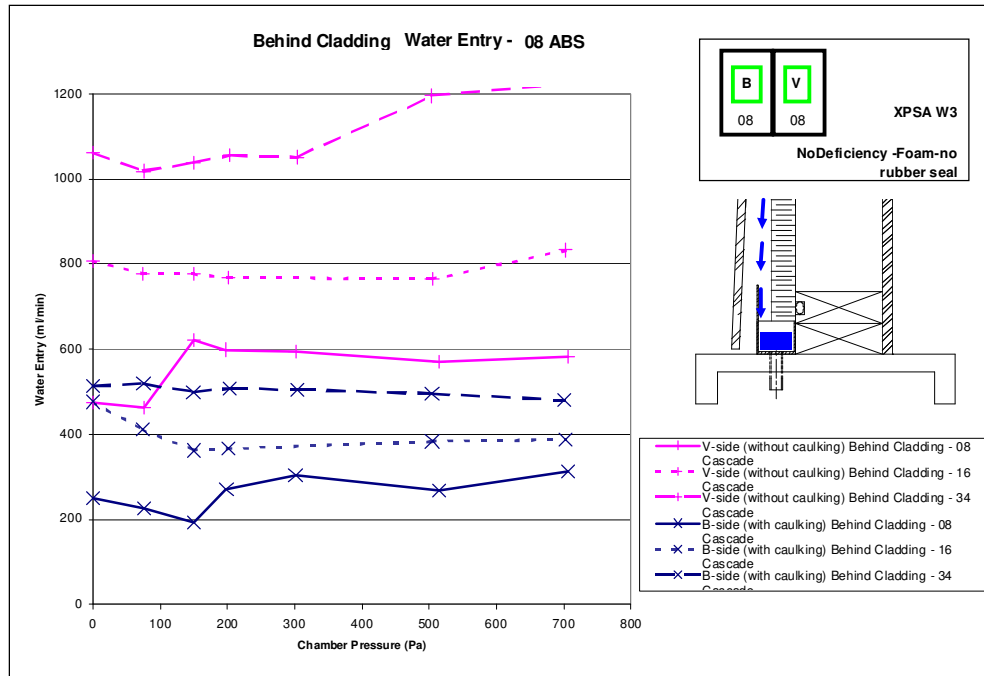
Figure 15 - Water collection rates at base of wall (behind cladding) Trial 3 - with foam; No Deficiency; 08 ABS

Collection of water behind cladding—As was the case in Test Trial Set 1, significant amounts of water passed behind the cladding to the collection trough at the base of the wall (Figure 15). Rates of water collection were slightly higher than those of Test Trial Set T1. Interestingly, water entry behind the cladding showed a higher degree of dependence on water spray rate than had been observed during Test Trial Set T1.

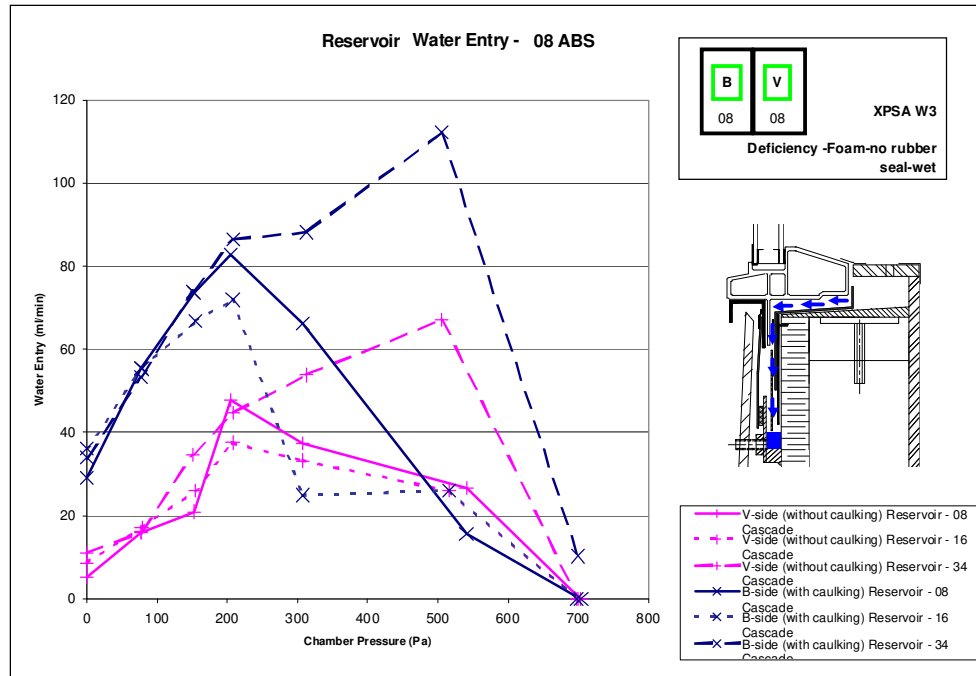
Figure 17 - Water collection rates from sill pan, Trial T3 - with foam; Deficiency at window corners; 08 ABS

Drainage from the sill pan—Little or no water was collected at the trough servicing the sill pan when no deficiencies were present at the windows (Figure 16), whereas with deficiencies, water evidently was introduced to the sill pan (Figure 17). The maximum drainage collection rate in this instance was ca. 110 ml/min. Rates of water collection from the sill pan were comparatively higher than the base condition (without foam), particularly at higher pressure levels. Visual observations for both sides of the wall also showed that the sill pan overflowed after only a few minutes at the 500 Pa (10.44 psf) pressure level (08 ABS leakage condition), indicating a higher rate of water entry than in the original trials. As in previous trials, sill pan drainage was almost completely arrested at the 700 Pa (14.62 psf) pressure level whereas drainage from the sill pan was evident at pressures differentials of up to 300 Pa (6.27 psf).

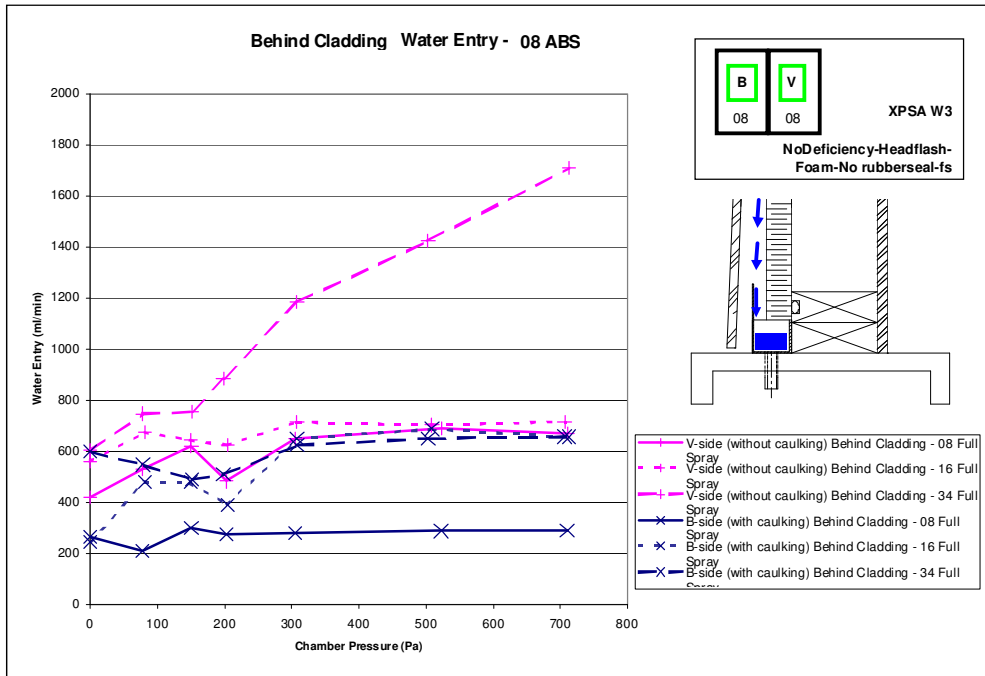
Figure 18 - Water collection rates at base of wall (behind cladding) Trial T4 - with foam and drip cap head flashing; No Deficiency; 08 ABS

Collection of water behind cladding—The amount of water collected at the base of the wall behind the cladding remained high despite the installation of the drip cap flashing (Figure 18). Addition of the drip cap flashing evidently did not reduce the amount of water that penetrated behind the cladding.

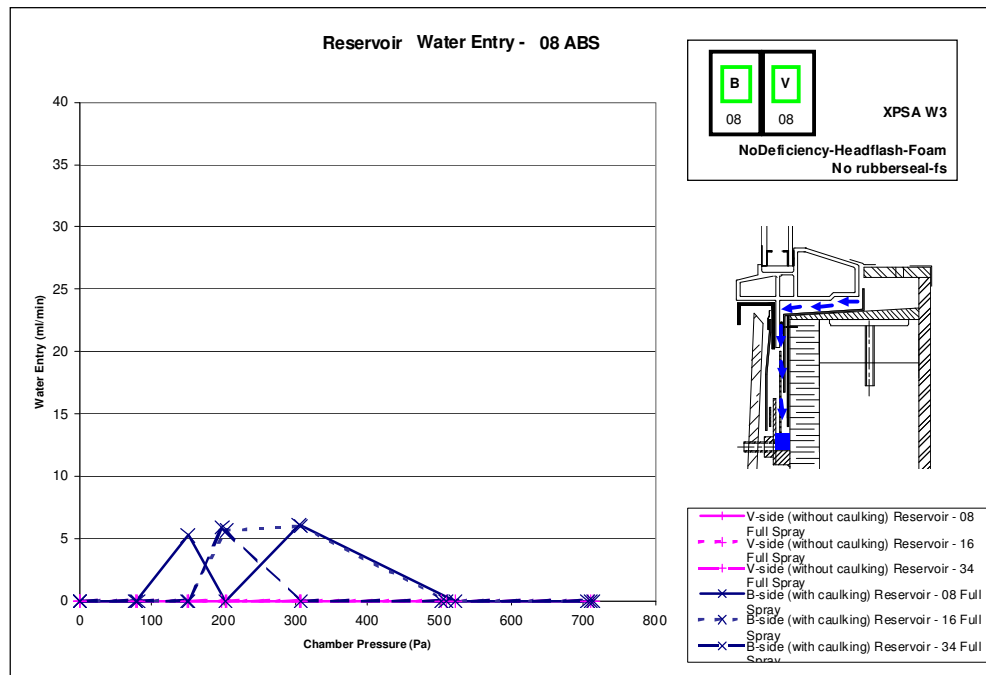
Figure 19 - Water collection rates from sill pan, Trial T4 - with foam and drip cap head flashing;
No Deficiency; 08 ABS

Drainage from the sill pan—Either with or without the drip cap installed at the head of the window, and with no deficiencies introduced at the window corners, water collection rates for troughs servicing the drainage from the sill pan were low; less than 15 ml/min and 6 ml/min with and without the cap installed respectively (Figure 16 and Figure 19). With deficiencies at the lower window corners, results with and without drip cap flashing were similar (Figure 17 and Figure 20). As well, water drainage from the sill pan ceased on the B-side (sealant) at approximately 500 Pa (10.44 psf) pressure level whereas water drainage on the V-side (without sealant) did not drop off at high test pressures; for both sides however drainage from the sill pan could be achieved at a pressure differential of 300 Pa (6.27 psf). Essentially, the addition of drip cap flashing did not reduce the amount of water reaching the rough sill.

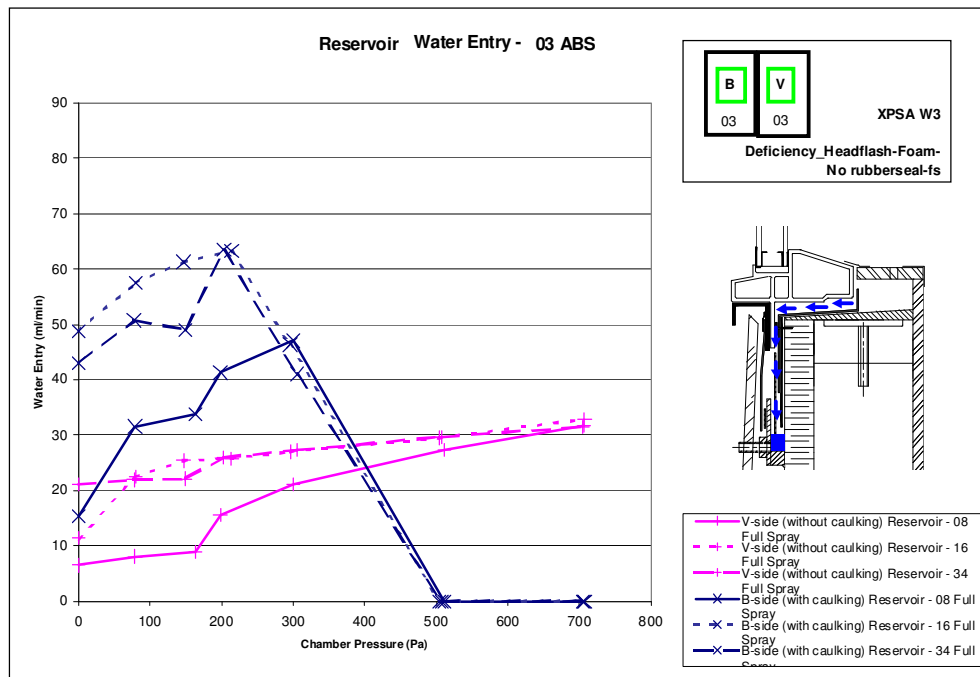
Figure 20 - Water collection rates from sill pan, Trial T4 - with foam and drip cap head flashing;
Deficiency at window corners; 03 ABS

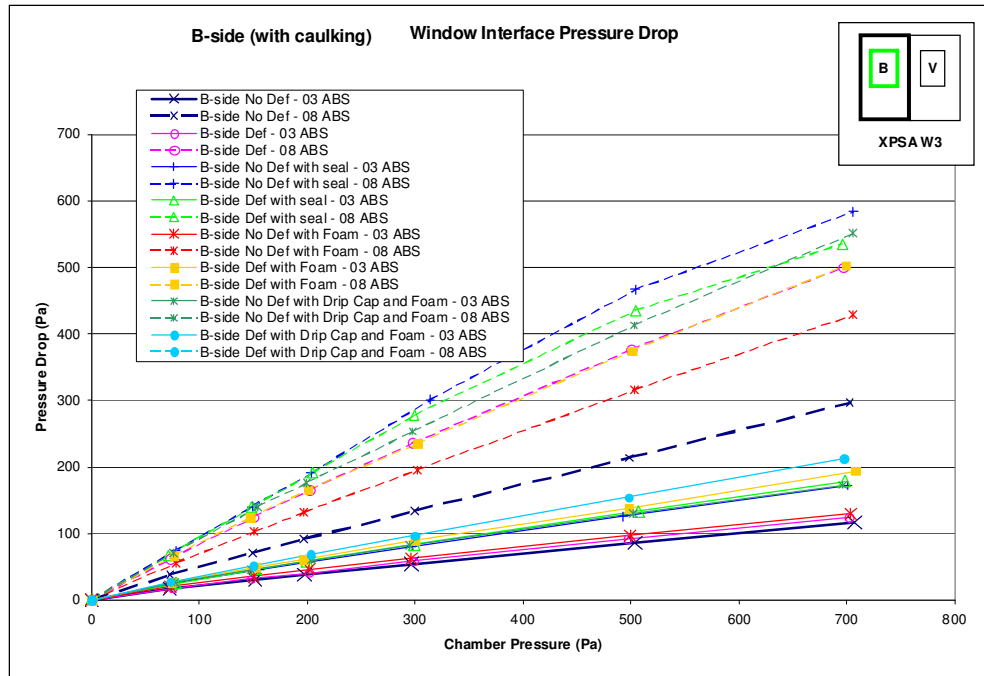
Figure 21 - Pressure drops for XPSA W3 B-side (With Sealant) wall/window interface, when dry

In Figures 21 and 22 the solid lines indicate trends in pressure drop across the window flanges with the specimen at the more restrictive (03) ABS condition, while the dotted lines indicate the corresponding trends at the less restrictive (08) ABS condition. At a chamber pressure of 700 Pa (14.62 psf), the pressure drop values at the 03 ABS condition on the B-side of the specimen ranged from 117 to 212 Pa while the corresponding values at the 08

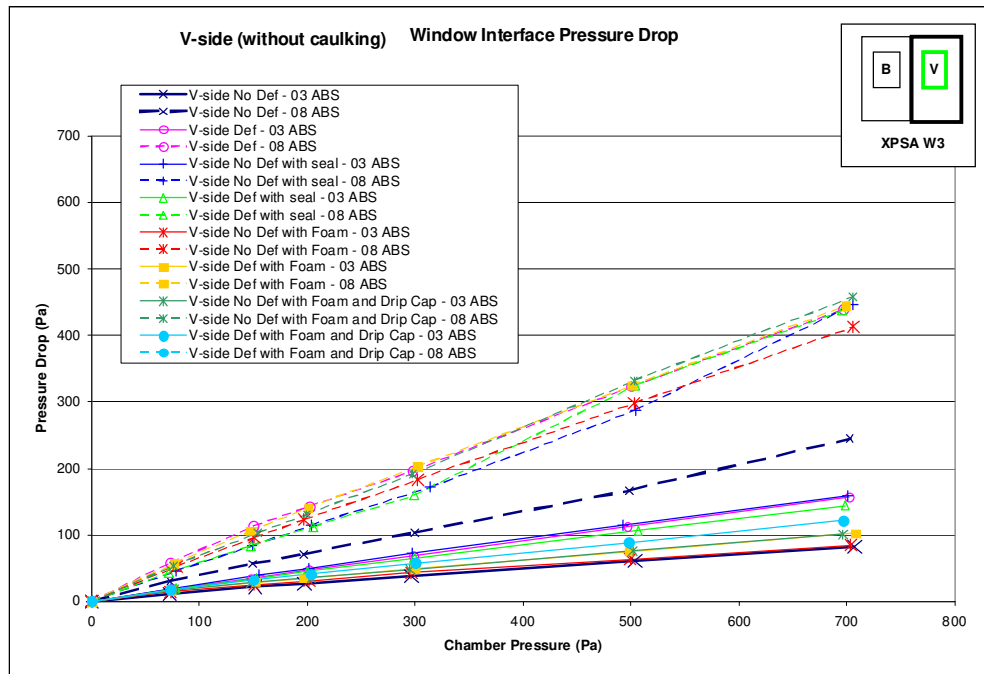
Figure 22 - Pressure drops for XPSA W3 V-side (Without Sealant) wall/window interface, when dry

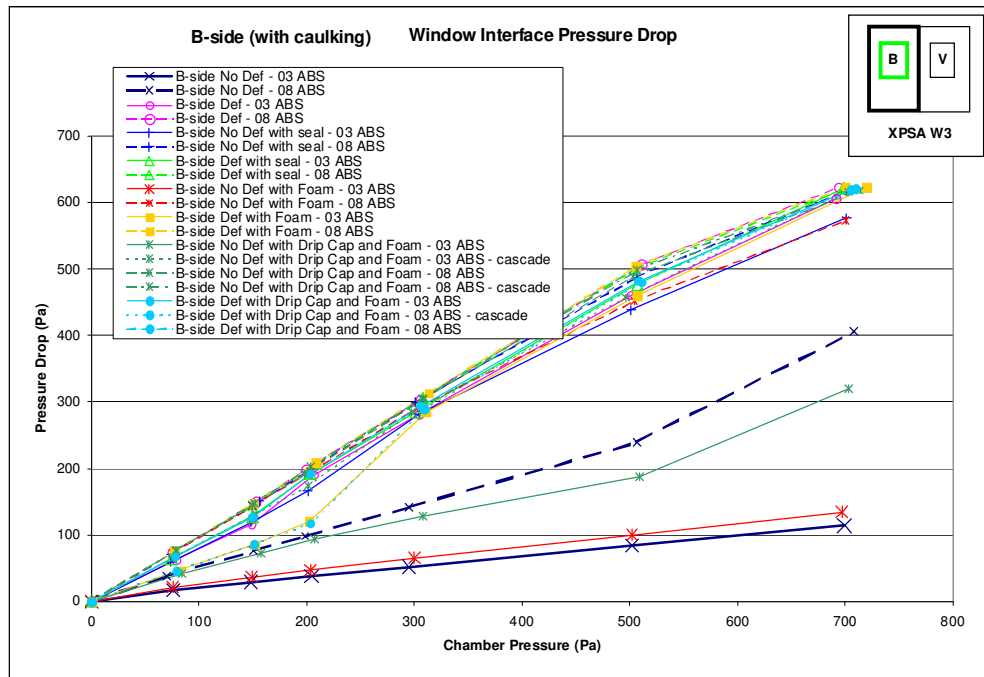
Figure 23 - Pressure drops for XPSA W3 B-side (with sealant) wall-window interface when wet, 3.4 spray rate

When tested in a wet condition, pressure drops across the window flanges increased in relation to those recorded under dry conditions (Figure 23 and 24). The largest relative increases in pressure drop across the window flanges, between dry and wet conditions, were recorded on the B-side of the specimen when the installation was in the more restrictive (03) ABS condition (Table 4). Although the pressure drops across the window flanges with the specimens in a wet condition are not drastically higher on the B-side, they nonetheless are higher than on the V-side of the specimen. Higher pressure drops provide for a greater driving force for water entry across the flanges and a greater resistance to drainage from the sill pan.

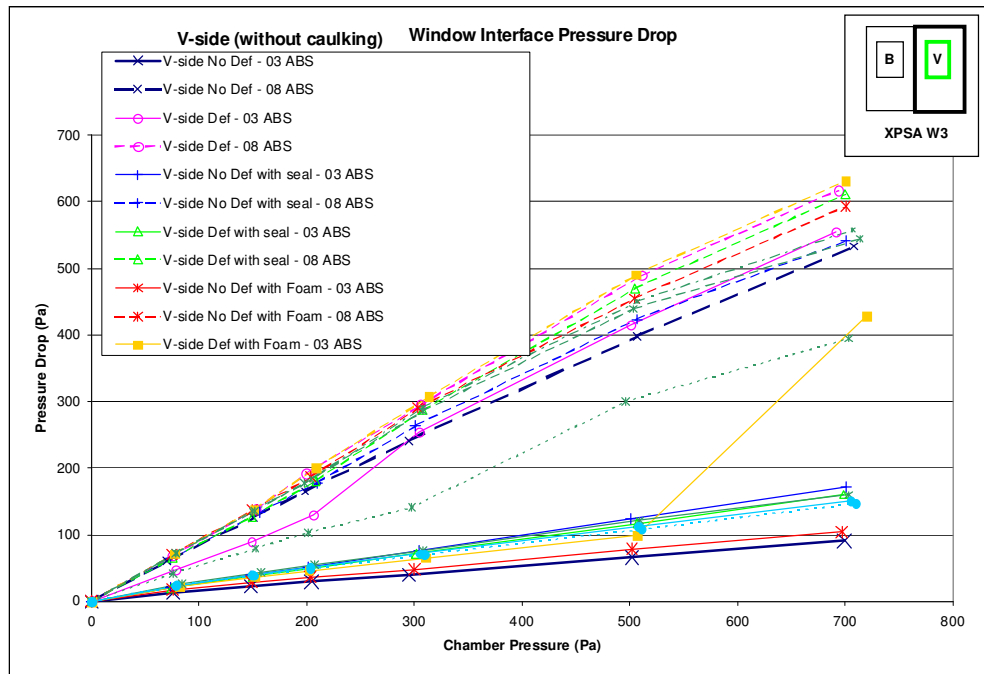
Figure 24 - Pressure drops (Pa) for XPSA W3 V-side (without sealant) at wall-window interface, when wet
