### **Report from task 2 of MEWS Project: description of 17 large scale wall specimens built for water entry investigation in IRC dynamic wall testing facility**

Bomberg, M. T.; Rousseau, M. Z.; Desmarais, G.; Nicholls, M.; Lacasse, M. A.

*Research Report (National Research Council of Canada. Institute for Research in Construction); no. RR-111, 2002-10-01*

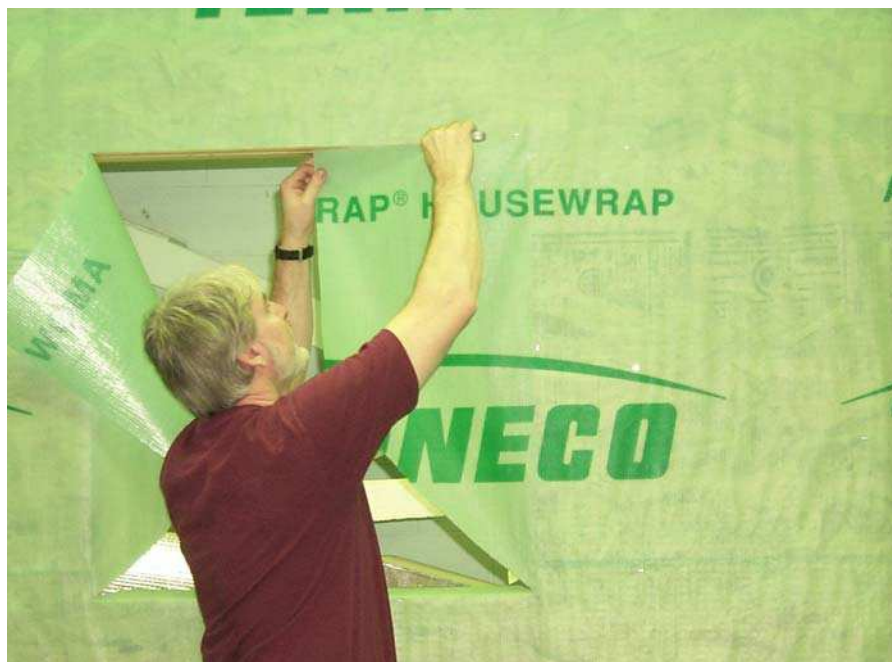
Figure 1.12. Modified I cut procedure for wall specimen No. 1

Figure 1.12 shows the “modified I cut” procedure for window openings with a polymeric water resistive barrier (WRB), as specified in the manufacturer’s literature. One may observe that when the WRB is cut in this way, the sill-jamb junctions are not covered by the water resistive barrier (see Figure 1.13). Therefore, in the two specimens with polymeric WRBs, deficiencies were introduced at the sill-jamb junctions (see Table 1.2). Figure 1.13 shows a 25 mm gap between the sill flashing membrane and the jamb of the window for specimens No. 1 and No. 3. The flashing membrane does not cover entirely the rough sill of the window opening: a strip of rough sill, 25 mm deep and 750 mm wide (the width of the rough opening) was left uncovered. Figures 1.14 and 1.15 show the completed window installation for the two specimens with a polymeric water resistive barrier.

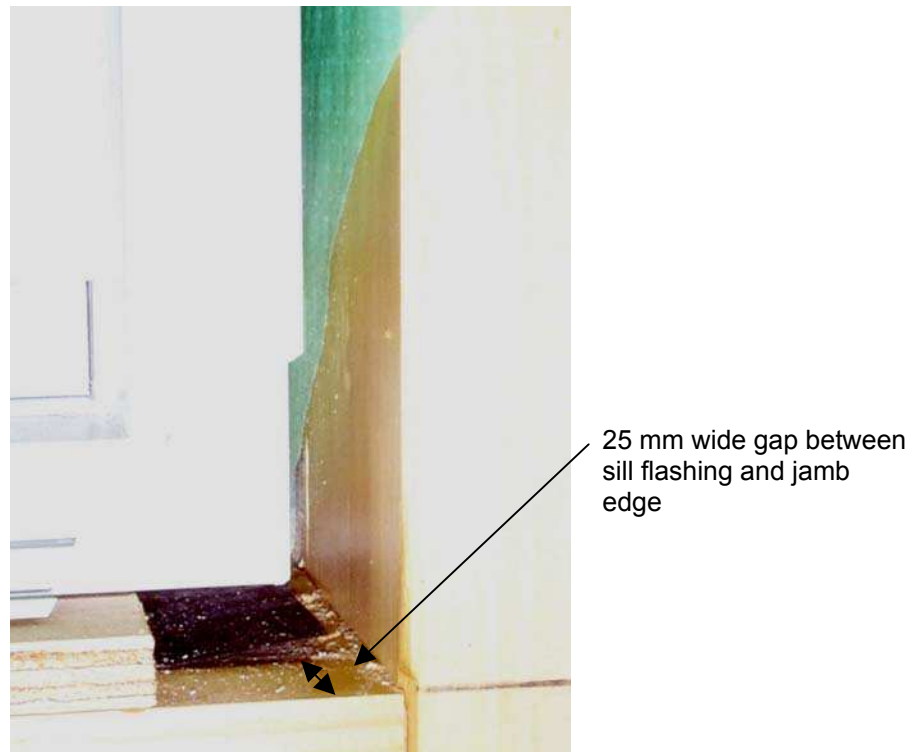
Figure 1.13. Deficiency at the sill and jamb levels for specimens No. 1 and No. 3

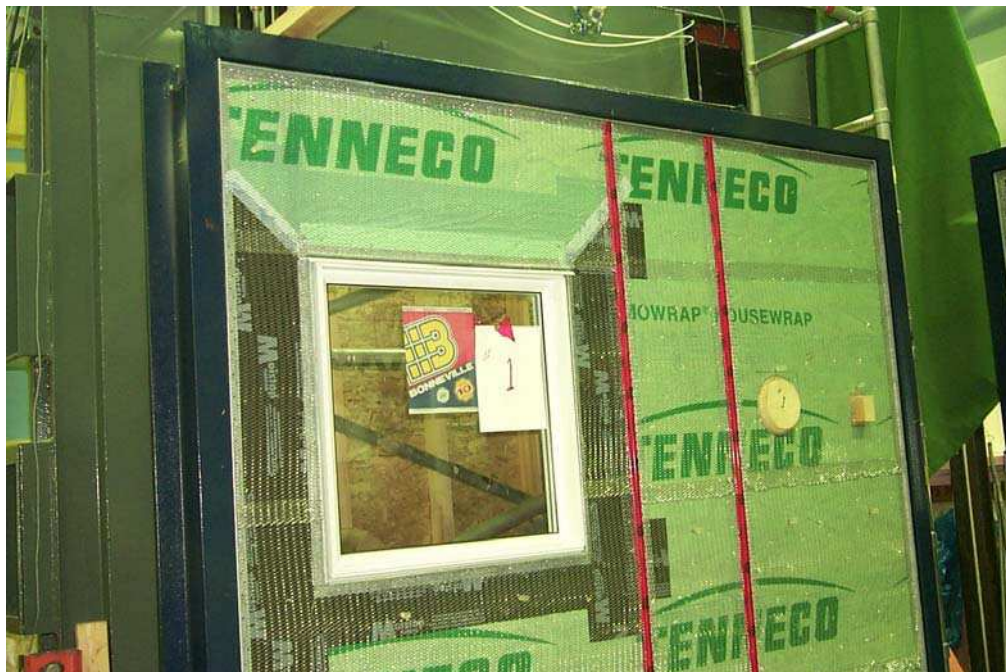
Figure 1.14. Completed window installation in specimen No. 1

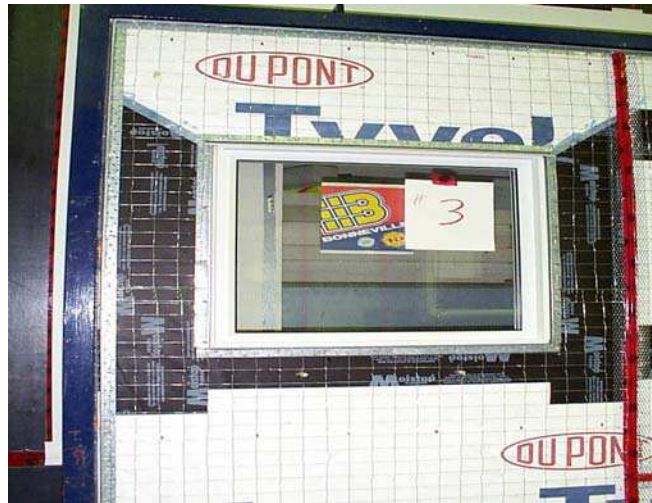
Figure 1.15. Completed window installation in specimen No. 3

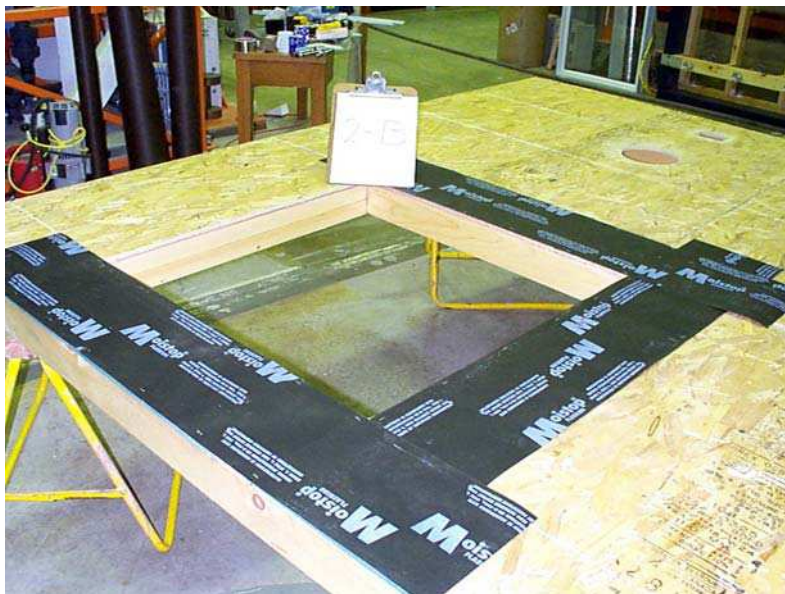
Figure 1.19. Installation of sill and jamb flashing on wall 2b

The sill flashing is first installed, then the jamb flashing, as illustrated in Figure 1.19. The window is to be installed next, followed by the elements for the window head: the head flashing and the metal drip flashing overlapped by the WRB. These elements are shown in Figure 1.20 before they are attached and without the WRB. An example of the completed window installation for specimens with a paper-based WRB is shown in Figure 1.21. One of the deficiencies for the walls with paper-based WRB is also visible in this photograph: the sill flashing is installed behind the WRB while a good practice would be to overlap it over the WRB.

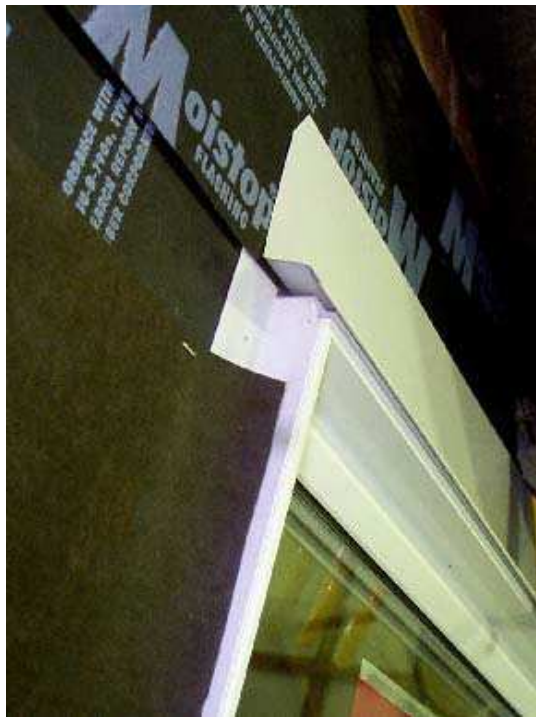
Figure 1.20. Window head elements in place before the last piece of paper-based water resistive barrier is applied

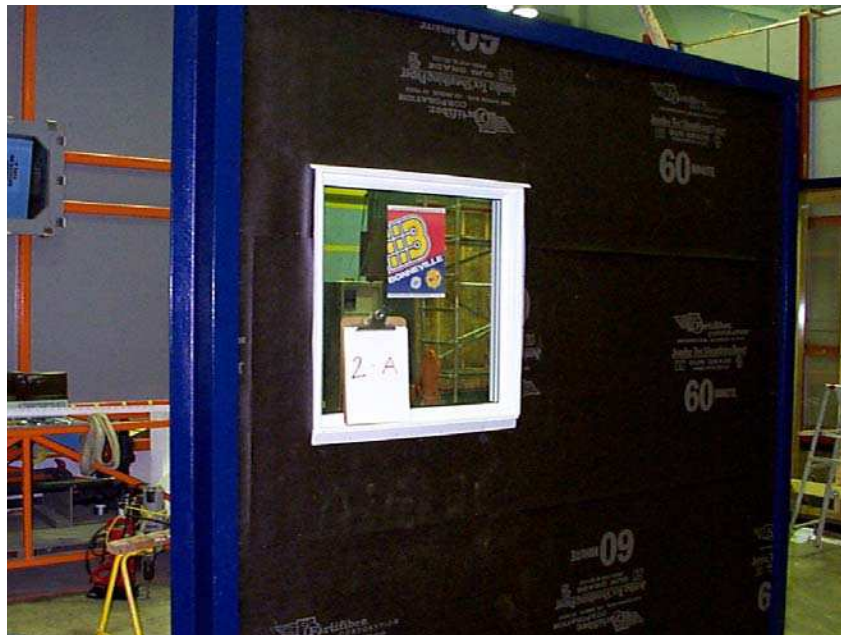
Figure 1.21. Completed window installation in specimen No. 2a

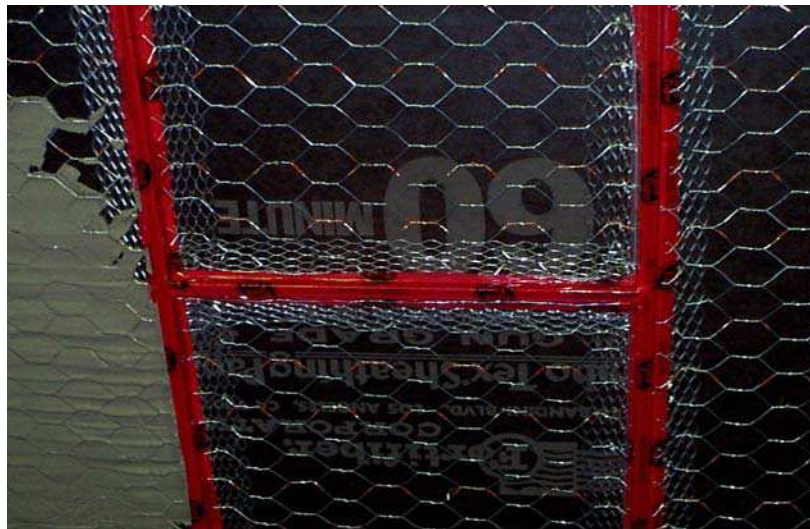
Figure 1.26. The control joints were covered with tape to reduce bonding of the stucco plaster to the metal control joint profile.

The two vertical control joints detail with deficiencies are illustrated in Figures 1.25 and 1.26.

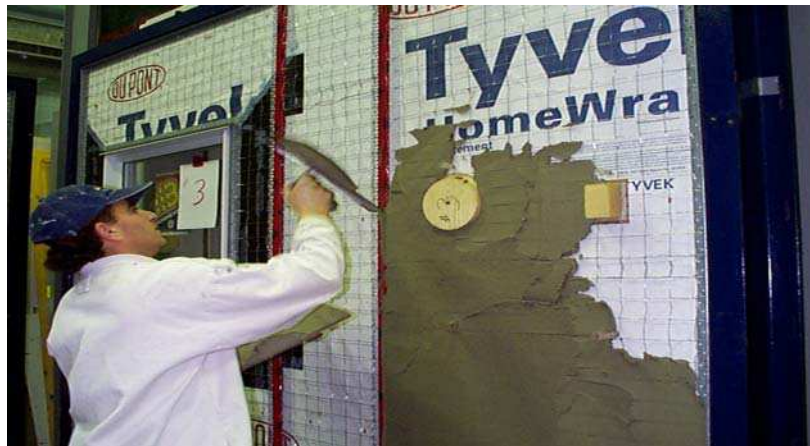
Figure 1.28. Application of the scratch coat on specimen No. 3

The application of the stucco plaster began on December 14<sup>th</sup>, 1999 with the application of the scratch coat (Figures 1.28 and 1.29). At that stage, plastic tubes were used to prevent the pressure sensors from being blocked up (Figure 1.30). They were removed on December 16<sup>th</sup>, 1999, before the application of the brown coat, (Figure 1.31). The brown coat for walls No. 1, No. 2a, No. 2b, and No. 3 was floated using a rigid sponge and water (Figure 1.32). An acrylic premix stucco was used for wall No. 4. It was applied in two 5 mm thick scratch and brown coats but in addition a very thin acrylic finish was applied on this wall on December 17, 1999 (Figure 1.33).

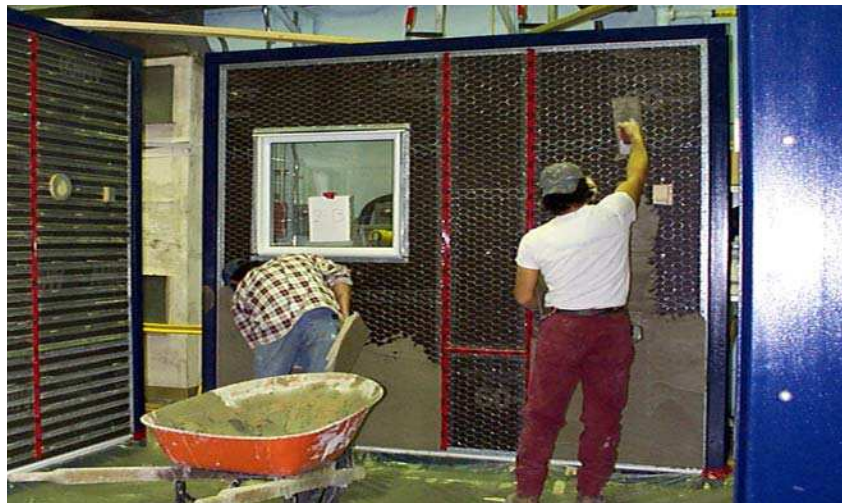
Figure 1.29 Application of the scratch coat on specimen No. 2b

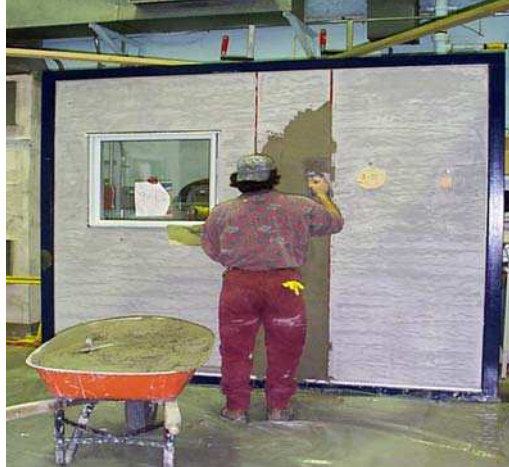
Figure 1.31. Application of the brown coat on wall specimen No. 2b

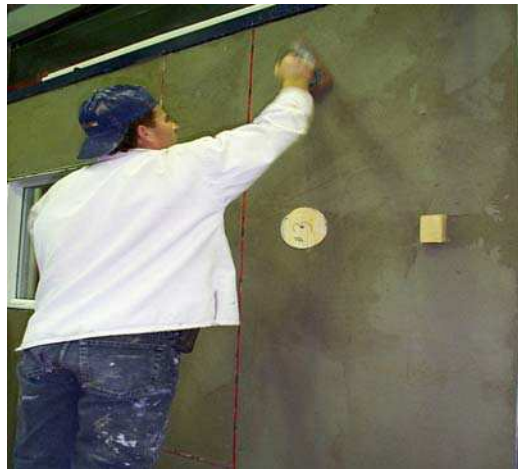
Figure 1.32. Floating of the brown coat on specimen No. 3

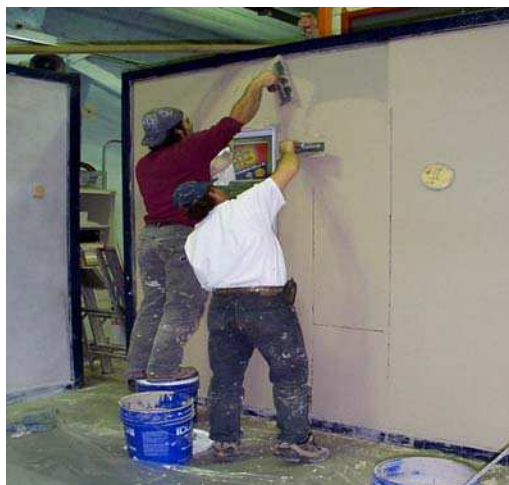
Figure 1.33. Application of the acrylic finish coat on specimen No. 4

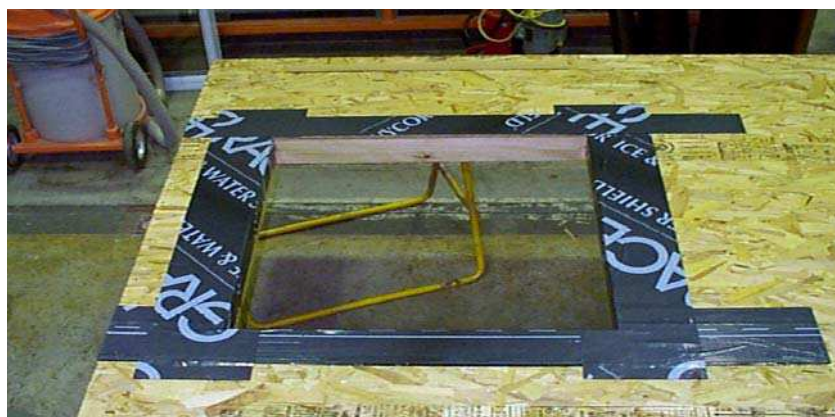
Figure 1.36. Self-adhesive flashing installed on wall specimen No. 5

Figures 1.34 and 1.35 illustrate the detailing at the wall/window junction for this specimen. A self-adhesive flashing membrane was used at the perimeter of the rough opening for the window. In this case, the sill, jamb and head flashing were installed before the window and the paper-based WRB. The flashed window opening can be seen in Figure 1.36. After the flashing membranes, the WRB and the windows were installed, the control joints and the metal lath were attached. The control joints were covered with tape to prevent the adhesion of the stucco to the joint (as a deficiency).

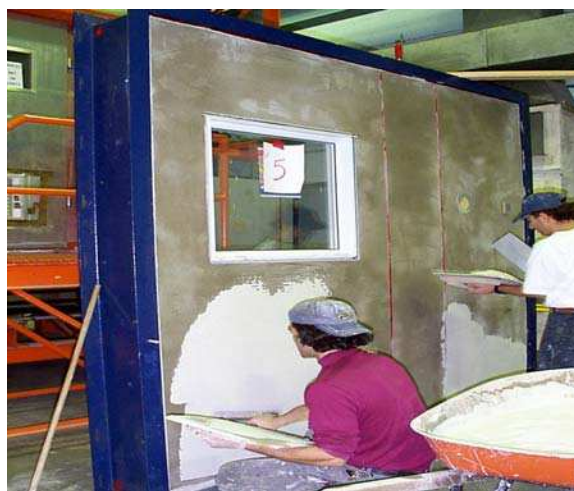
This specimen included a three-coat stucco plaster, the third coat consisting of 6 mm thick white cement based stucco mix (Figure 1.42).

Figure 1.42. Application of the finish coat on wall No. 5.

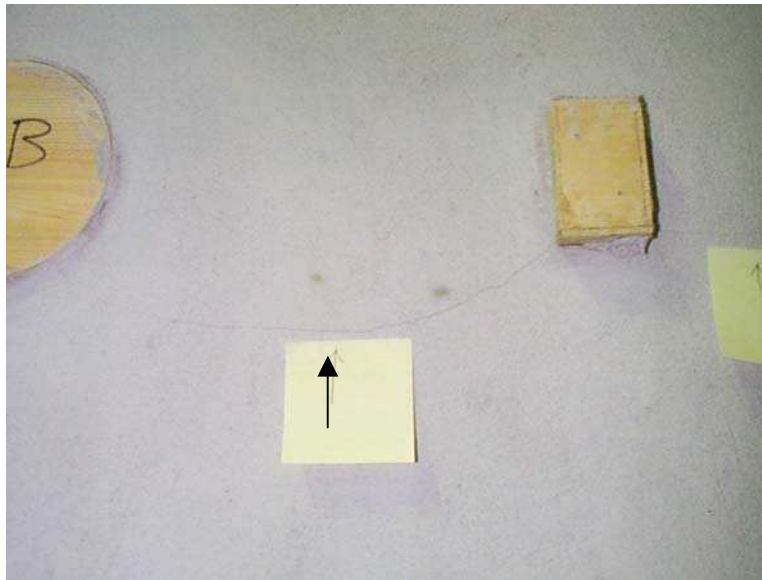
Figure 1.44. Crack between duct and electrical outlet openings (see arrow on sticker)

On January 17<sup>th</sup>, 2000 all cracks were recorded. However a few more cracks appeared before the second inspection on January 24, 2000. Cracks developed where material shrinkage caused excessive stress concentration e.g., corners of the window (Figure 1.43) and between the outlet box opening and the duct opening (Figure 1.44) and between two vertical control joints (Figure 1.45).

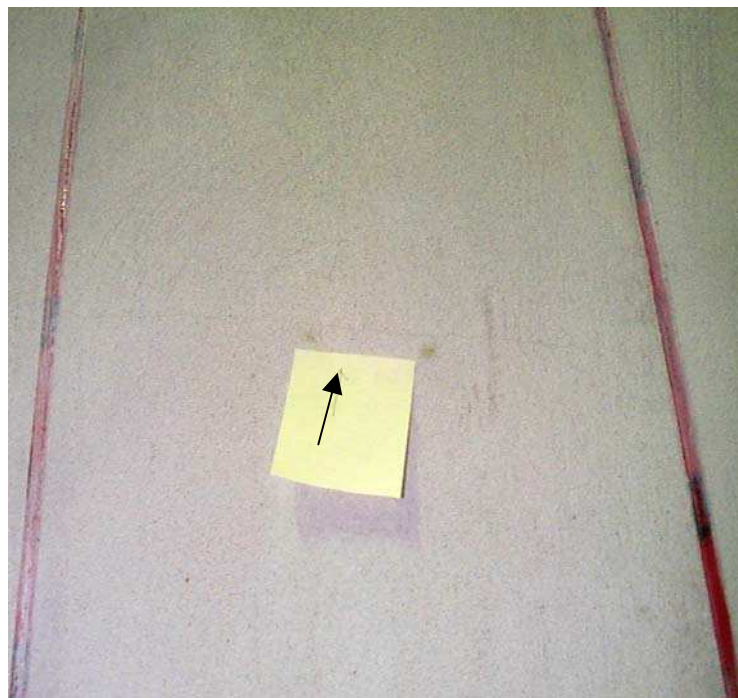
Figure 1.45. Crack between the vertical control joints (see arrow on sticker)

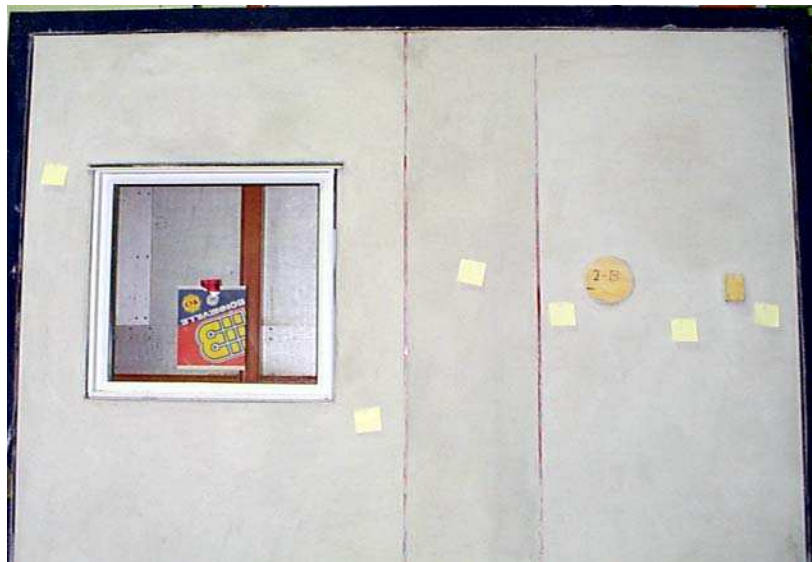
Figure 1.46. Cracks in specimen No. 2b covered for 15 days

The formation of cracks is likely to be related to the conditions of curing. To assess the effect of curing conditions, specimens No. 2a and No. 2b (of identical construction) were exposed to different curing conditions, namely, specimen No. 2b was covered with burlap and a polyethylene film for 15 days while specimen No. 2a was covered in the same manner for 28 days. Specimen No. 2b exhibited more cracking than wall No. 2a (Figures 1.44 and 1.45). By January 24<sup>th</sup>, 2000 specimen No. 2b had developed an additional crack between the outlet penetration and the vertical joint.

It was observed that the curing conditions had an effect on the formation of cracks in the stucco. The specimens protected with burlap and polyethylene for a longer period benefited from a sheltered micro-climate offering better curing conditions; and thus that specimen showed less cracking than the specimen which was protected for a shorter period. These walls all had the same lime-cement stucco mix (Type N). The other two specimens were three-coat applications and each had a different type of the stucco plaster mix: one had an acrylic stucco premix and the other a Portland-cement stucco mix. These were neither sprayed with water nor protected with burlap and polyethylene. Yet, they did not show cracking.

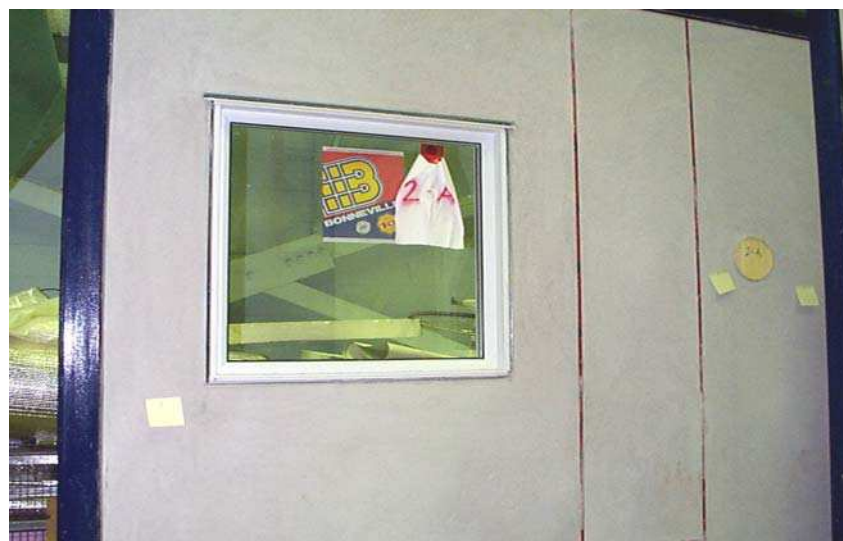
Figure 1.47. Cracks in specimen No. 2a protected for 28 days

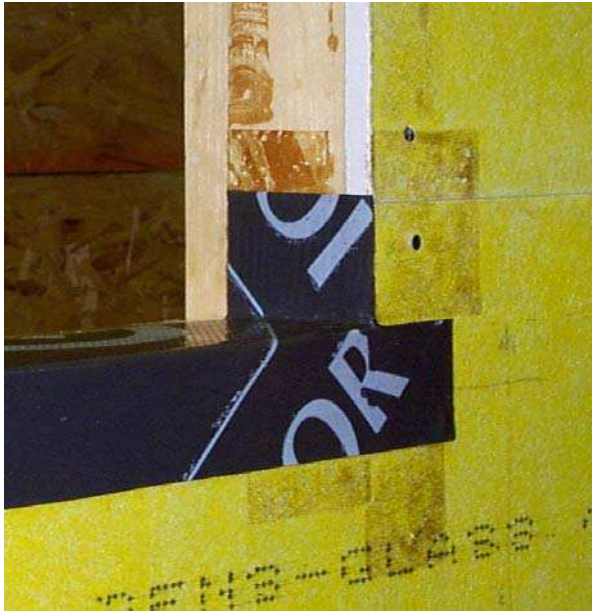
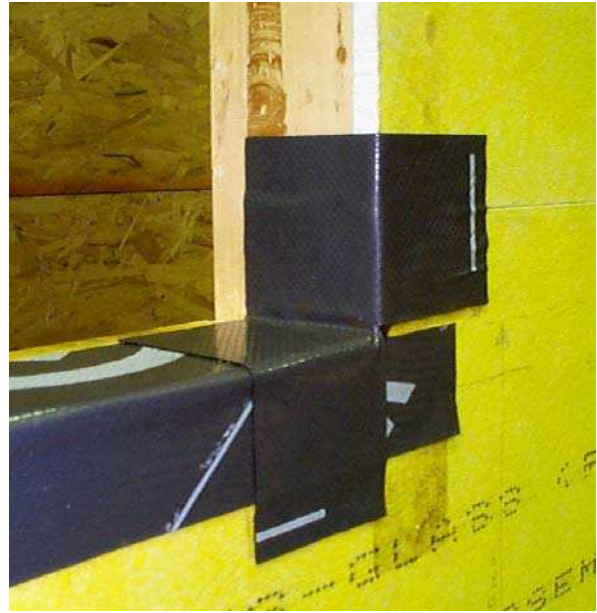
Figure 2.16. Rough opening treatment - Step 1. Figure 2.17. Rough opening treatment - Step 2.

The window installation procedure is the same for four of the specimens (No. 7, No. 8, No. 9 and No. 10) up to the installation of the WRB. First, the rough opening is covered with a self-adhesive water resistive membrane. The sill piece is first applied, followed by the corner piece and then the jamb piece. The last piece to be installed is the head piece. This flashing membrane installation procedure, with the deficiencies incorporated for this testing program, is illustrated in Figure 2.15 to Figure 2.19. Once the rough opening is protected, the window is installed (*before* the WRB).

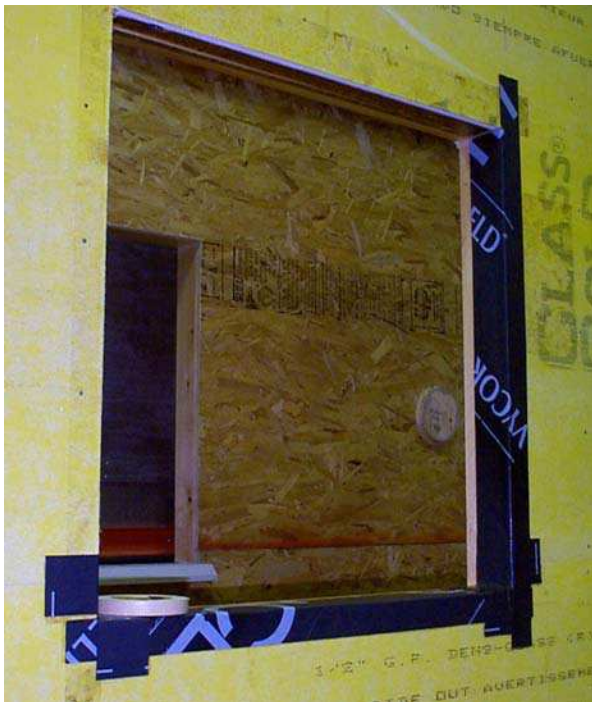
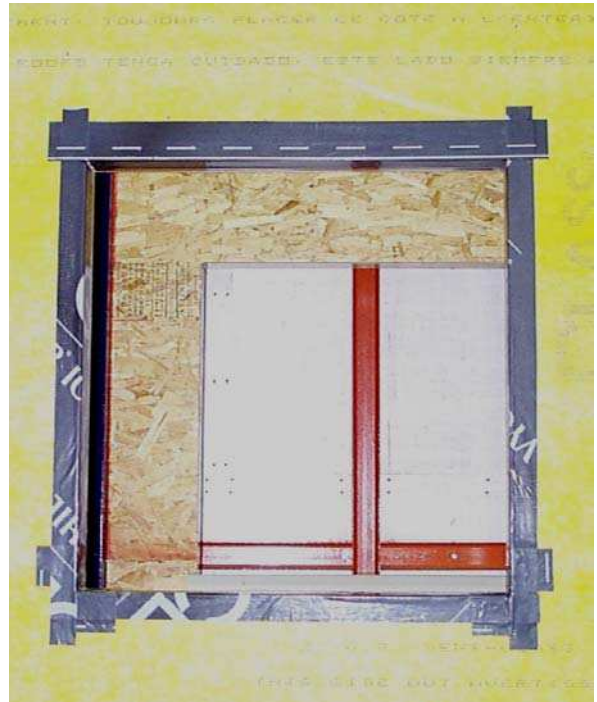
Figure 2.18. Rough opening treatment - Step 3. Figure 2.19. Rough opening treatment - Step 4.

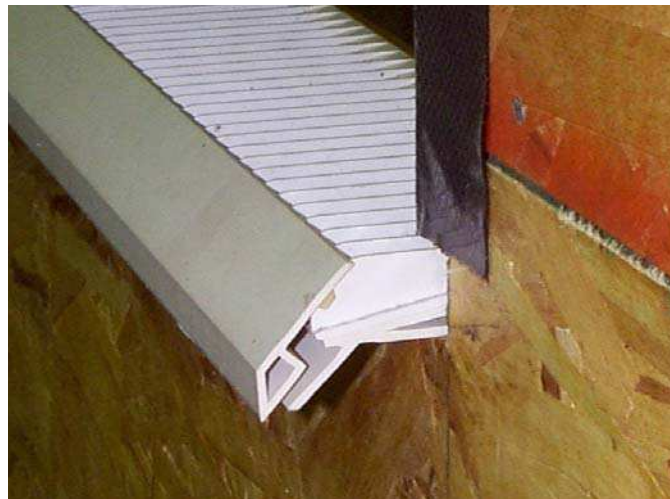
Figure 2.22. Front of prefabricated sill - Wall No. 6.

Wall No. 6 is a barrier wall with source drainage at the window consisting in a prefabricated sill. This rigid sill is installed over the rough jamb and set in sealant, making the sill and corner flashing membrane pieces unnecessary. The prefabricated sill is wider than the rough opening to catch any water that might leak along the jambs. After the prefabricated sill is put in place, the jamb flashing membrane is installed as described above and shown in Figure 2.14 with the difference that it laps the prefabricated sill instead of the sill flashing. The window is installed, followed by the head drip flashing.

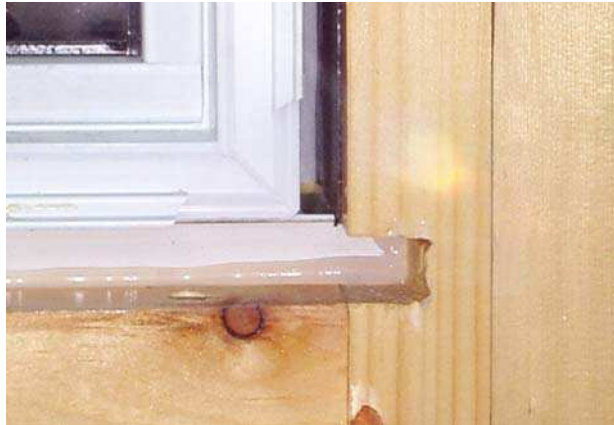
Figure 2.23. Prefabricated sill embedded in sealant - Wall No. 6.

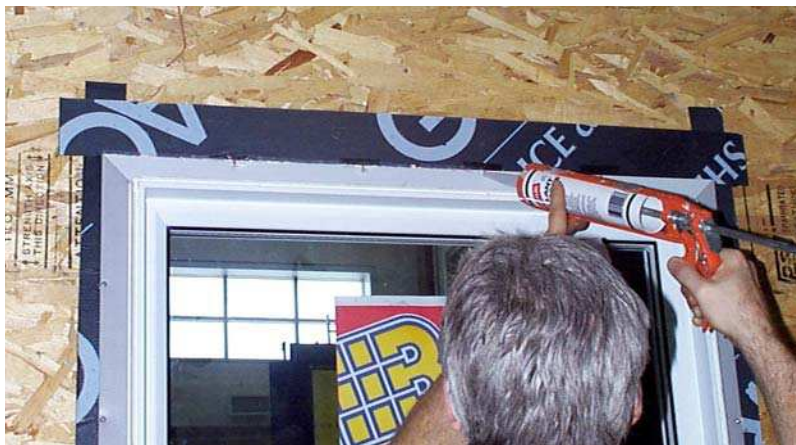
Figure 2.24. Sealant at top of jamb - Wall No. 6.

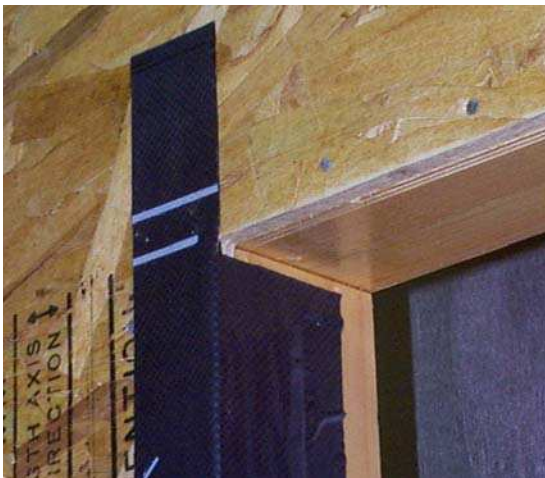
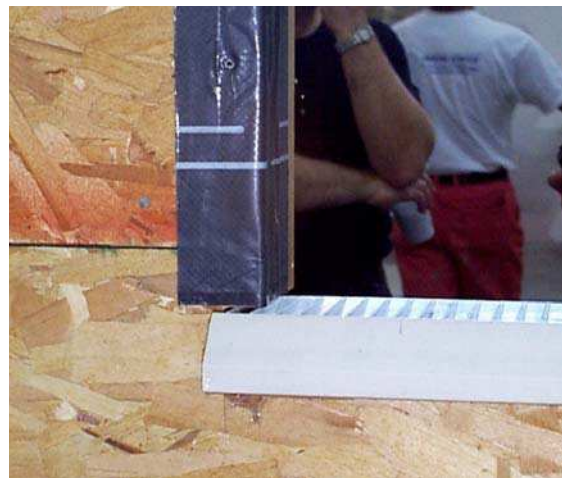
Figure 2.25. Deficiencies at top and bottom of jamb flashing membrane.

For wall No. 7, the head drip flashing is then installed, followed by the paper-based WRB. Construction details for wall No. 7 are found in Figure 2.25 and Figure 2.26. In the case of walls No. 8, 9 and 10, the WRB coating is applied and then the head drip flashing is installed. The construction details for these specimens are shown in Figure 2.29 to Figure 2.38.

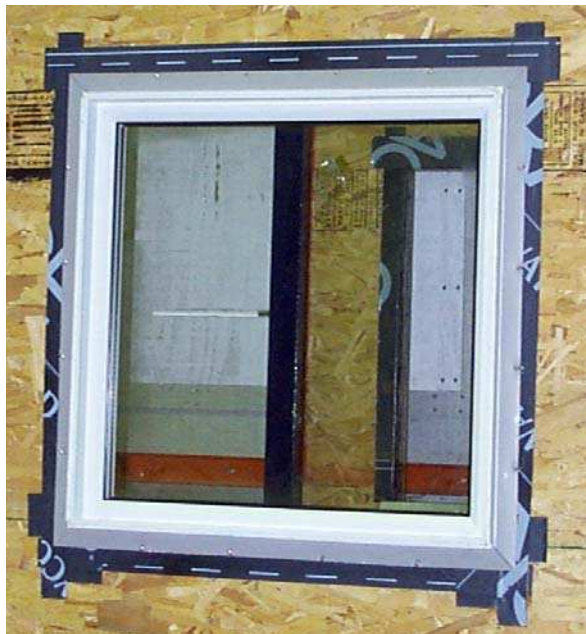
Figure 2.28. Window installed in wall No. 7.

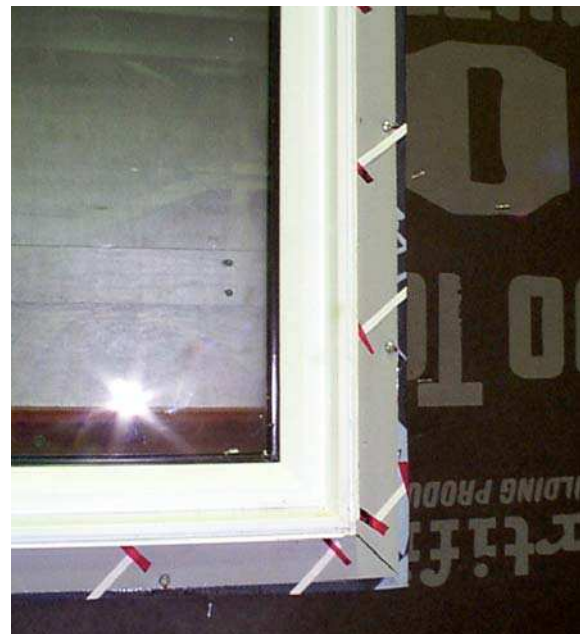
Figure 2.29. Wall No. 7. Deficiency: 6 mm gap between window flange and paper based WRB

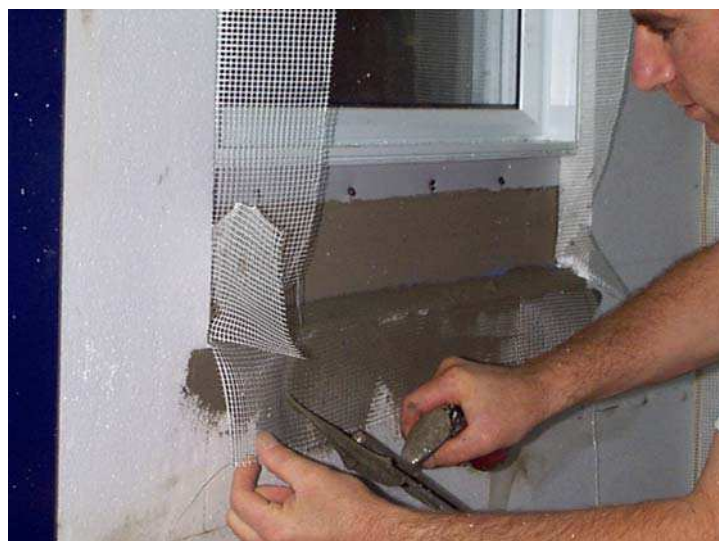
Figure 2.32. Backwrap for sill piece - Wall No. 8.

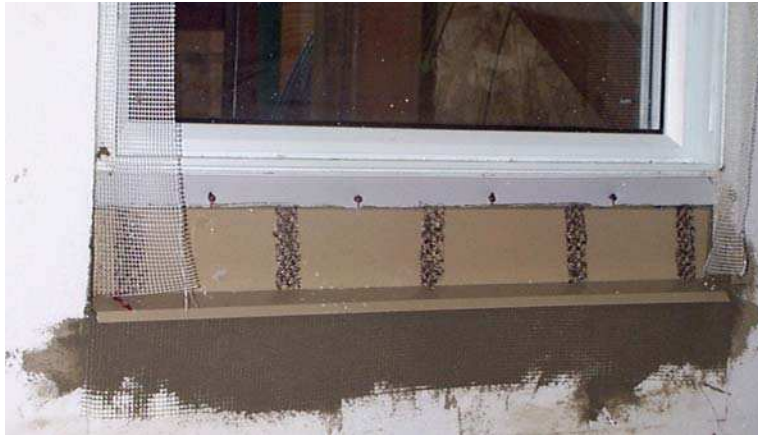
Figure 2.33. Sill drip flashing with drainage pieces - Wall No. 8.

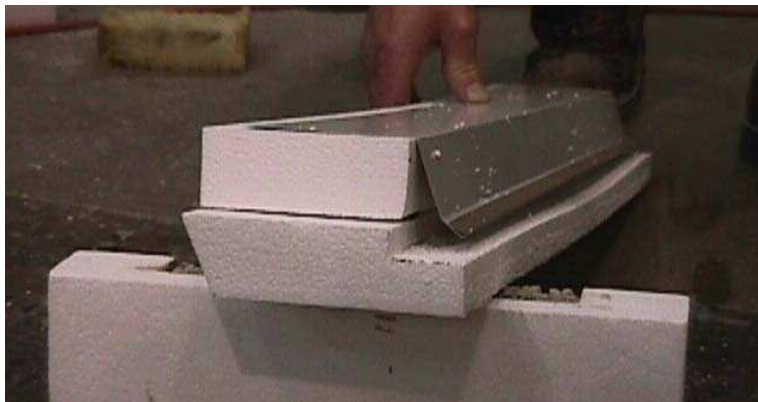
Figure 2.34. Sill piece - Wall No. 8.

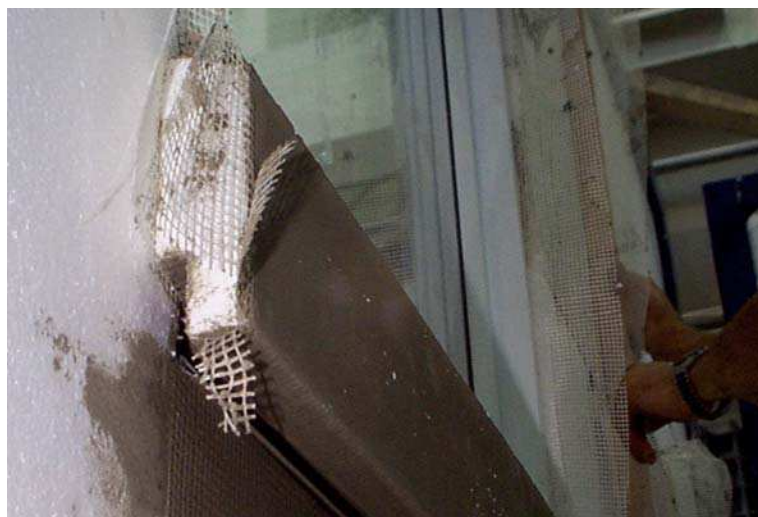
Figure 2.35. Sill piece installed - Wall No. 8.

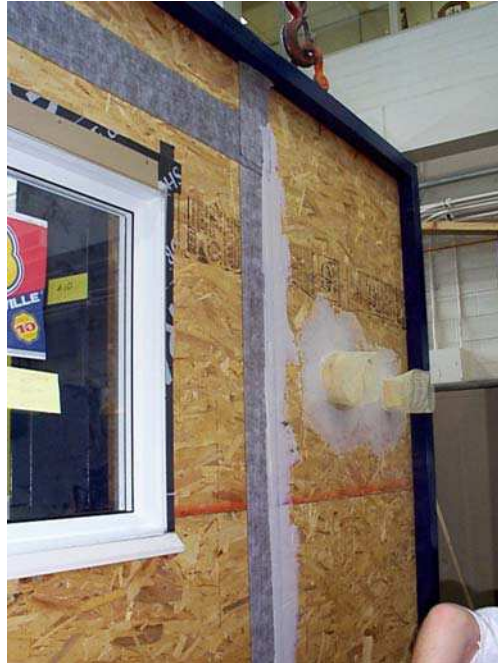
Figure 2.46. Wall No. 6. Self-adhesive membrane behind control joints and backwrapping of penetrations

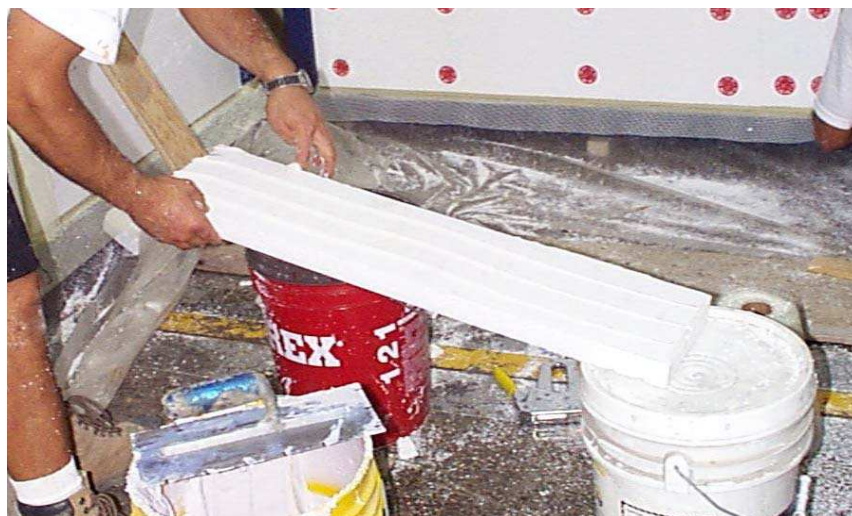
Figure 2.47. Wall No. 6. Application of adhesive to the back of the EPS insulation

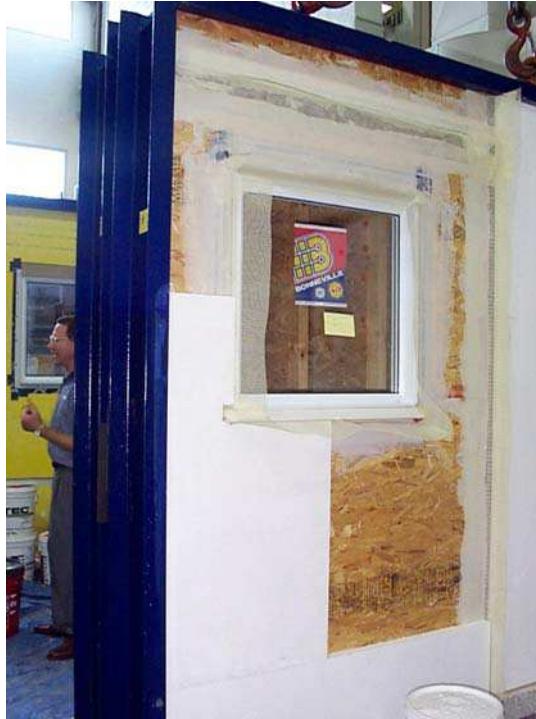
Figure 2.48. Wall No. 6. Installation of EPS insulation

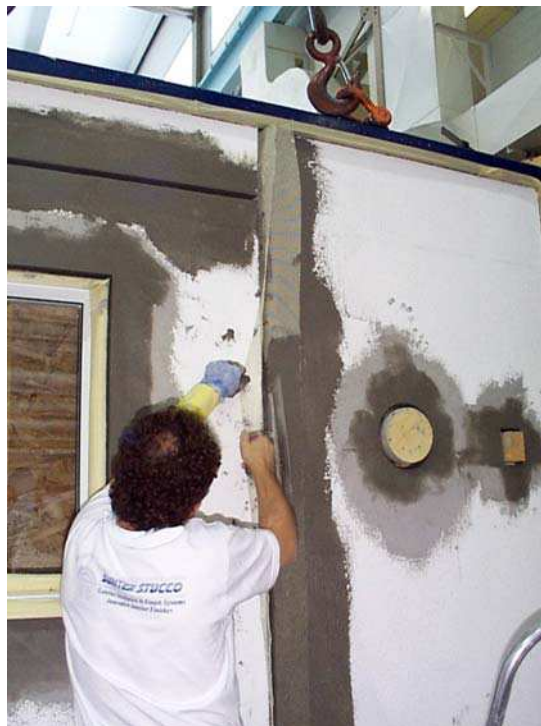
Figure 2.49. Wall No. 6. Backwrapping of EPS insulation

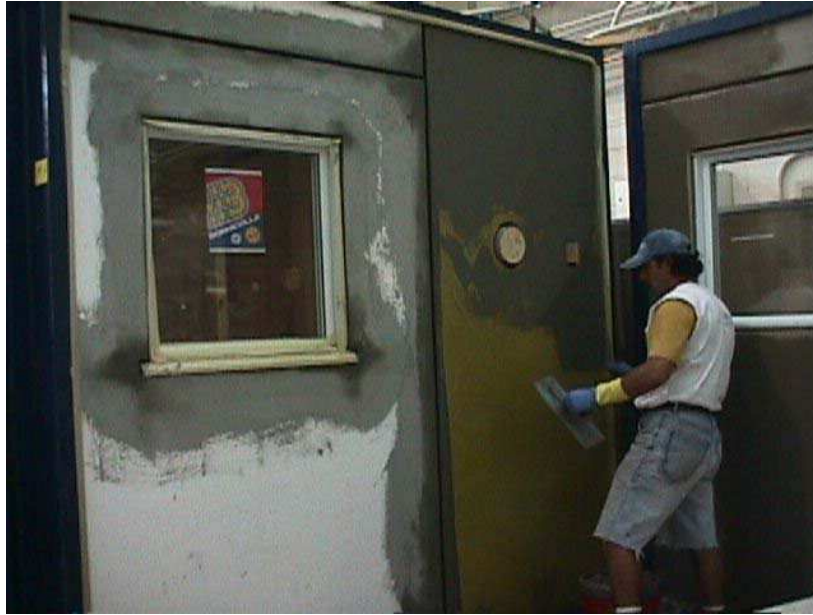
Figure 2.50. Wall No. 6. Application of mesh and base-coat

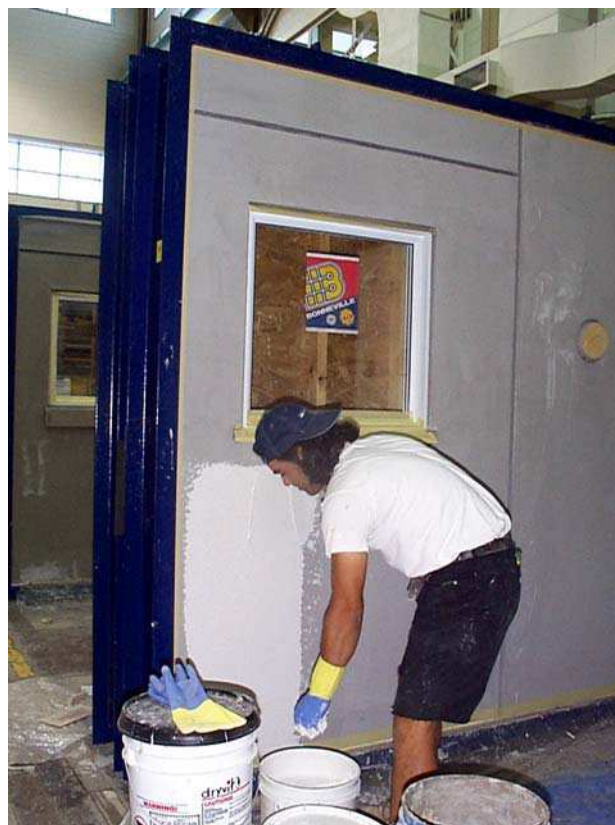
Figure 2.51. Wall No. 6. Application of finish coat

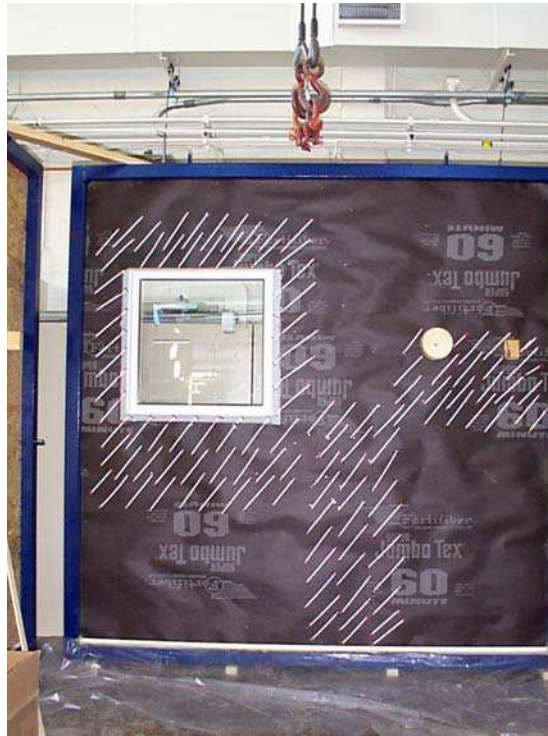
Figure 2.52. Wall No. 7. WRB membrane with water sensitive paper strips

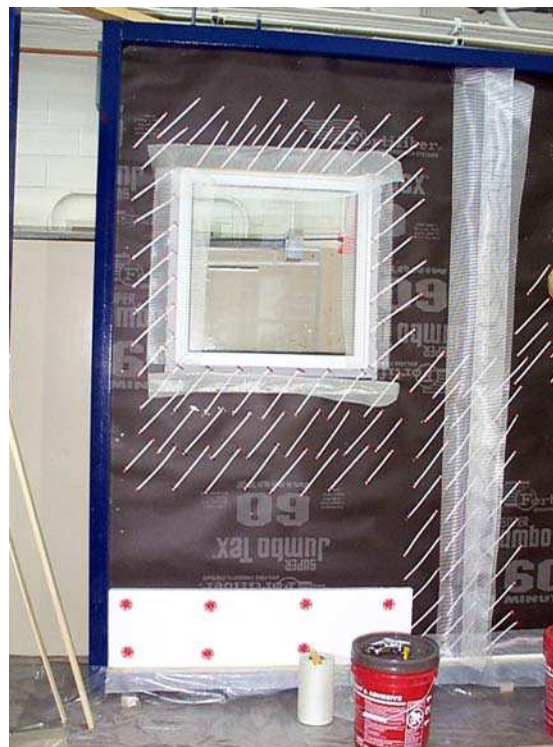
Figure 2.53. Wall No. 7. Backwrapping of vertical joint and insulation installation

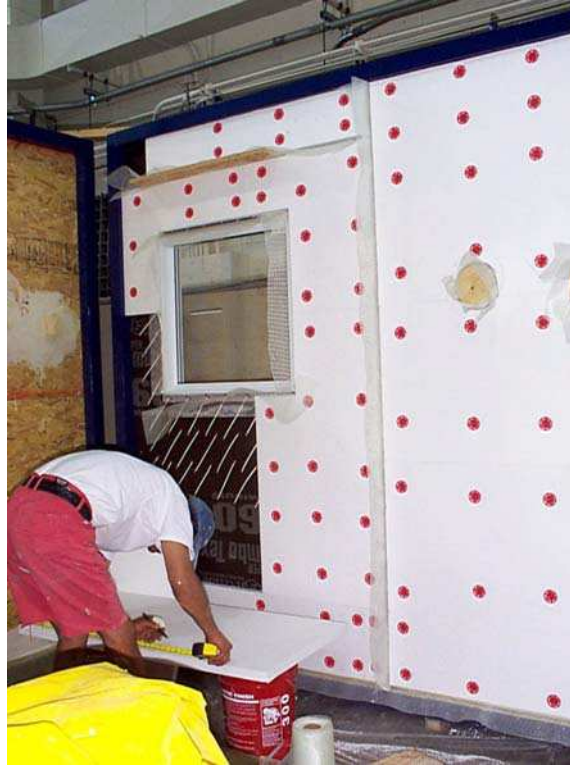
Figure 2.54. Wall No. 7. Insulation mechanically attached

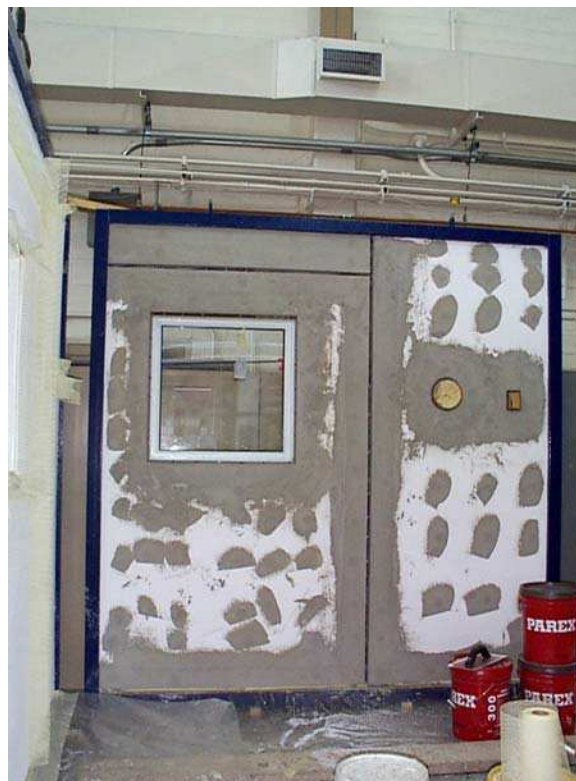
Figure 2.55. Wall No. 7. Spotting of fasteners and backwrapping completed

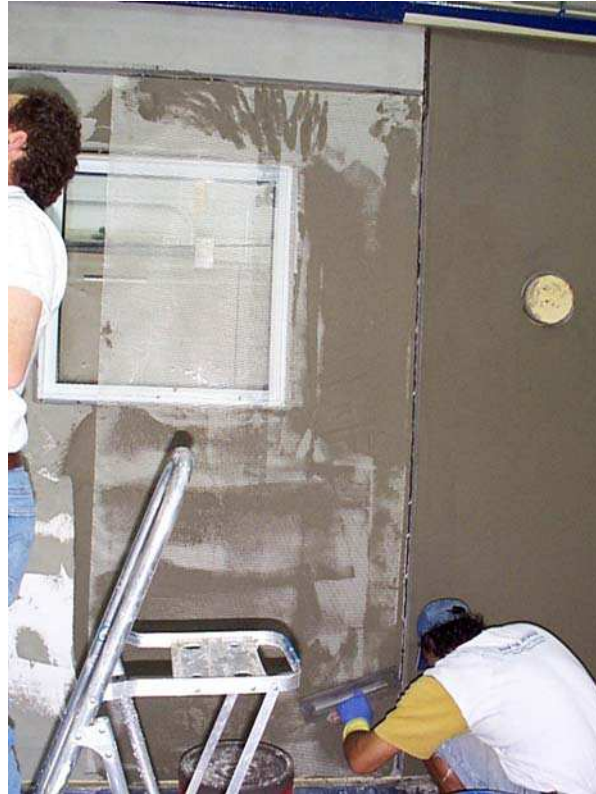
Figure 2.56. Wall No. 7. Application of base-coat and mesh

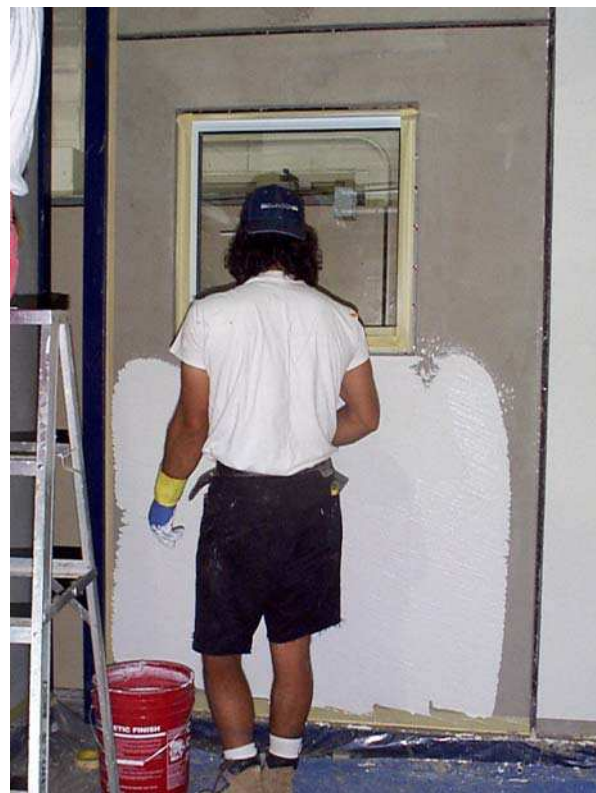
Figure 2.57. Wall No. 7. Application of finish coat

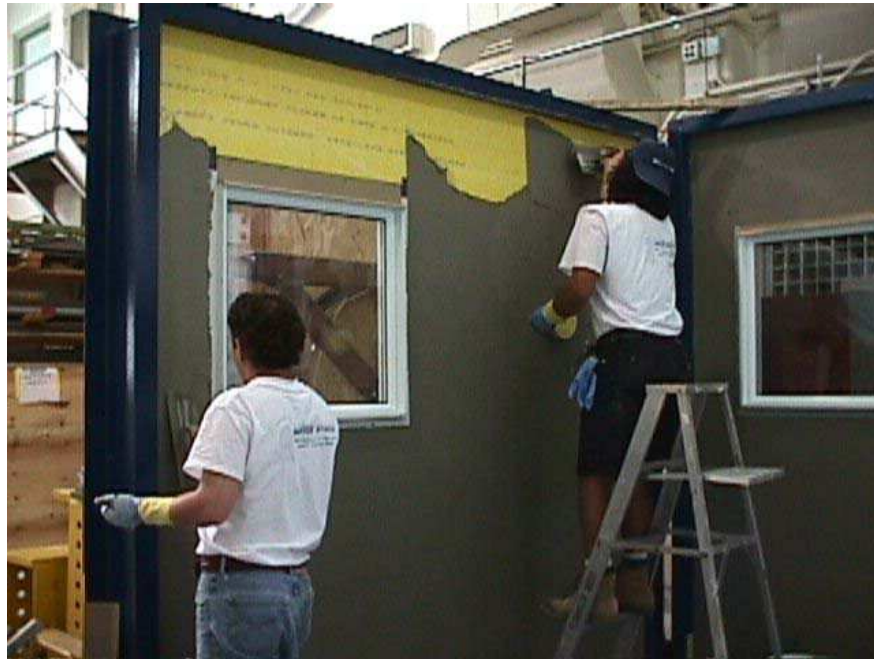
Figure 2.58. Wall No. 8. Application of WRB coating

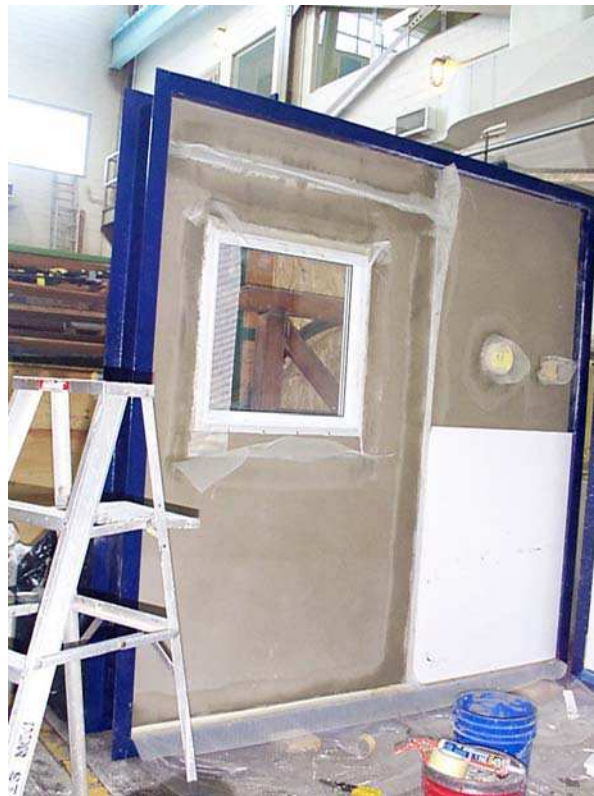
Figure 2.59. Wall No. 8. Backwrapping and installation of adhered EPS insulation

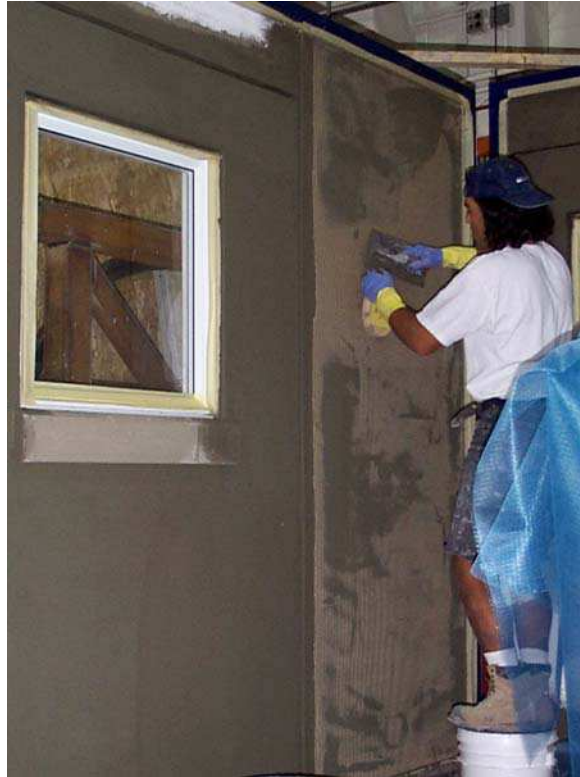
Figure 2.60. Wall No. 8. Application of base-coat and mesh
