### **Report from task 2 of MEWS Project: description of 17 large scale wall specimens built for water entry investigation in IRC dynamic wall testing facility**

Bomberg, M. T.; Rousseau, M. Z.; Desmarais, G.; Nicholls, M.; Lacasse, M. A.

*Research Report (National Research Council of Canada. Institute for Research in Construction); no. RR-111, 2002-10-01*

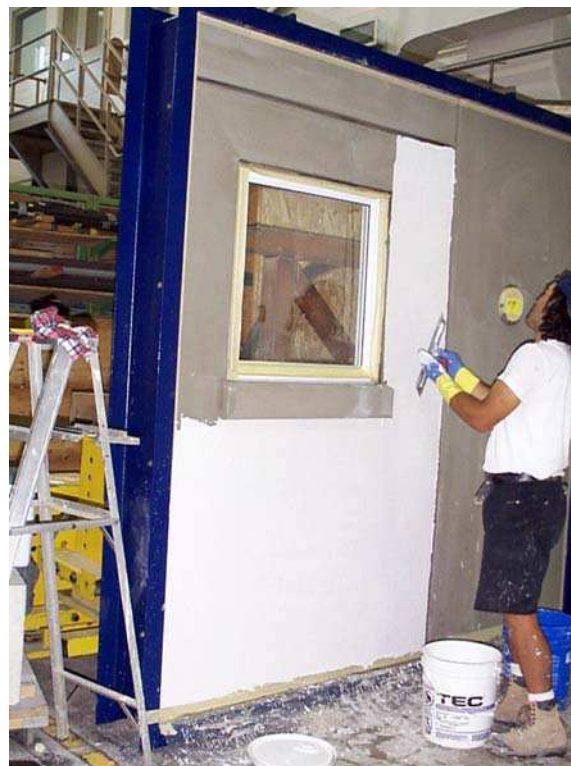
Figure 2.61. Wall No. 8. Application of finish coat

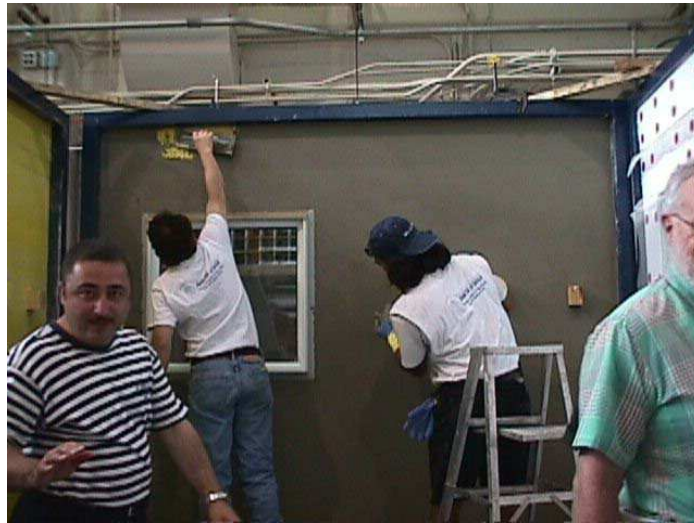
Figure 2.62. Wall No. 9. Application of WRB coating

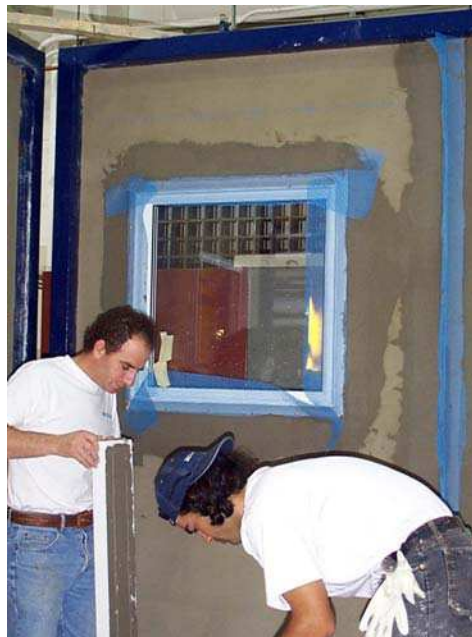
Figure 2.63. Wall No. 9. Backwrapping around openings

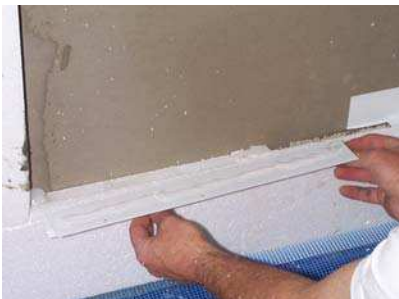
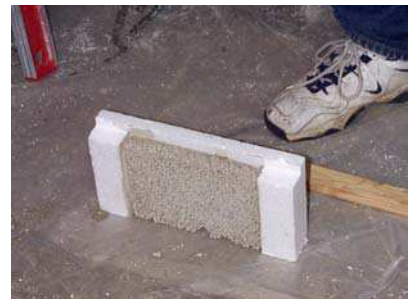
Figure 2.64. Wall No. 9. Drainage system components

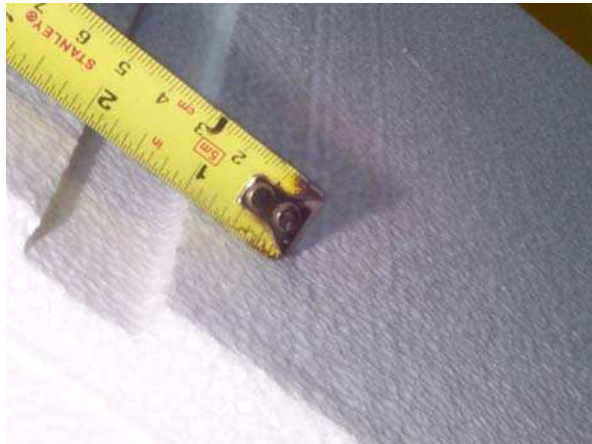
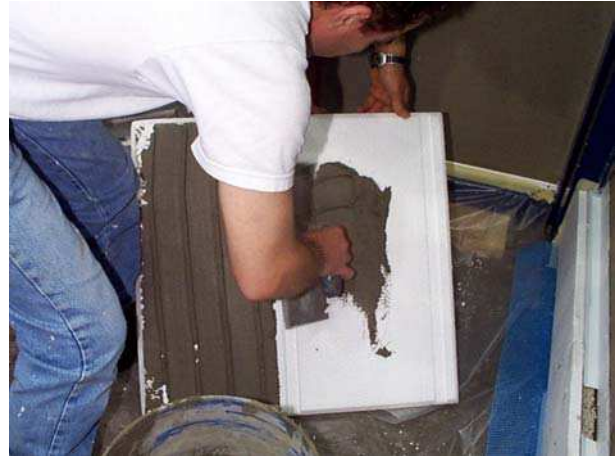
Figure 2.65. Wall No. 9. EPS insulation with vertical grooves, application of adhesive behind the insulation

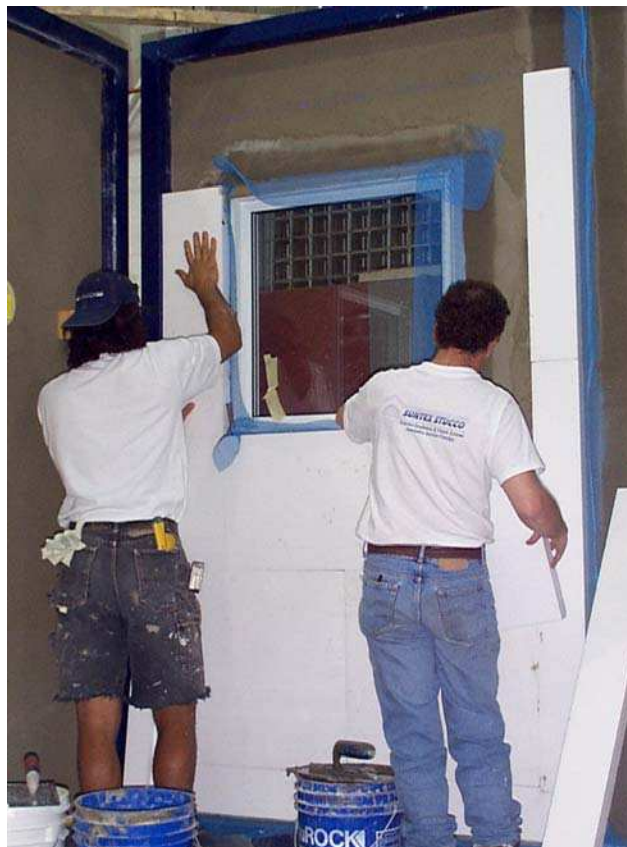
Figure 2.66. Wall No. 9. Installation of EPS installation

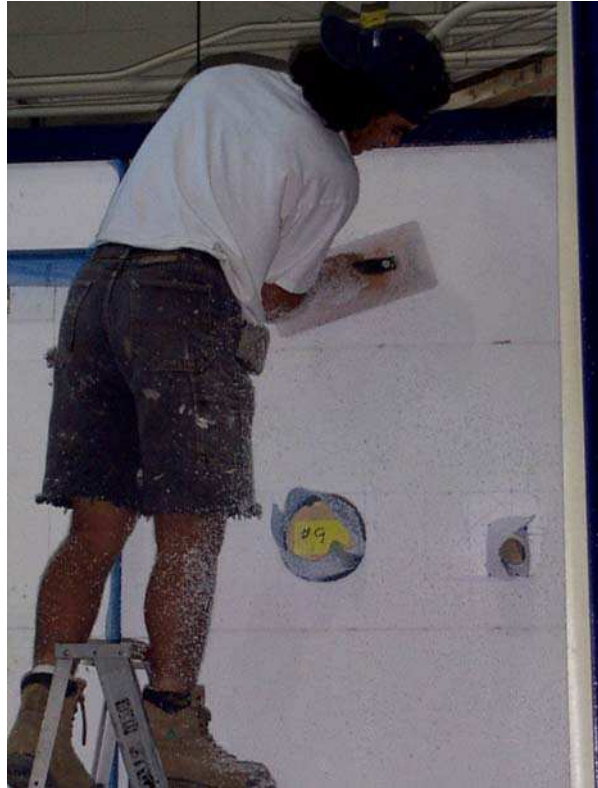
Figure 2.67. Wall No. 9. Sanding of EPS insulation

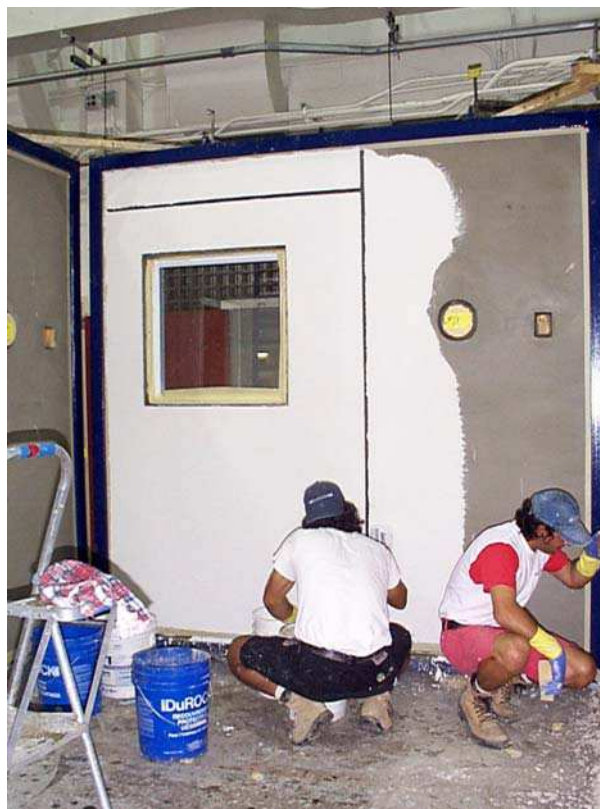
Figure 2.68. Wall No. 9. Application of finish coat

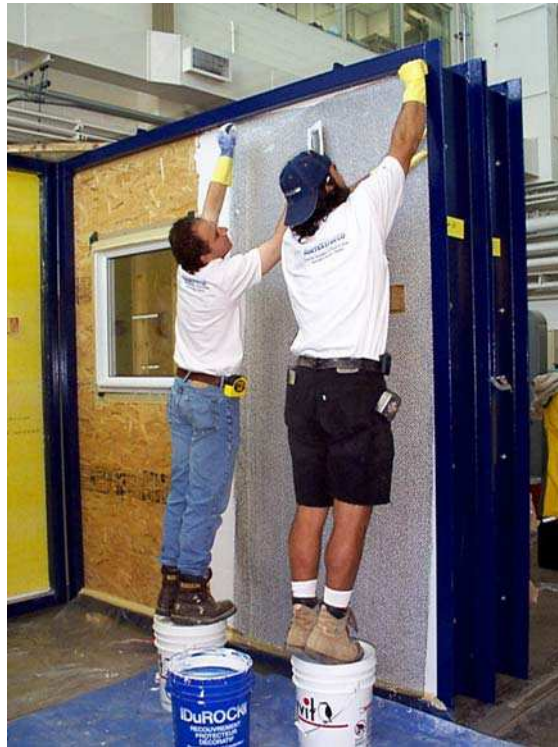
Figure 2.69. Wall No. 10. Application of WRB coating and nylon drainage mat

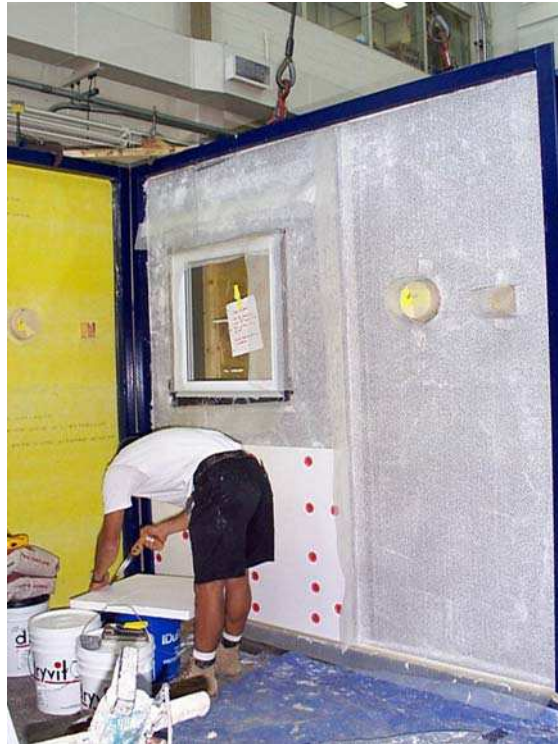
Figure 2.70. Wall No. 10. Installation of mechanically attached EPS insulation

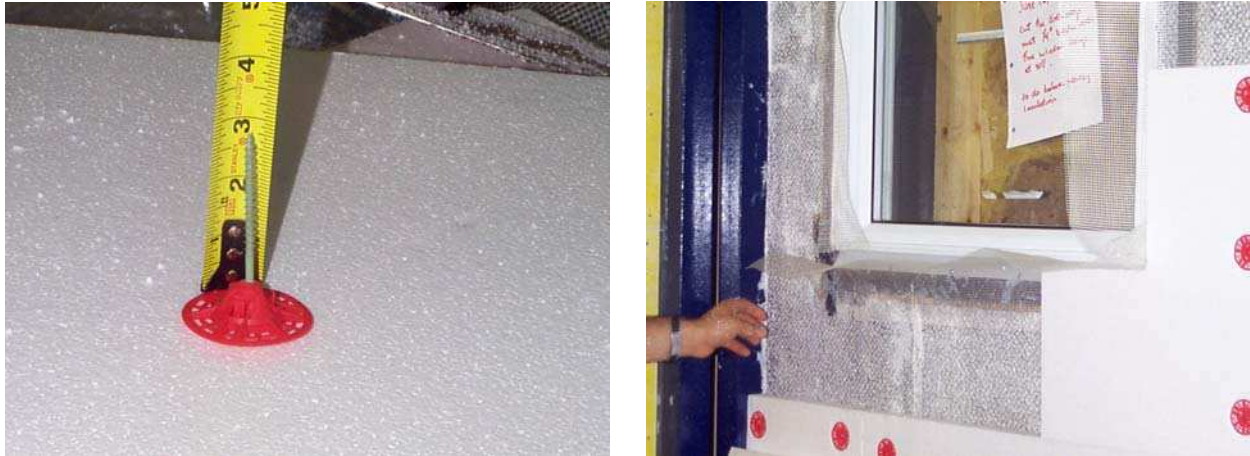
Figure 2.71. Wall No. 10. Rust proof fasteners and backwrapping over insulation

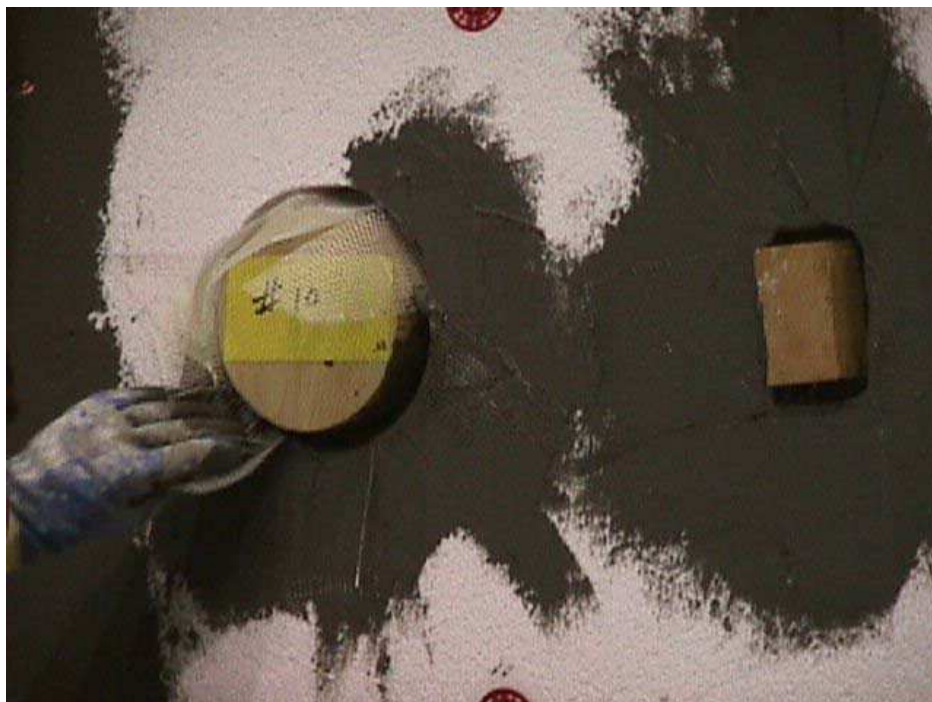
Figure 2.72. Wall No. 10. Backwrapping of penetrations

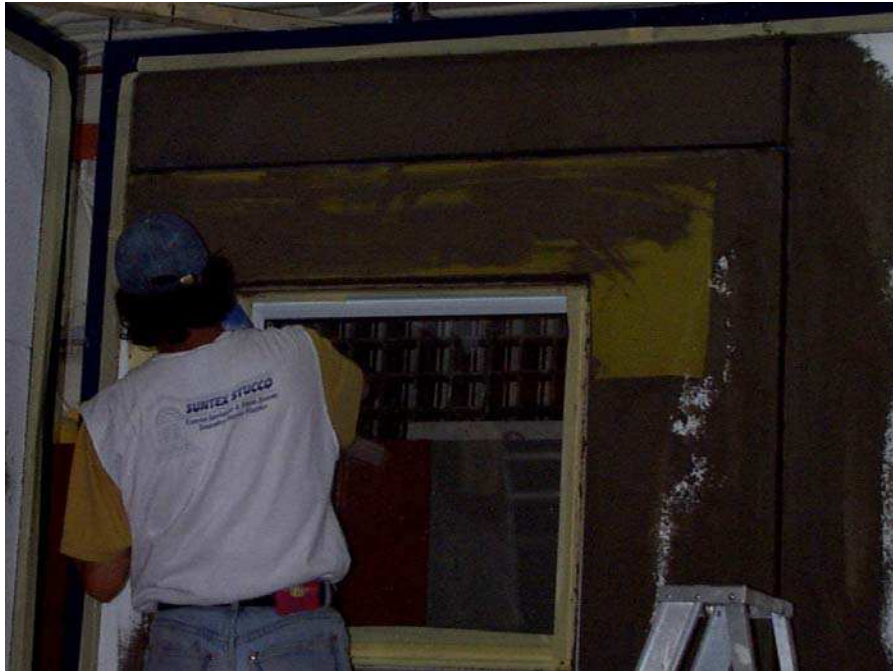
Figure 2.73. Wall No. 10. Installation of base-coat and mesh

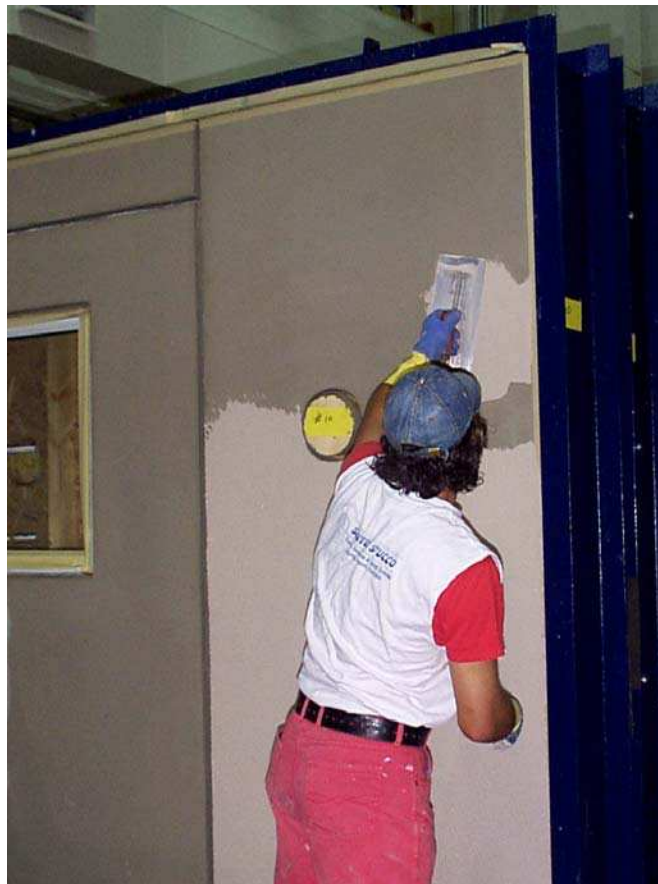
Figure 2.74. Wall No. 10. Application of finish coat

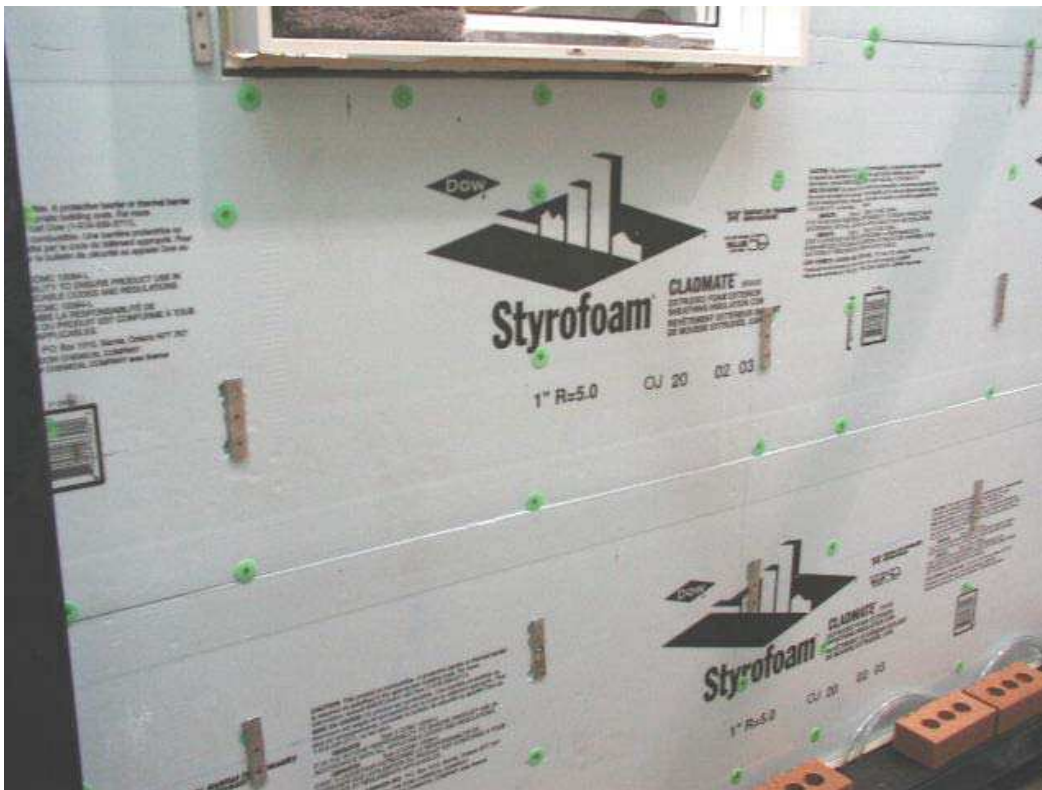
Figure A3.1 Installation of the foam sheathing on specimen No. 11

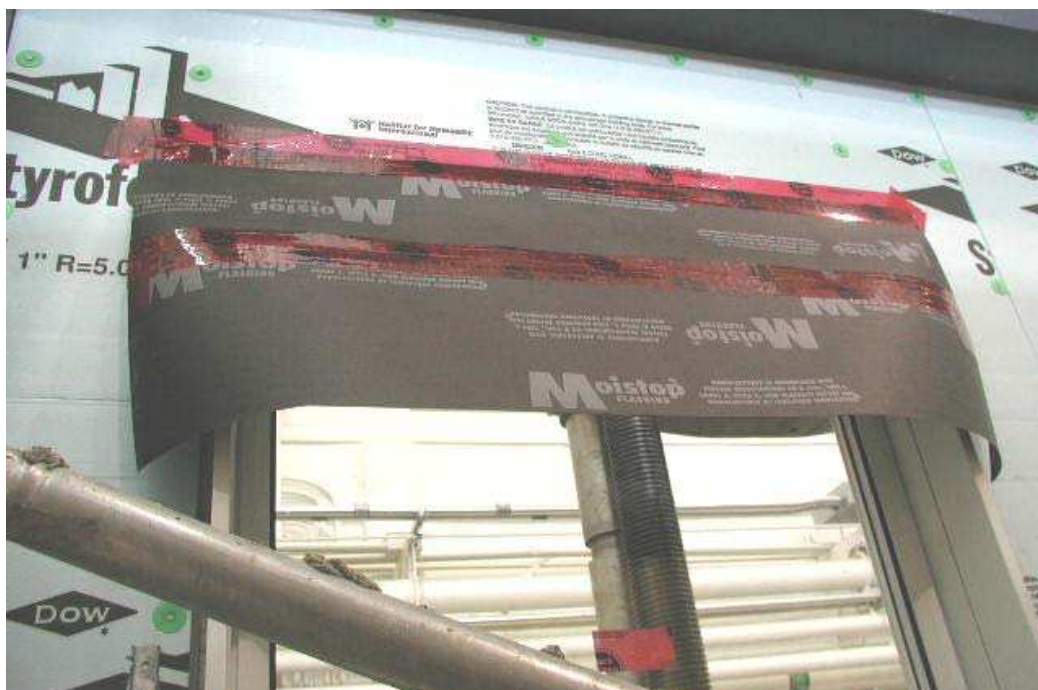
Figure A3.2 Installation of the flashing membrane at the window head of specimen No. 11

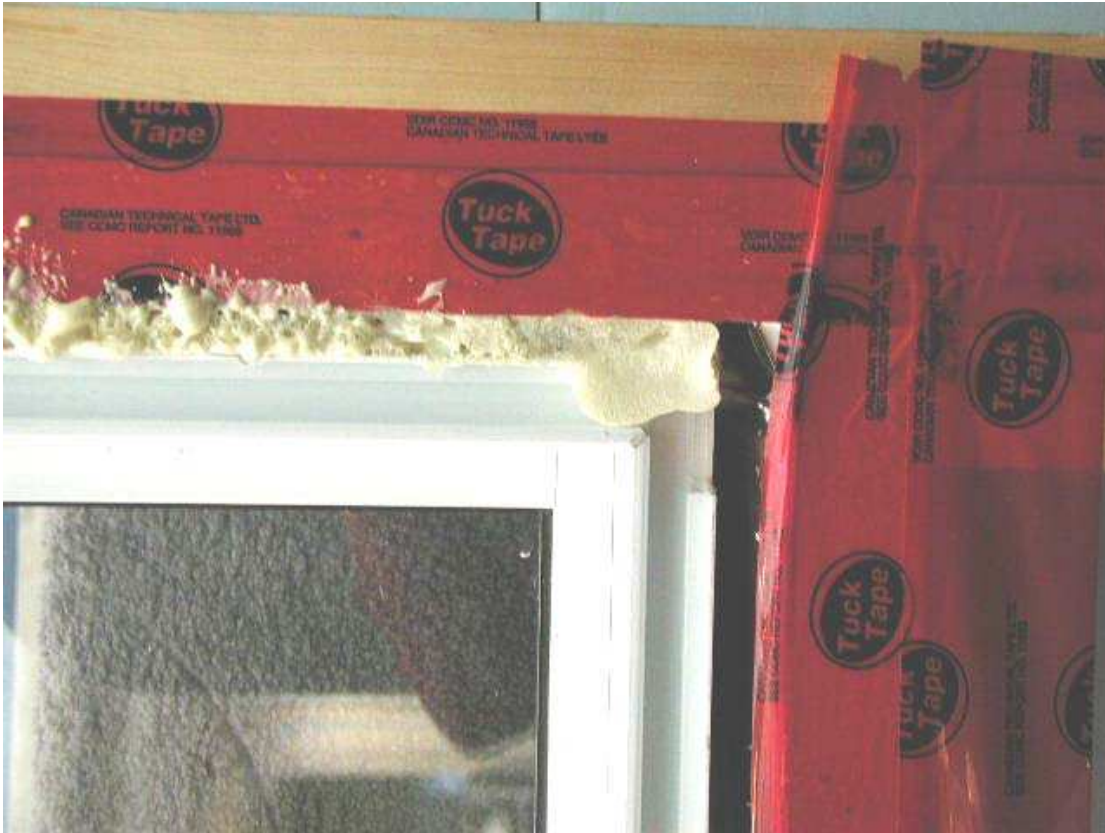
Figure A3.3 Specimen No. 11. Foaming at the window head and jambs (rough sill is left clear to place the water collection gutter)

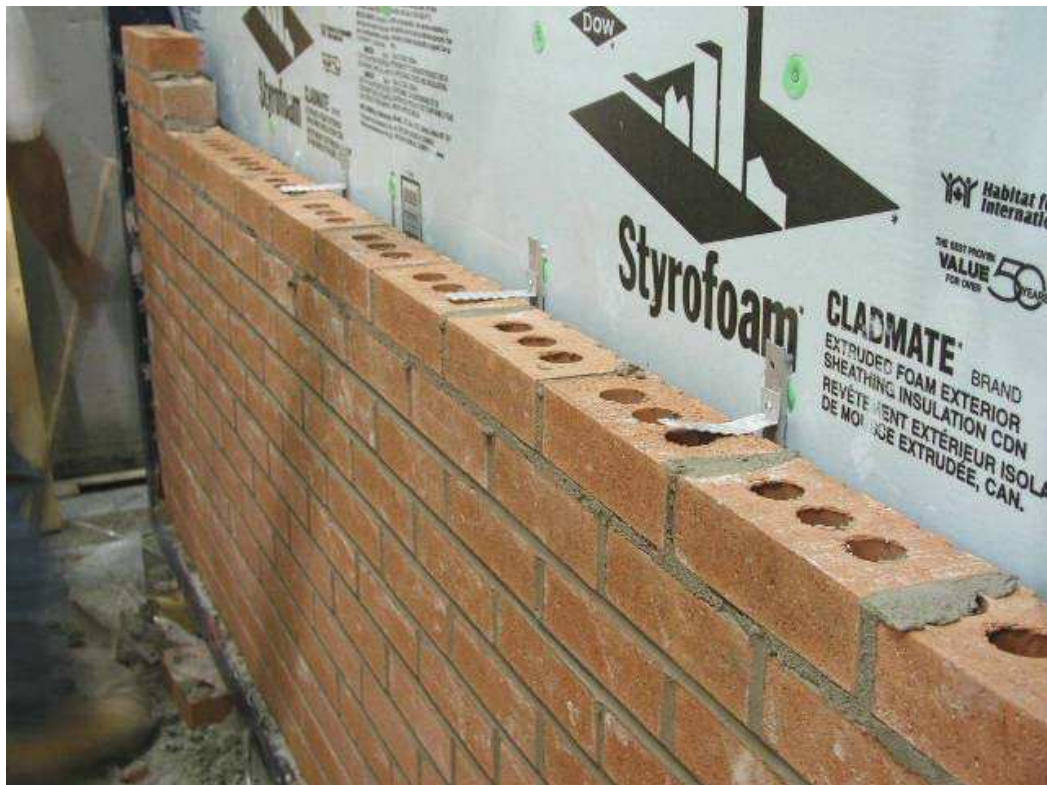
Figure A3.6 Specimen No. 11. Brick laying by a local masonry company

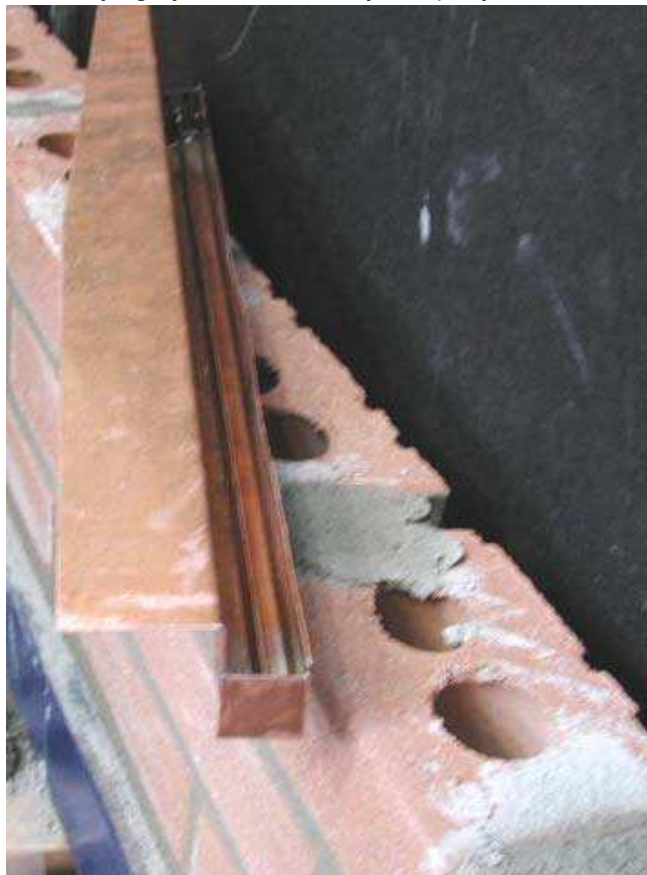
Figure A 3.7 Profile of a water collection trough to be placed in the cavity

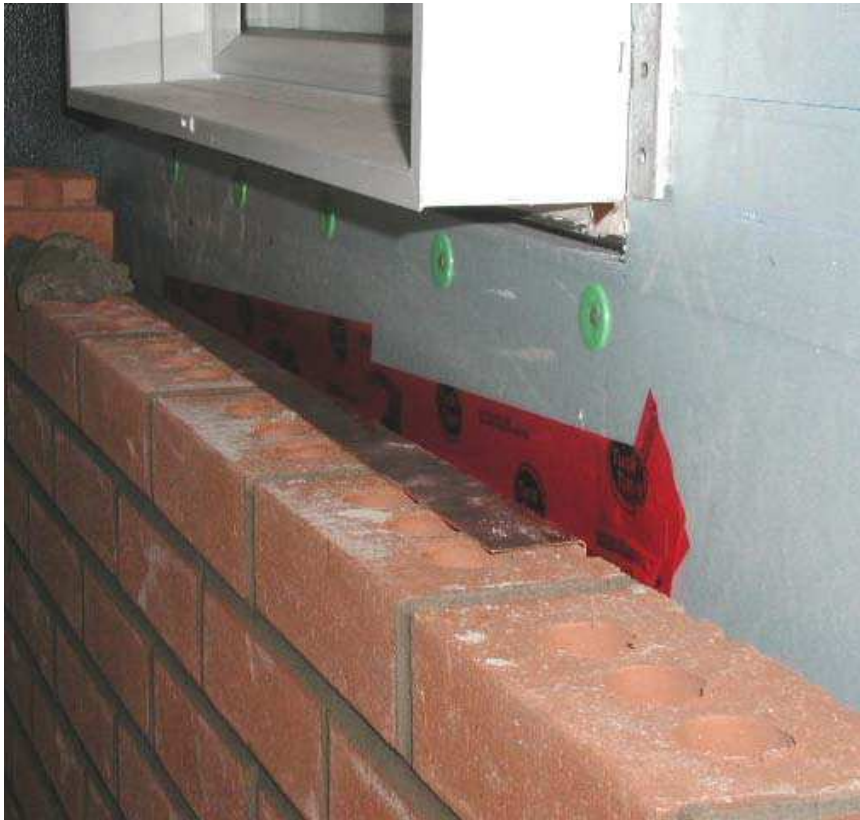
Figure A3.8 Window frame extension and installation of the water collection through in the cavity behind the brick veneer

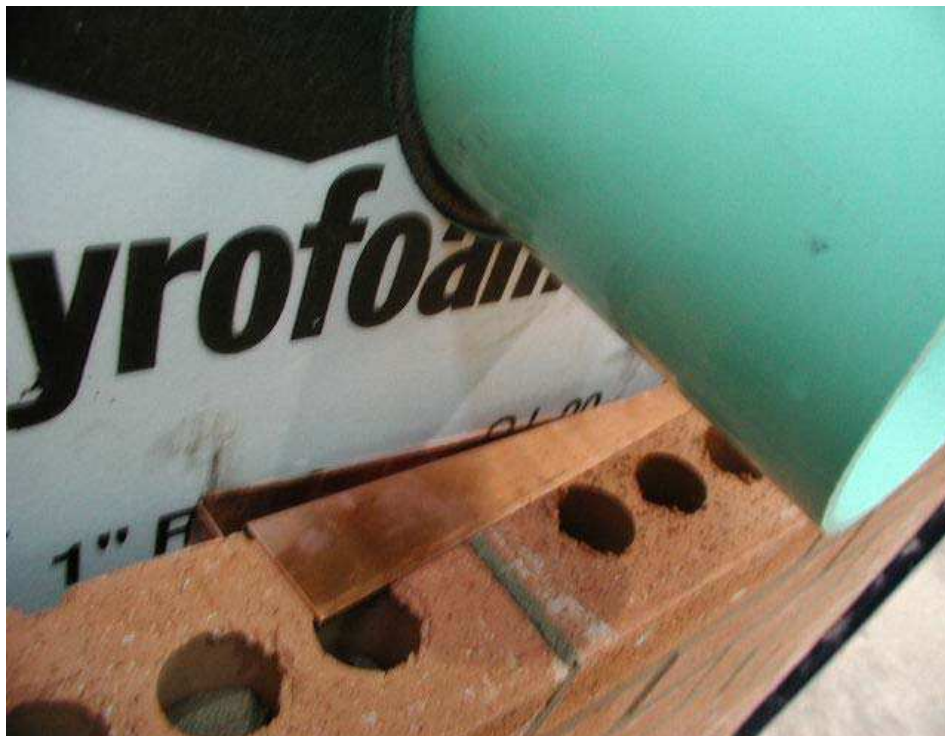
Figure A3.9 Specimen No. 11 at the form that will be used for the ventilation duct later on

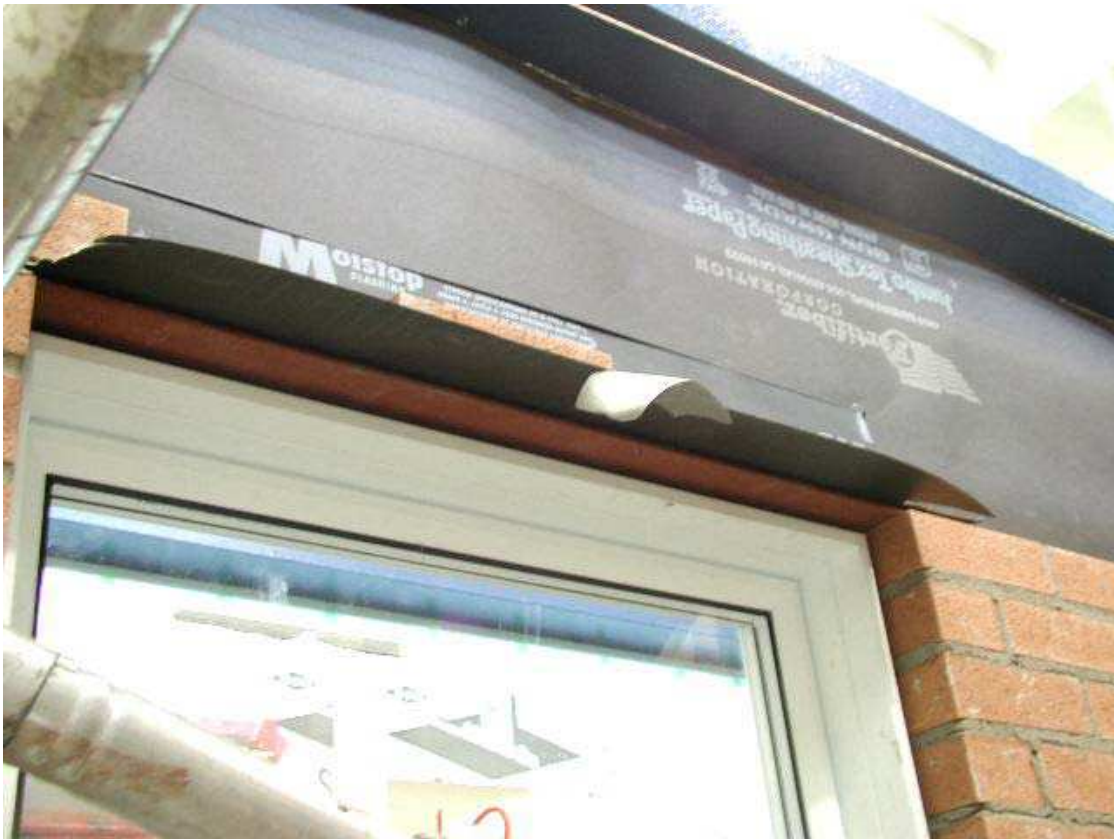
Figure A3.10 Specimen No. 12 at window head showing the shelf angle and the flashing membrane

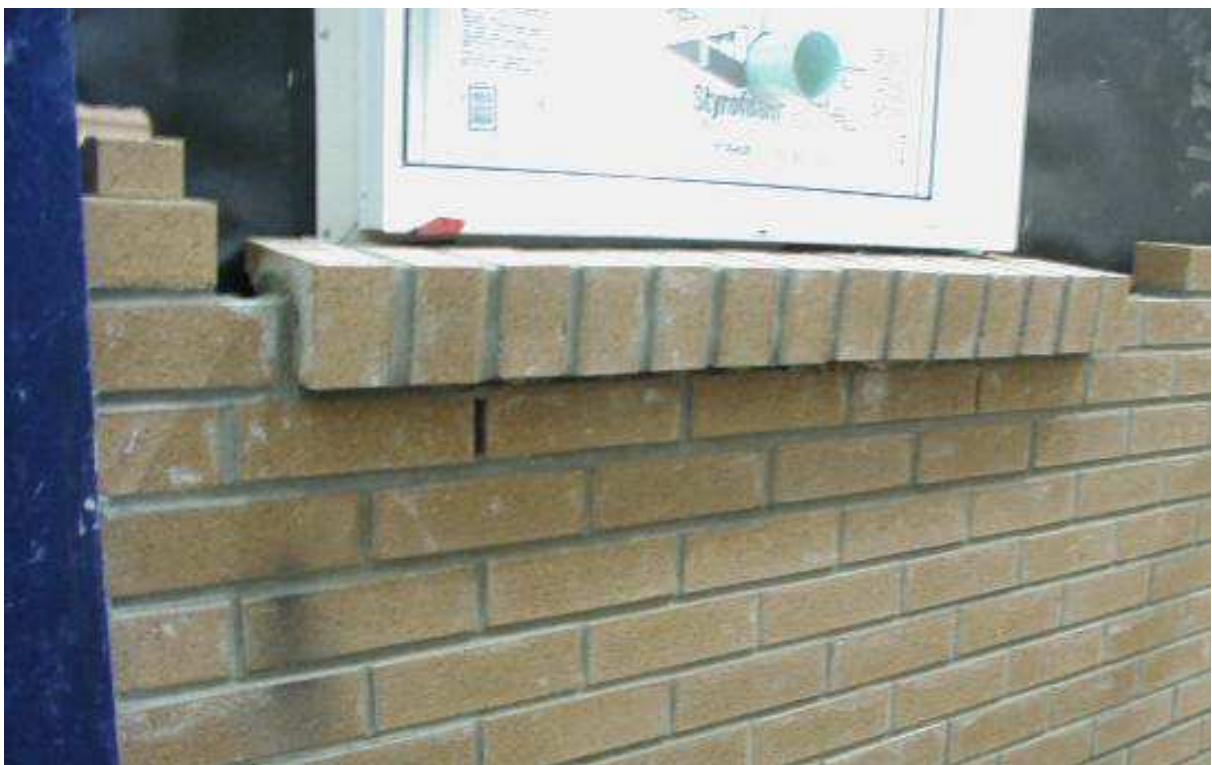
Figure A3.11 Rowlock window sill for specimen No. 12

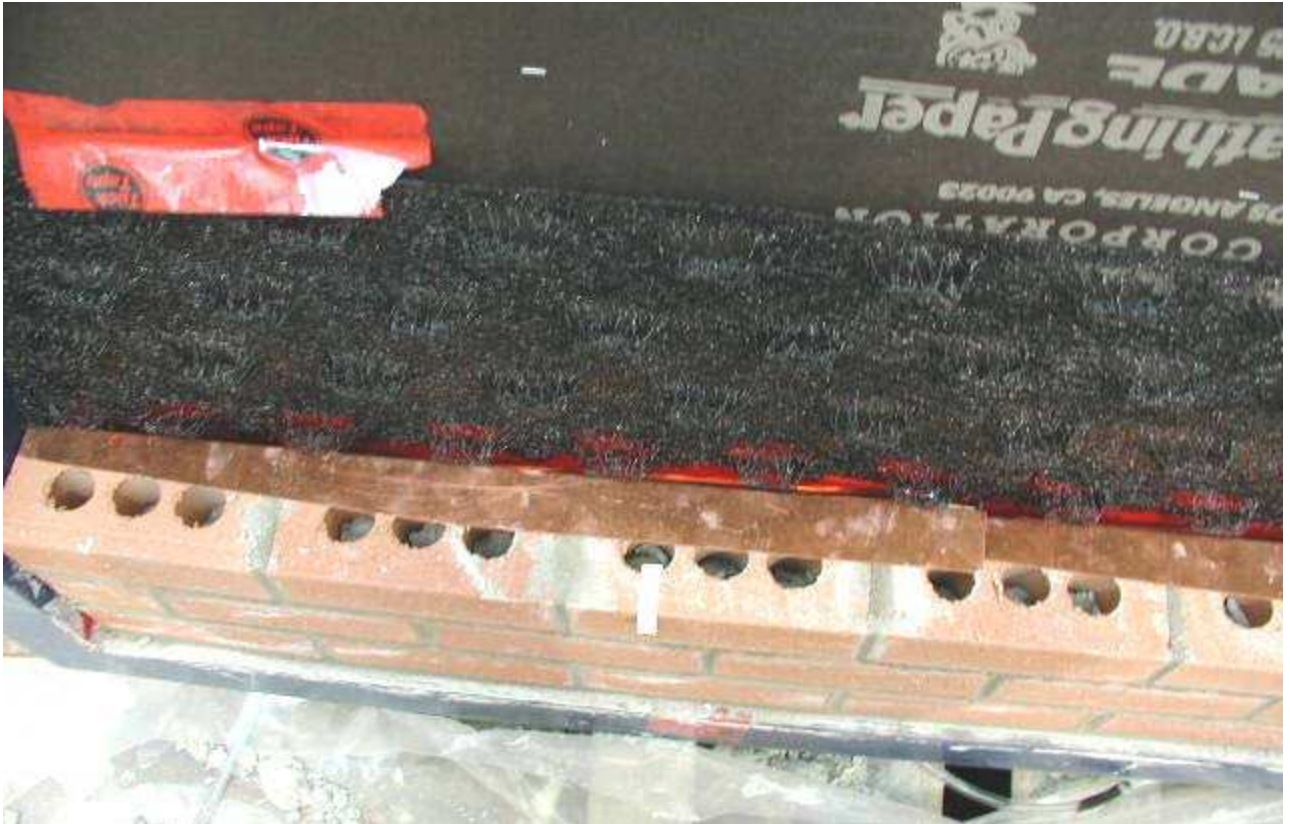
Figure A3.14 Descending view of the brick veneer. Mortar Maze was installed in the cavity to reduce the occurrence of mortar droppings in the water collection troughs.

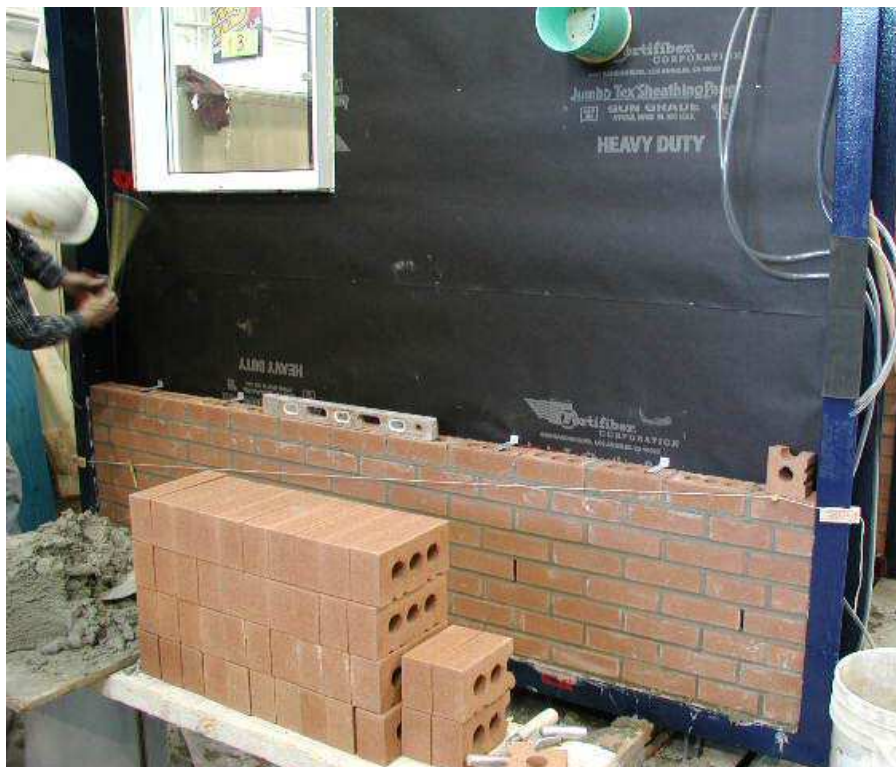
Figure A3.15 Brick laying in progress. Weepholes are placed every three bricks.

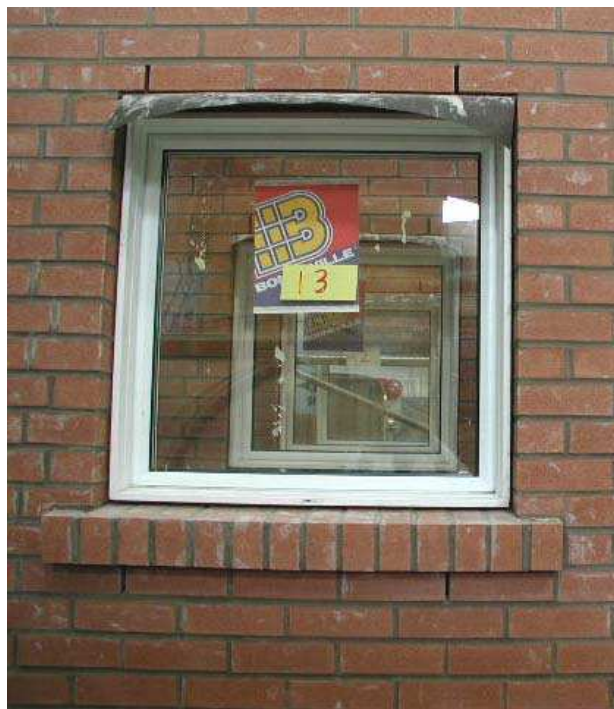
Figure A3.17 Window of specimen No. 13

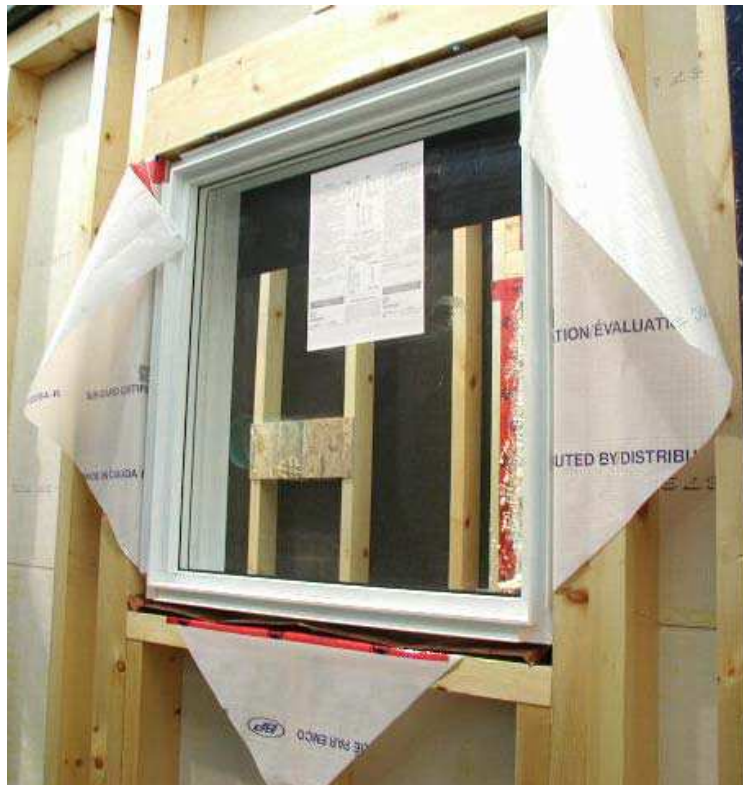
Figure A3.19 Installation of the window on specimen No. 14. Dupont procedure was followed.

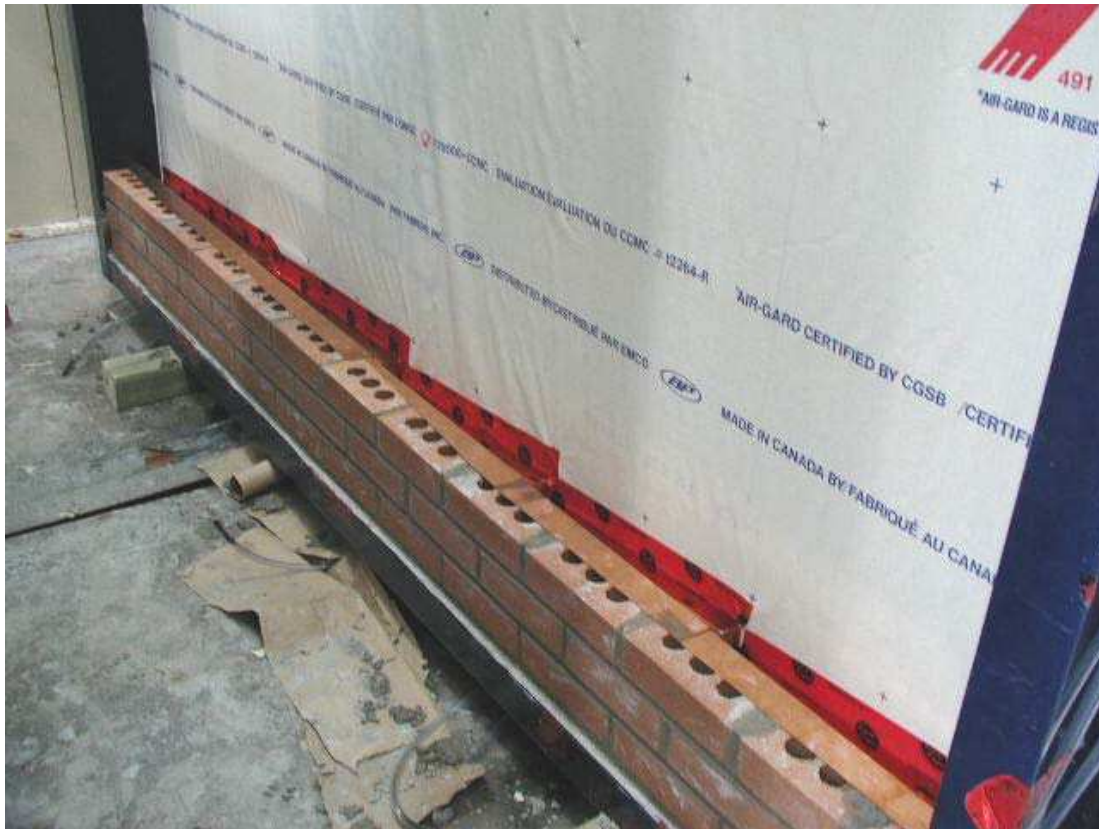
Figure A3.20 Installation of the water collection roughs at the bottom of the specimen No. 14

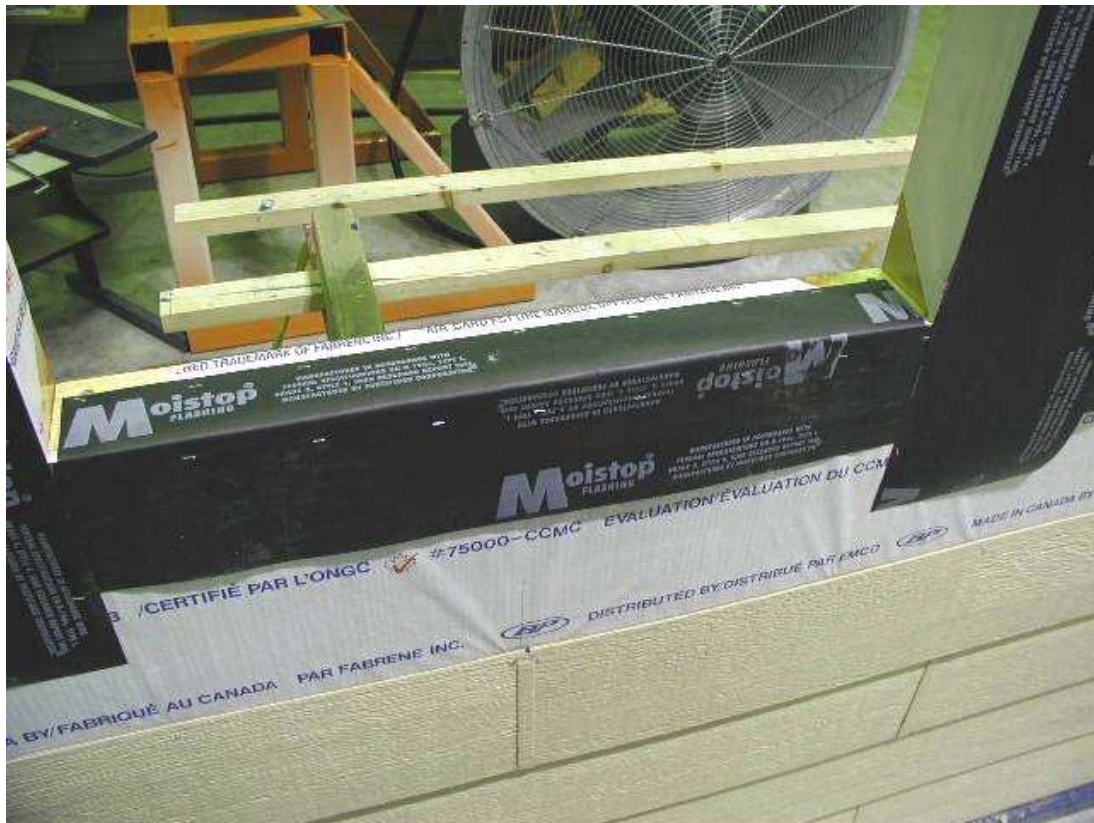
Figure A.4.1 Specimen No.15 at window sill

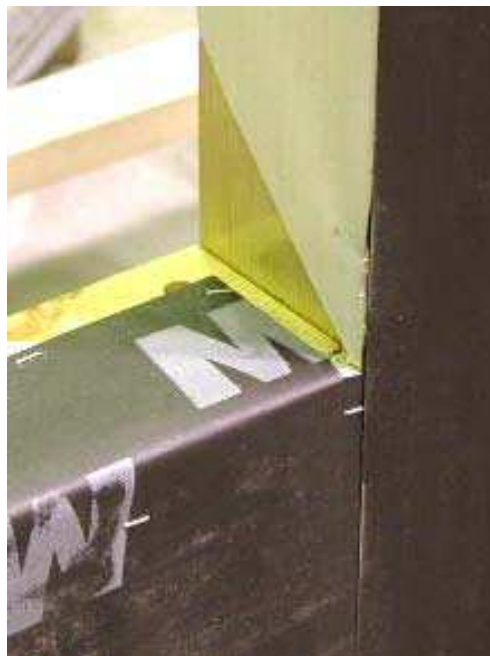
Figure A4.2 Specimen No.15. Close-up on the deficiencies at the rough sill

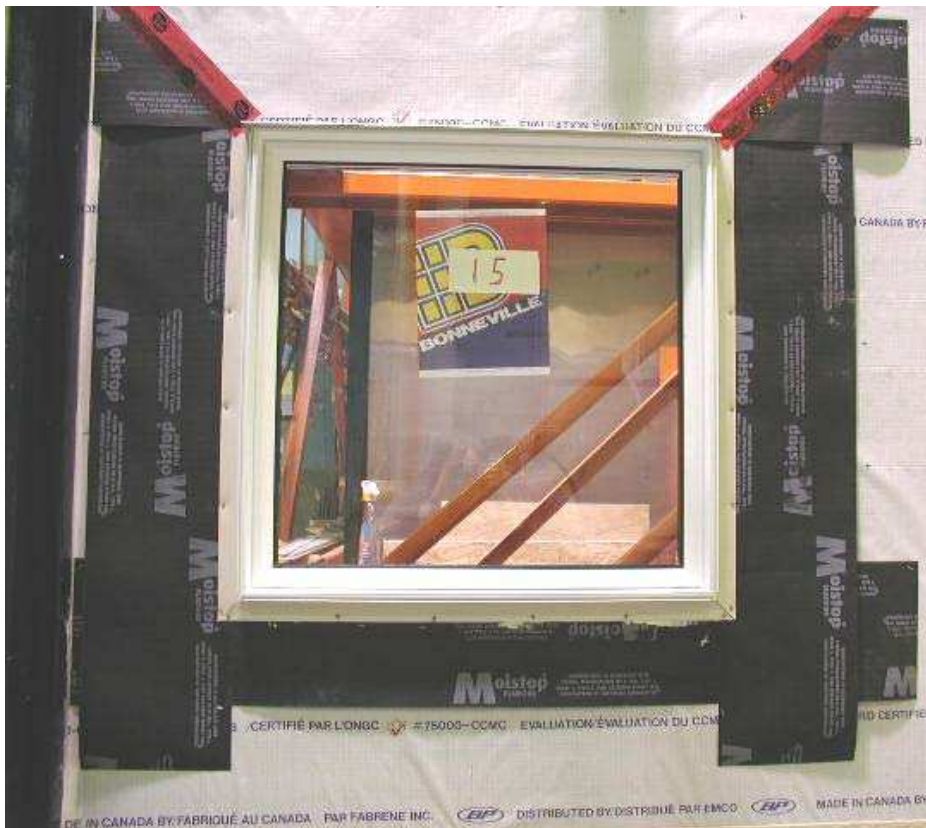
Figure A4.3 Specimen No.15. Front view of the membranes installed around the window (left) according to Dupont procedure (right)

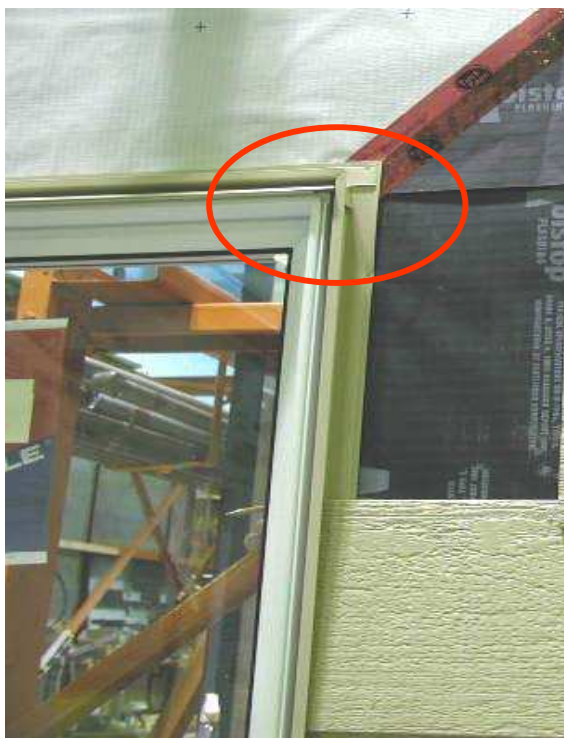
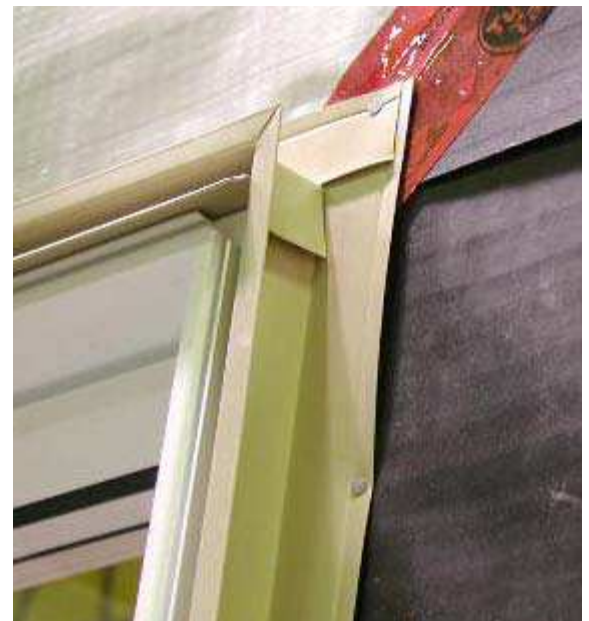
Figure A4.4. Specimen No. 15 Placement of J-trim around window

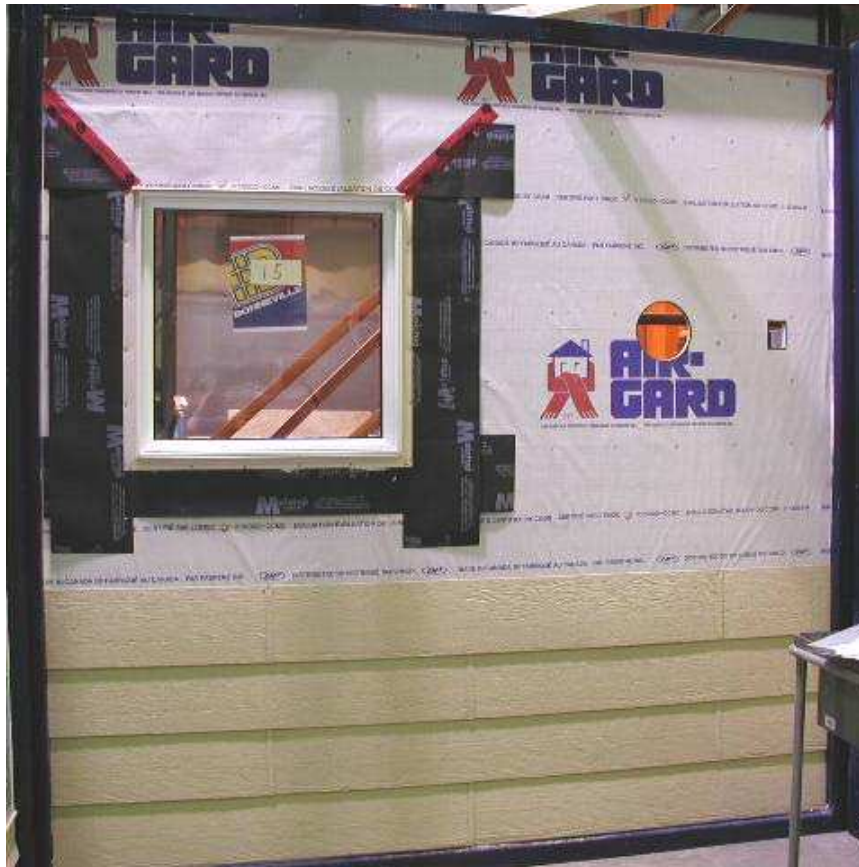
Figure A4.5 specimen No.15 Installation of the hardboard siding

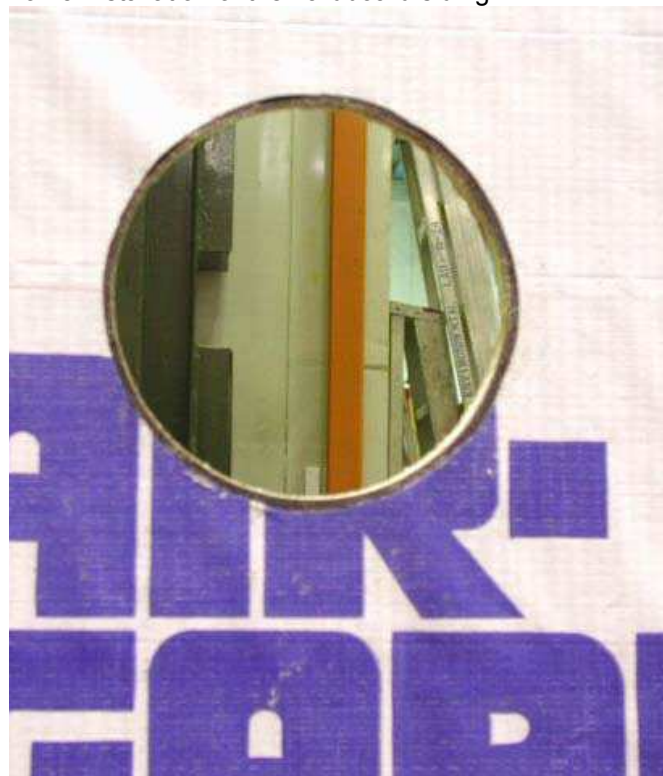
Figure A4.6 Specimen No.15. Deficiency in the installation of the WRB at the duct opening
