### **Report from task 2 of MEWS Project: description of 17 large scale wall specimens built for water entry investigation in IRC dynamic wall testing facility**

Bomberg, M. T.; Rousseau, M. Z.; Desmarais, G.; Nicholls, M.; Lacasse, M. A.

*Research Report (National Research Council of Canada. Institute for Research in Construction); no. RR-111, 2002-10-01*

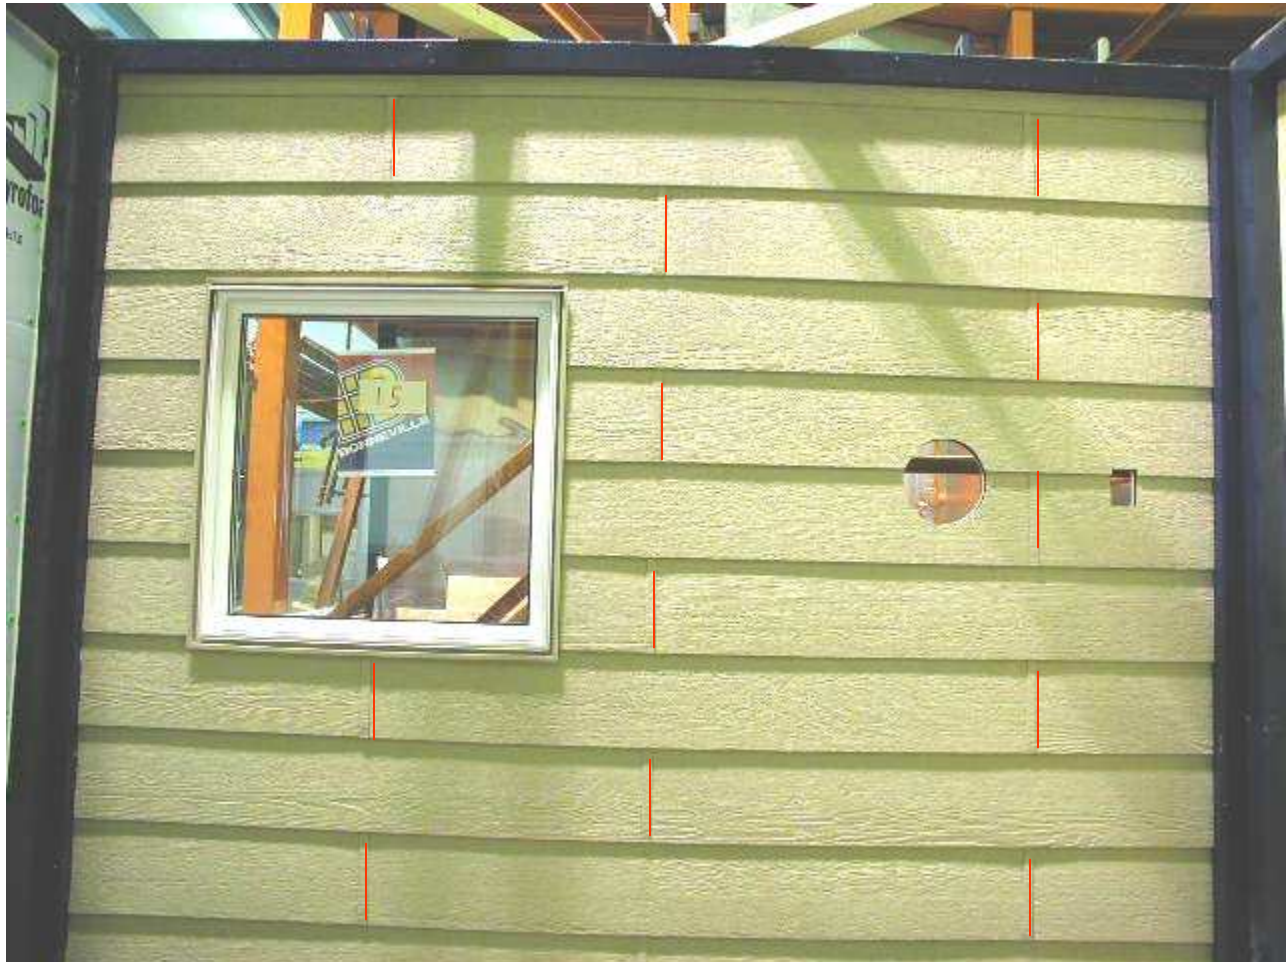
Figure A4.7 Specimen No.15. Location of the joints in the siding (same location for all 3 specimens)

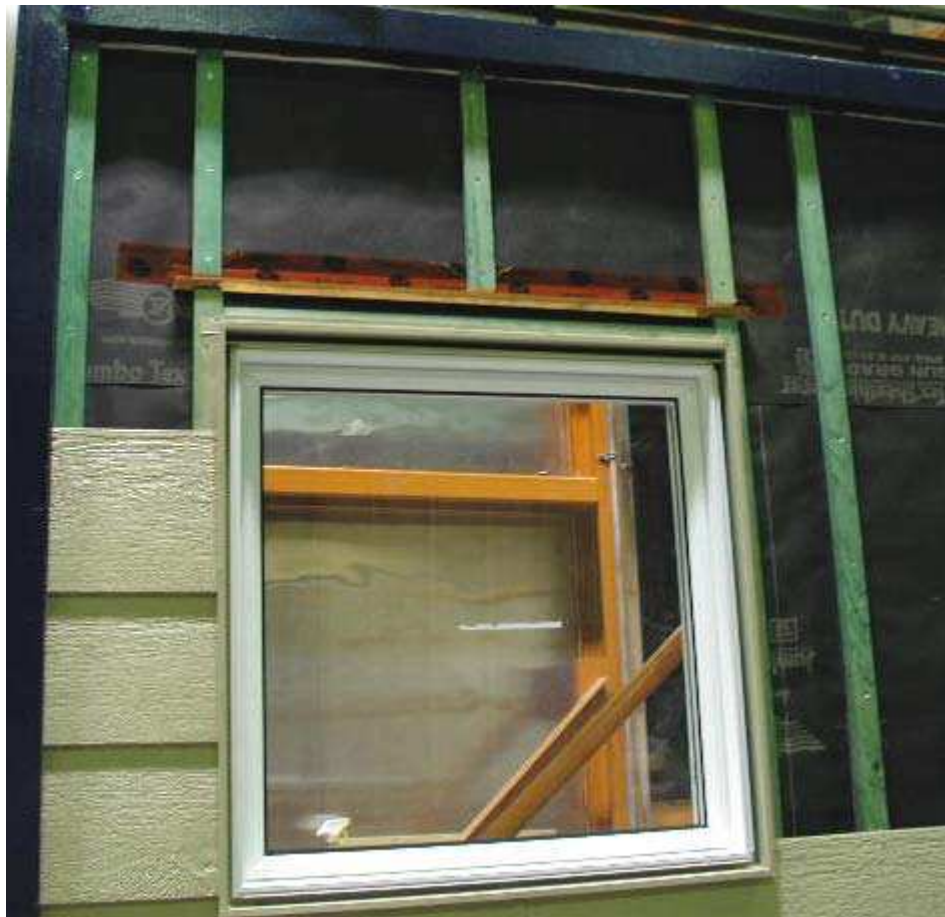
Figure A4.8 Specimen No.16. Detailing around the window of, showing the furring strips, J-trim and deflector at head

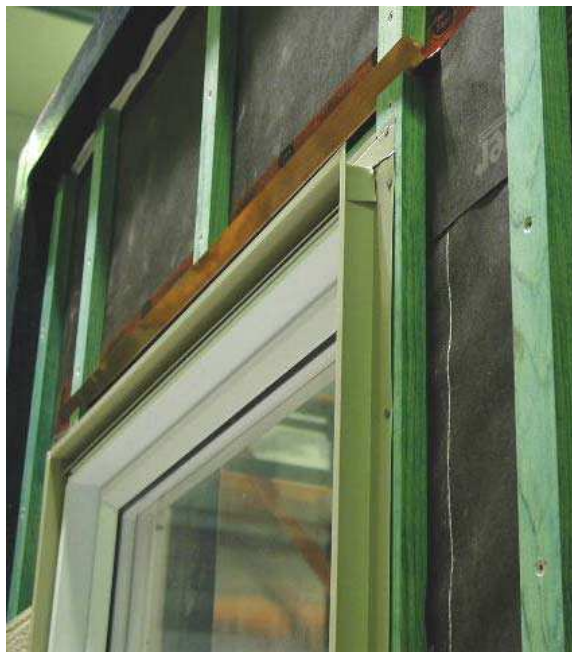
Figure A4.9 Specimen No.16. Zoom on the detailing at the window head

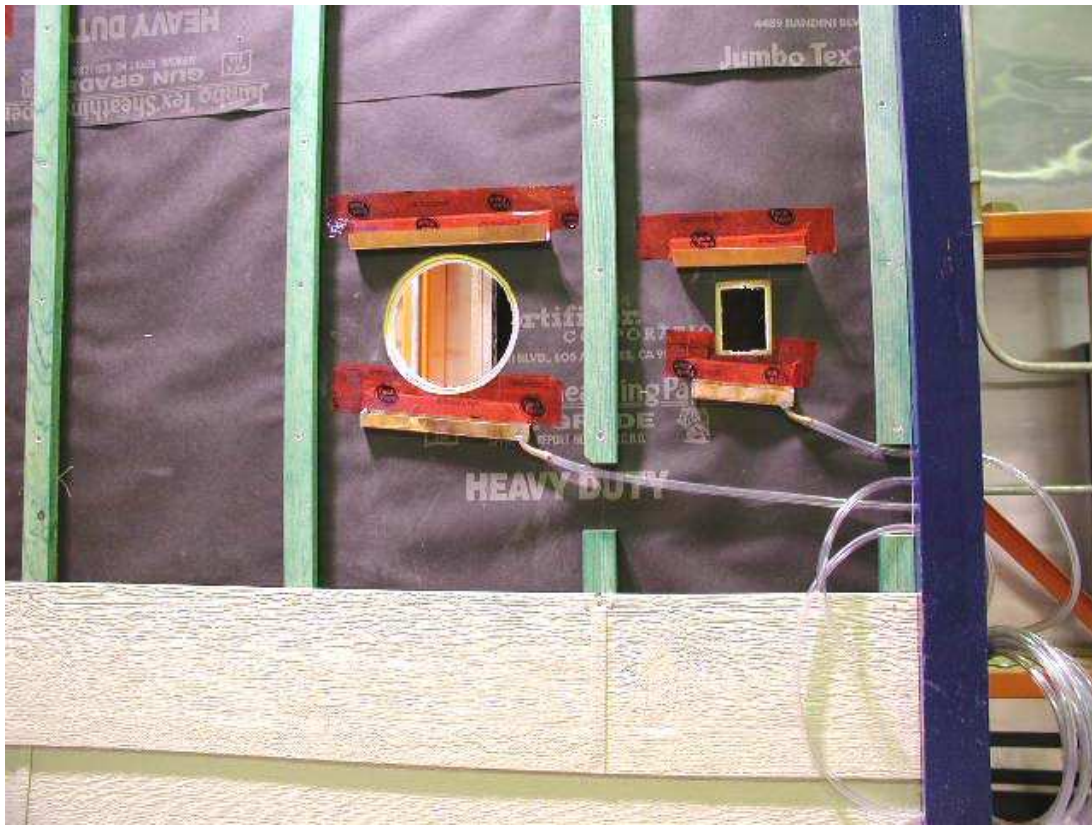
Figure A4.10 Specimen No.16. Detailing at the ventilation duct and outlet, showing the gutter system placed for water collection

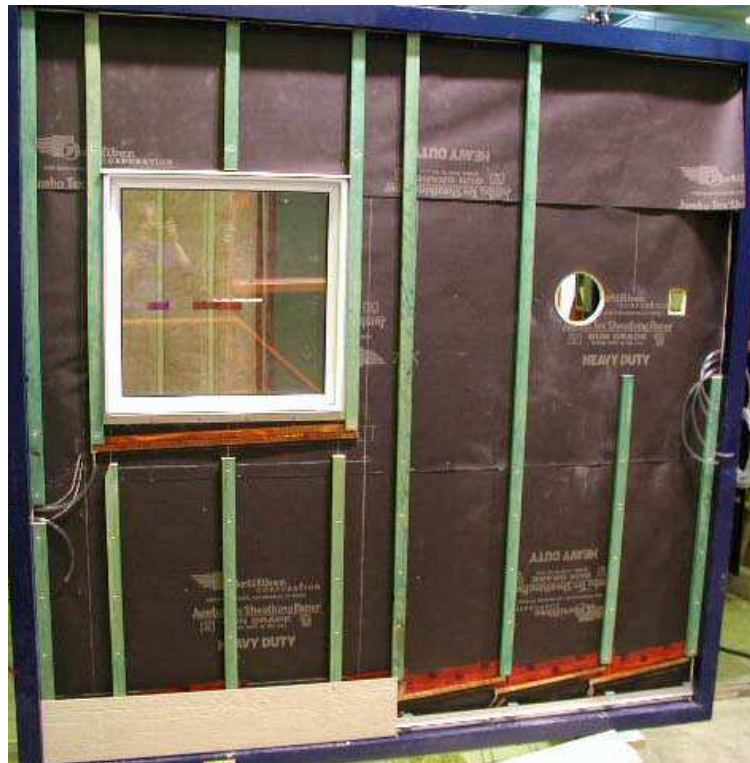
Figure A4.11 Specimen No. 16. Placement of furring strips and water collection system at the bottom of each cavity

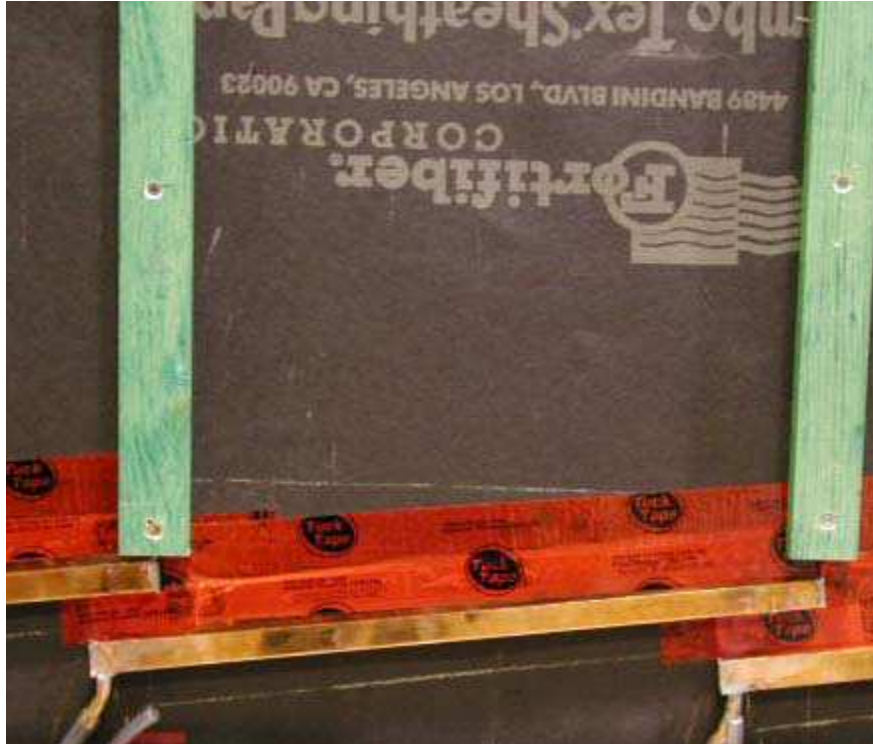
Figure A4.12 Specimen No. 16. Zoom on the water collection device at the bottom of each cavity

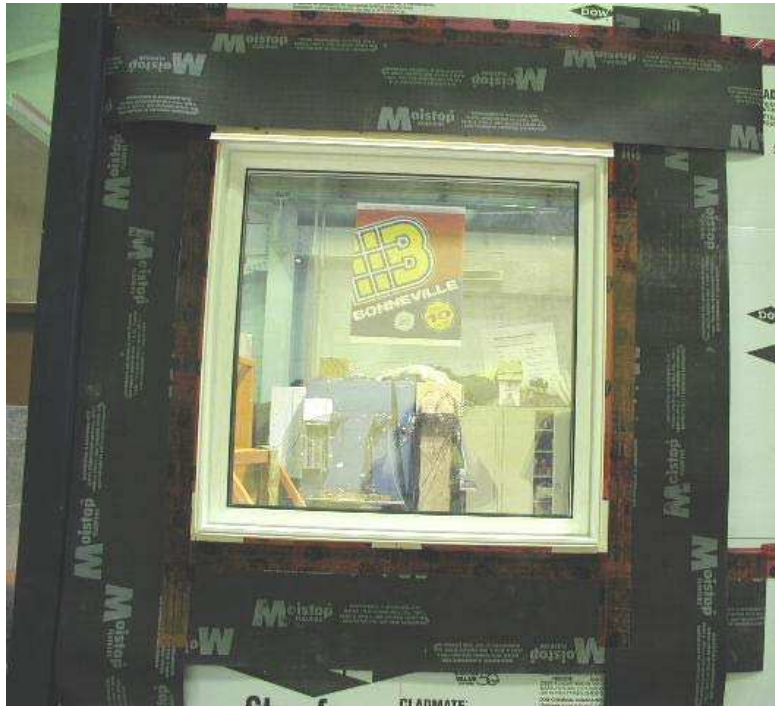
Figure A4.14 Specimen No.17. Placement of membranes around the window frame

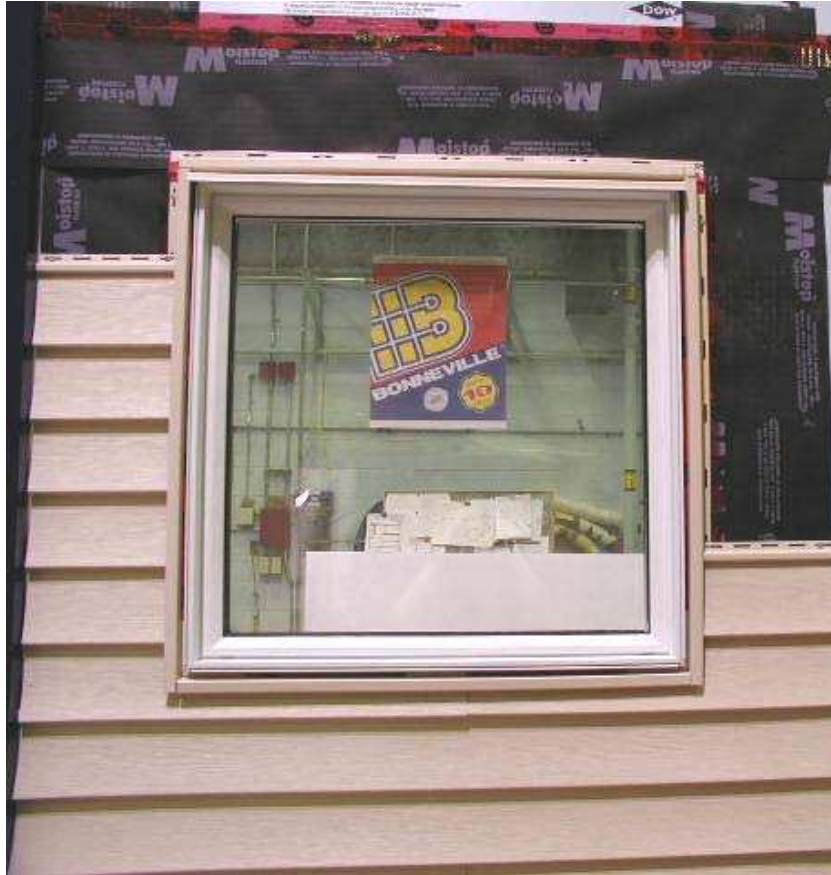
Figure A4.15 Specimen No.17. Installation of the vinyl siding and J-trim around the window frame

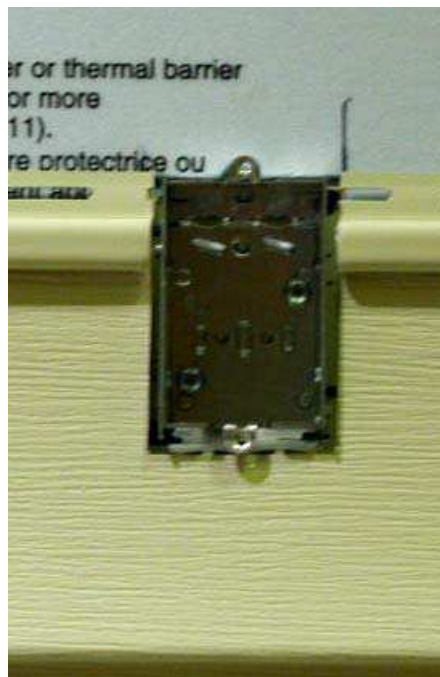
Figure A4.17 Specimen No 17. Installation of the electrical outlet

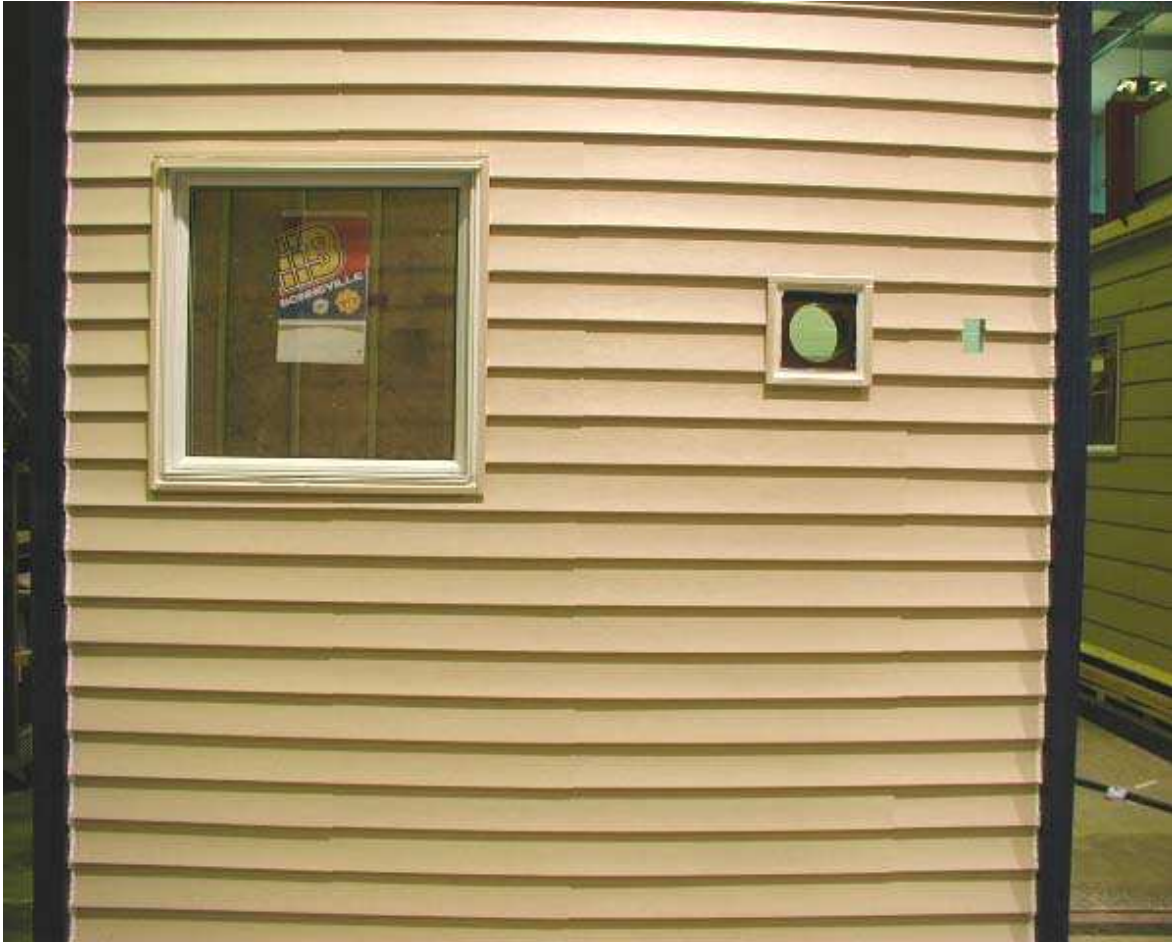
Figure A4.18 Specimen no 17. Installation of vinyl siding completed
