Repeated leakage tests on small panels of dry-press bricks Davison, J. I.

Internal Report (National Research Council of Canada. Division of Building Research), 1964-11-01

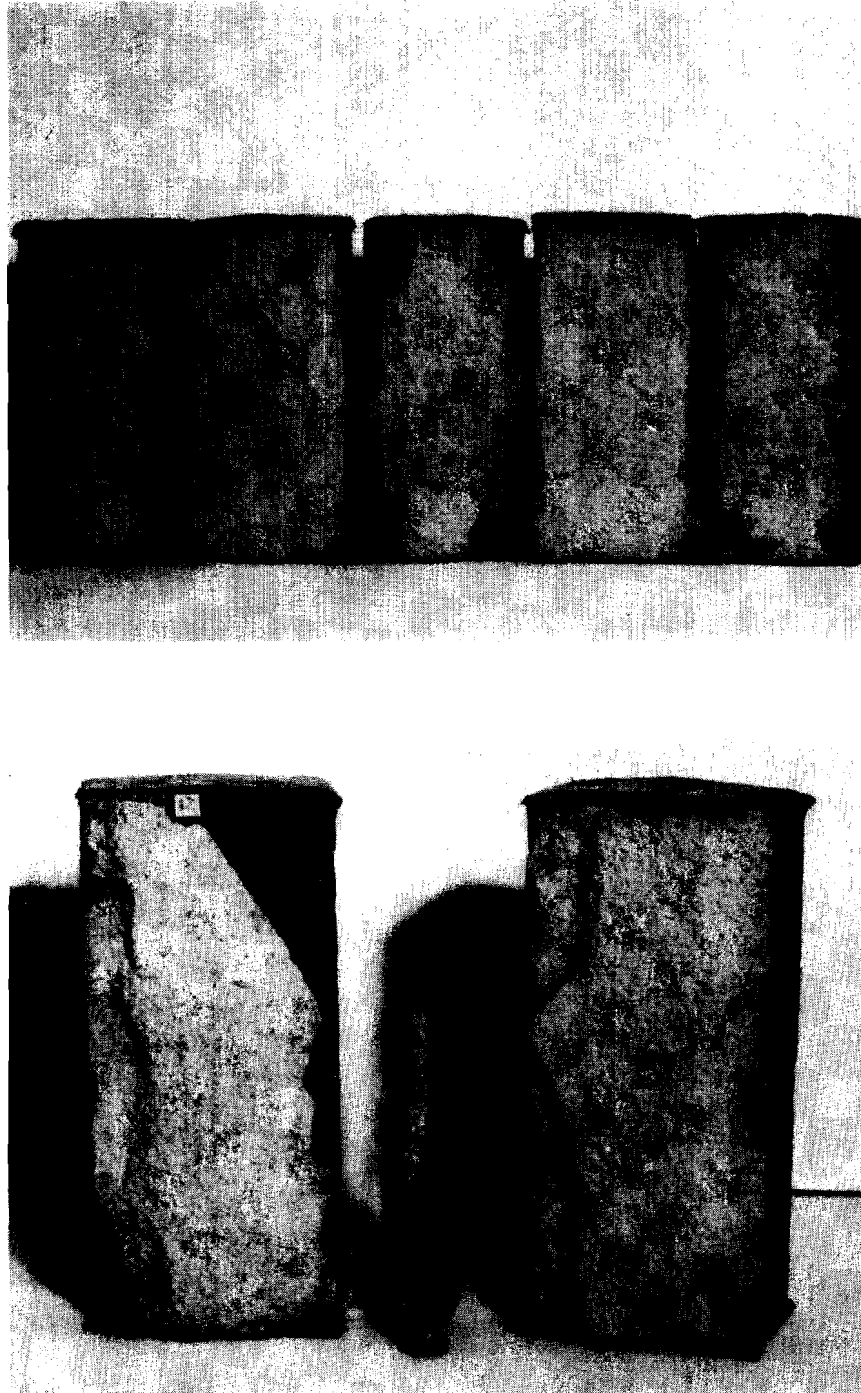
FIGURE 2

Panel P71

Top - Fractured joints. Note complete extent of bond and breaks through mortar beds.

Bottom - Mortar has been chipped away and bricks broken. No evidence of mortar penetrating brick. Note clean separation of brick and mortar on sample in middle.

under optimum conditions, created by periodically wetting the mortar during leakage tests. Visual examination of fractured joints revealed a complete extent of bond with all breaks occurring through the mortar beds instead of at the brick-mortar interface. The extent of bond and nature of the fractures are shown in Figure 2, a photograph of joints after the test.

To investigate (1) the nature of the bond between mortar and brick, and (2) the possibility of mortar penetrating the brick, some of the mortar was chipped from the units. It did not separate cleanly and invariably there was some mortar left on the brick -- a layer between the mortar bed and the unit. The brick was then broken (by chipping) to see if there was any evidence of mortar penetration. There was no visual evidence of this; a very definite boundary appeared to separate brick and mortar. This is clearly shown in the bottom photograph in Figure 2.
