### Report from Task 6 of MEWS Project: experimental assessment of water penetration and entry into wood-frame wall specimens: final report

Lacasse, M. A.; O'Connor, T.; Nunes, S. C.; Beaulieu, P.

*Research Report (National Research Council of Canada. Institute for Research in Construction); no. RR-133, 2003-02-01*

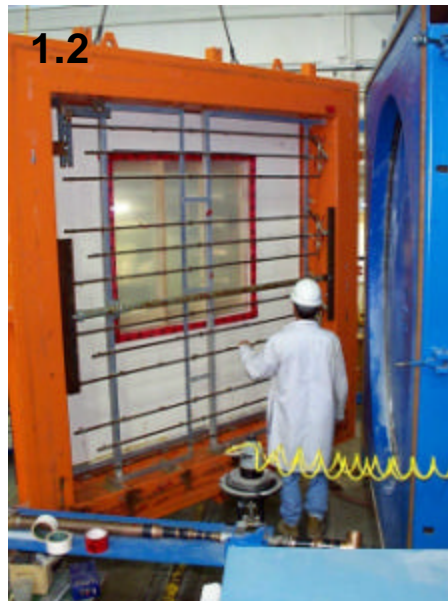
Figure 1.3 - **Inside view of apparatus** showing test specimen (sizes up to 2.44 by 2.44-m). The exterior cladding faces the inside of the apparatus.

The facility used to conduct the tests was the Dynamic Wind and Wall test Facility (DWTF). This facility, shown in Figure 1.3 to 1.4, is capable of subjecting full-scale test specimens (nominal size 2.44 by 2.44-m) to static or dynamic pressure fluctuations of over 2 KPa and spray rates of up to 8 L/min.-m<sup>2</sup> (Figure 1.3 and Figure 1.6). Dynamic pressure fluctuations are obtained by the displacement of a sealed 2.4-m diameter piston, which forms part of the back of the apparatus (Figure 1.5). The displacement of the piston (up to 75 mm) causes the volume of the space between it and the test specimen assembly to increase or decrease, thus varying the air pressure difference across the specimen. The movement of the piston can be programmed to produce sinusoidal, triangular or square waveforms of air pressure at frequencies ranging from 0.1 to 10Hz and amplitudes up to or exceeding 2KPa. A secondary blower generates the steady-state (static) component of air pressure. This blower provided the means to assess the air leakage characteristics of the specimens.

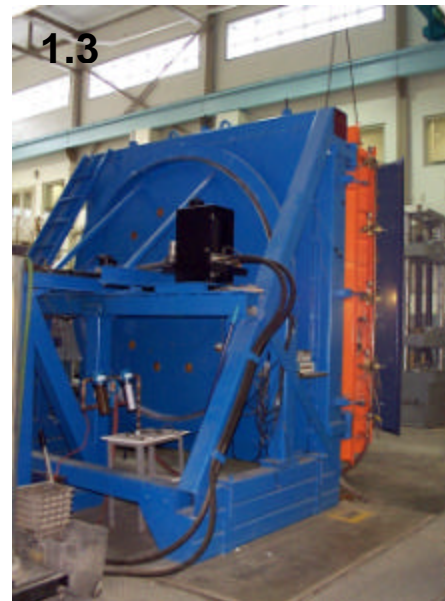
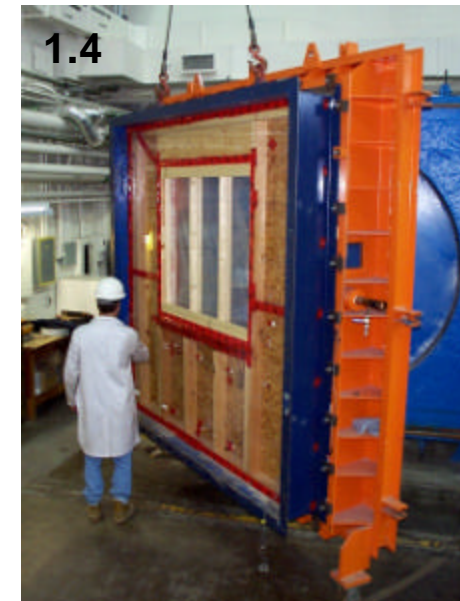
Figure 1.4 - **Inside view of apparatus** showing piston and water spray racks.

The apparatus also contains a pressure regulated water spray system (Figure 1.4) that simulates the action of rain deposition on the cladding surface. Different water deposition rates (hereafter referred to as spray rates) are achieved by regulating the pressure level along specific arrays of spray nozzles.

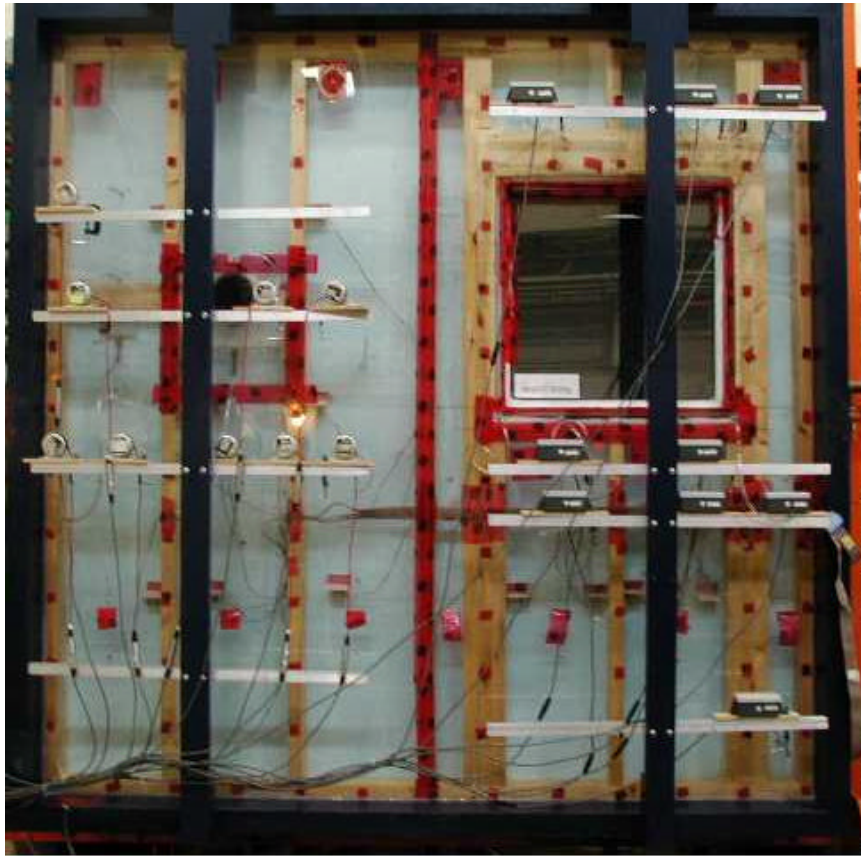
Figure 1.7 : View of 'stud-cavity' side of specimen WA-17 (Brick masonry veneer)

A photograph depicting the specimen is provided in Figure 1.7 and shows the stud cavity side of the specimen in which the various pressure and moisture sensors are identified.

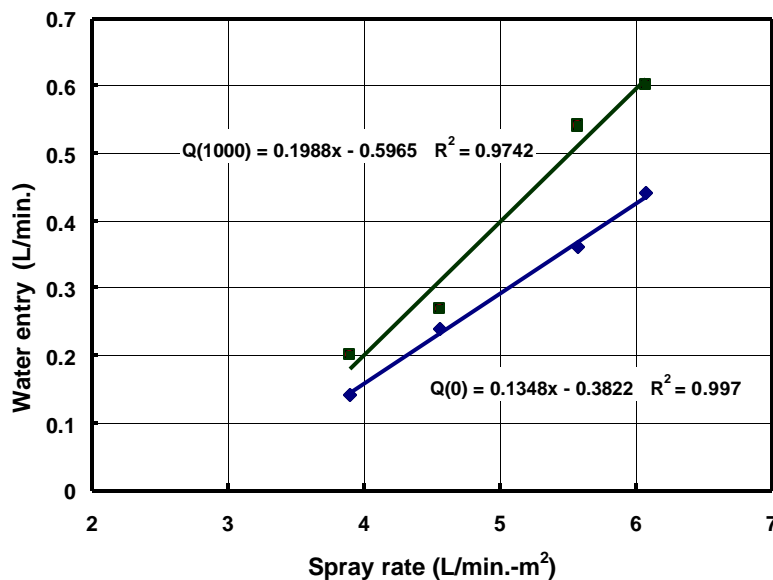
**Figure 2.6** – Water entry through deficiency as a function of differential chamber pressure – 90-mm<sup>2</sup> Ventilation duct deficiency through a fully vented rainscreen having a sealed second line of defence

The water entry varies as a function of both the spray rate and differential chamber pressure as shown in Figure 2.5 and Figure 2.6 below. As in the previous instance, the dependency of water entry on the spray rate is more significant than for changes in the differential pressure. Water entry rates are shown to vary linearly with precipitation rate (Figure 2.6).

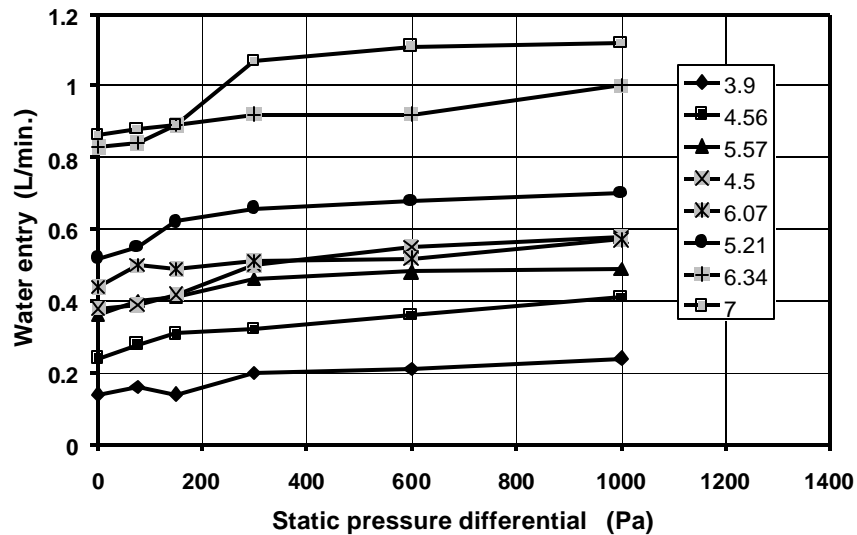
**Figure 2.7** – Water entry through deficiency as a function of differential chamber pressure – 90-mm<sup>2</sup> ventilation duct deficiency on non-vented rainscreen having the second line of defence not sealed Values in the legend relate to spray rate (L/min-m<sup>2</sup>)

Water entry varies as a function of both the spray rate and differential chamber pressure and the dependency of water entry on changes in the differential pressure is not as evident as is the water entry in relation to the simulated precipitation rate (Figure 2.7 and Figure 2.8).

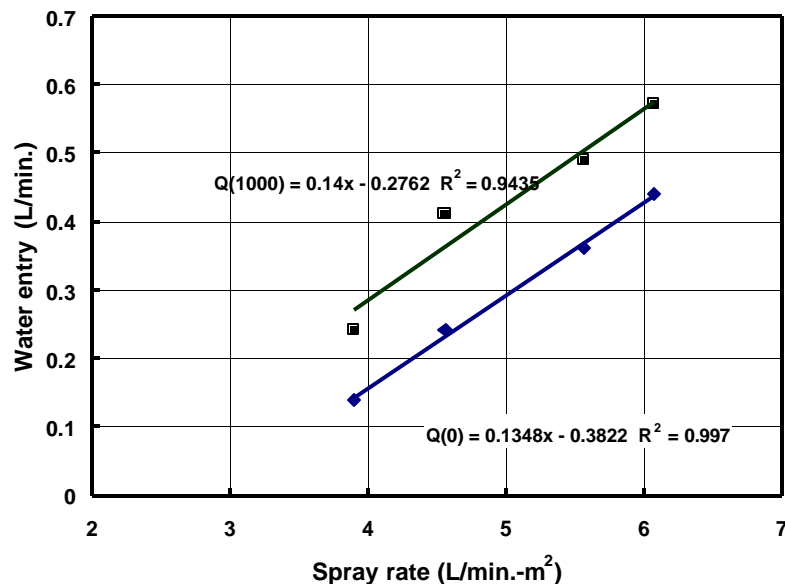
**Figure 2.8** – Water entry through deficiency as a function of differential chamber pressure – 90-mm<sup>2</sup> ventilation duct deficiency on non-vented rainscreen having second line of defence not sealed

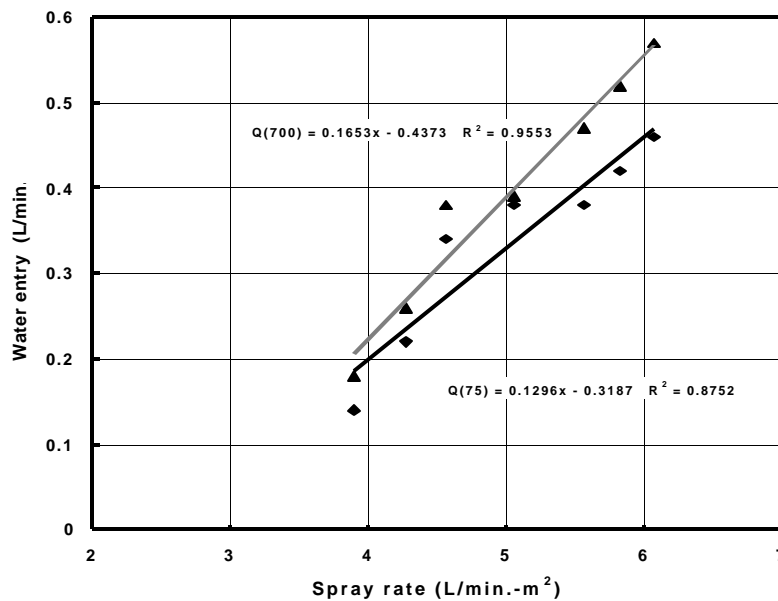
**Figure 2.12** - Water entry through deficiency as a function of differential dynamic pressure – 90-mm<sup>2</sup> Ventilation duct deficiency on fully vented rainscreen having the second line of defence sealed

Results from water entry tests through a deficiency in a ventilation duct and conducted under dynamic pressure conditions (0.5 Hz) are provided in Table 2.9 to 2.21 and Figure 2.11 to 2.15. Details on the type of data specific to a given test condition are provided in the respective sub-sections.

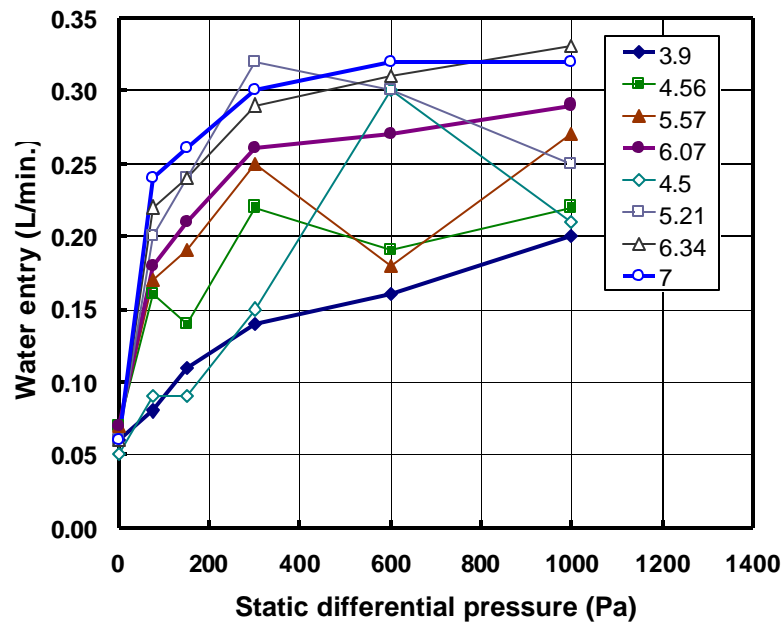
**Figure 2.17** – Water entry (L/min.) through deficiency as a function of static differential pressure – 45-mm<sup>2</sup> deficiency above electrical outlet ; non-vented rainscreen; second line of defence not sealed. Values in the legend relate to spray rate (L/min-m<sup>2</sup>)

Results shown in Figure 2.17 indicate that rates of water entry increase in proportion to the static pressure difference across the assembly and this dependence is shown to occur for each of the precipitation rates (3.9 to 7 L/min.-m<sup>2</sup>) to which the deficiency was subjected. The dependency of water entry on precipitation rate is not as significant in these tests as in was for water entry through the larger deficiency above the ventilation duct.

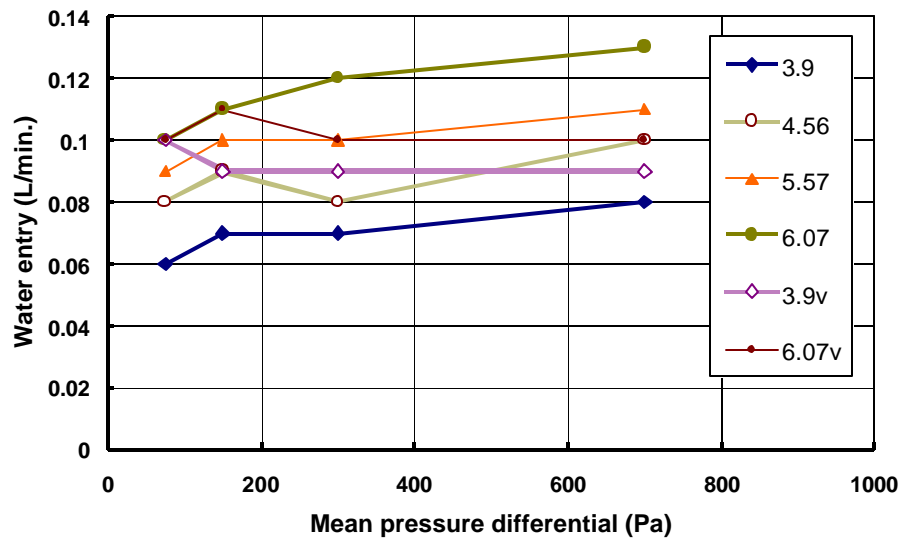
**Figure 2.21** – Water entry (L/min.) through a 6-mm diameter deficiency in OUTBOARD corner of window as a function of mean dynamic pressure differential for non-vented rainscreen; second line of defence not sealed; Values in the legend relate to spray rate (L/min-m<sup>2</sup>)

An overview of the results indicates that the volume of water entry increases in relation to the static pressure different across the wall assembly as shown in Figure 2.19. Similar results in regards to the dependence of water entry on the mean dynamic pressure differential were obtained for water entering the outboard deficiency as shown in Figure 2.21.

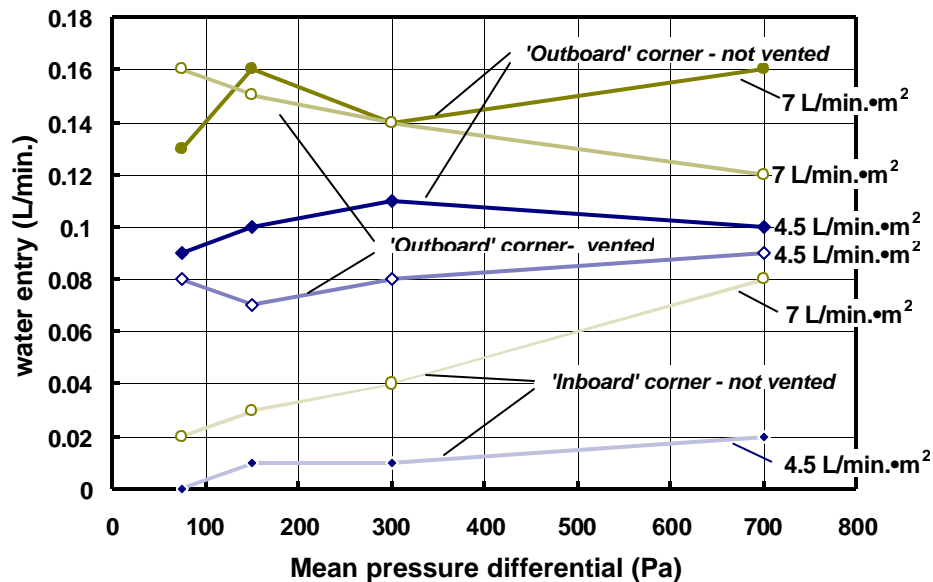
**Figure 2.22 – Water entry (L/min.) through 6-mm diameter deficiencies in corner of window as a function of mean dynamic pressure differential for both non-vented and vented rainscreens having the second line of defence not sealed**

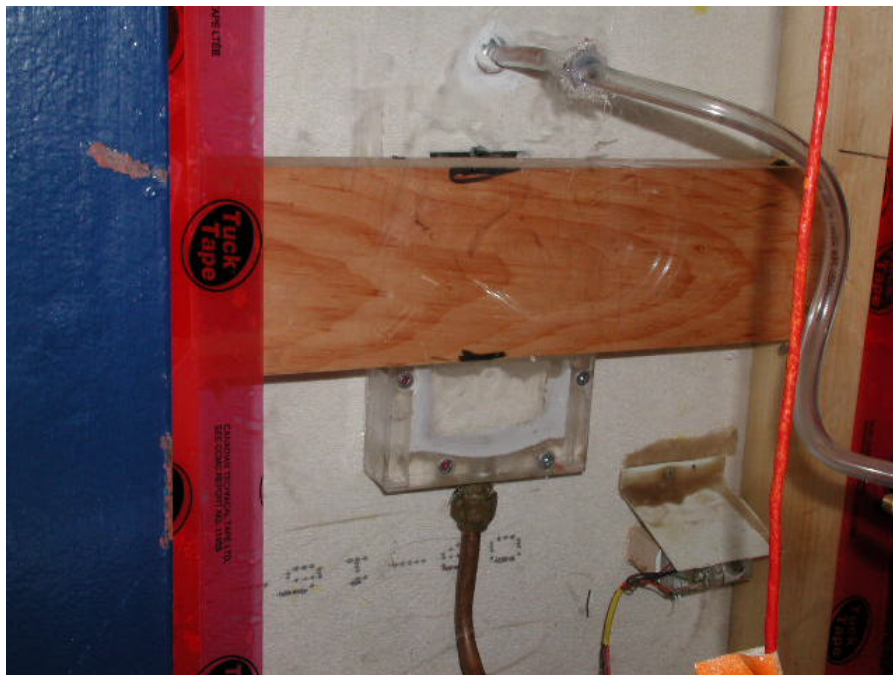
**Figure 4.6 – EIFS WA-8 : Water entering through deficiency above electrical outlet but draining between gypsum board and EPS insulation.**

As was noted previously, no water was collected about the electrical outlet for WA-8. However, water was nonetheless observed to be entering through the deficiency above the outlet and draining in between the EPS and sheathing membrane (polymer cement coating) apparently down through vertical grooves formed in the adhesive layer (polymer cement coating). Figure 4.6 shows the stud cavity in which is located the water collection trough for the electrical outlet at an instance, over the course of the test, where drainage was observed to occur between EPS insulation and membrane.

It is not possible to estimate what quantities of water may have been drained at the interface, however it is certain that water was present at the interface given the previously reported results from penetration tests and as noted above, the observations made during the water entry assessments.

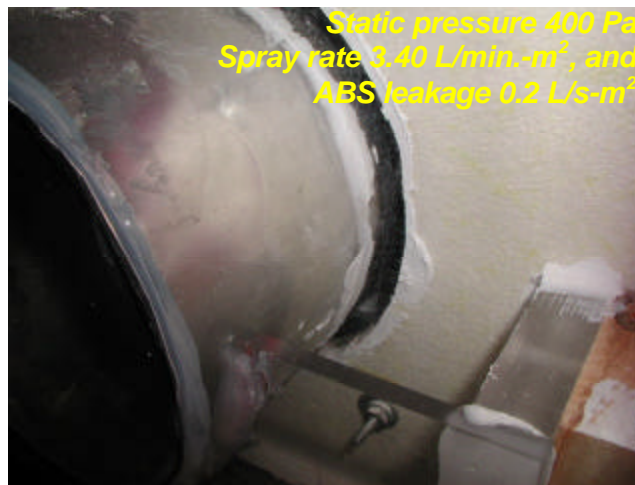
WA-8 — For those walls not exhibiting any water entry, as in the case of WA-8, evidence of where water drained is provided in Figure 4.7 below. This figure shows water coming through the deficiency and draining between the sheathing board (glass mat gypsum) and the insulation. The grooves provided by the application of a cementitious coating using a notched trowel offer vertical drainage paths into which water can flow.

**Figure 4.7 – EIFS WA-8 : Stage 7 - at test initiation, water coming through deficiency above ventilation duct and slowly draining between glass mat gypsum board and insulation**

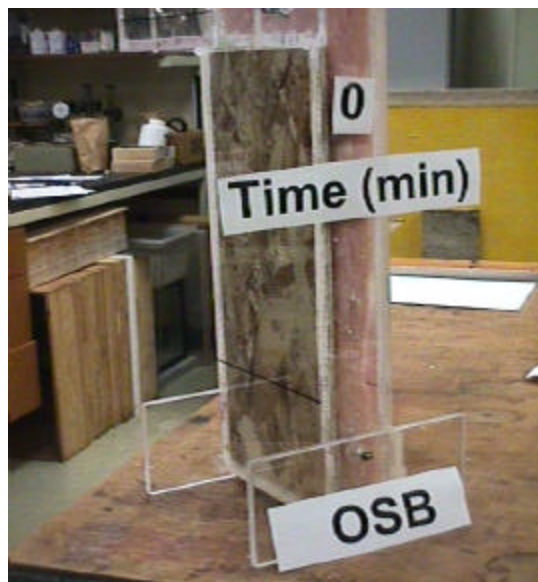
Figure B.45 - Set-up for test case No. 2 with OSB backing

In the initial experiment (Figure B.44), water flows from the reservoir to the interface between a fiberglass specimen and the plexiglas front panel. This test is taken as a base case in which water is either absorbed by the fiberglass or drains to the base of the apparatus. In the second experiment (Figure B.45) water likewise flows to the interface between the batt insulation and the front panel, however, in this case the front panel is OSB of the same type used in full-scale tests as sheathing board. The second test resembles more closely a “real” case and is intended to show the distribution of water on the OSB sheathing board and batt insulation.

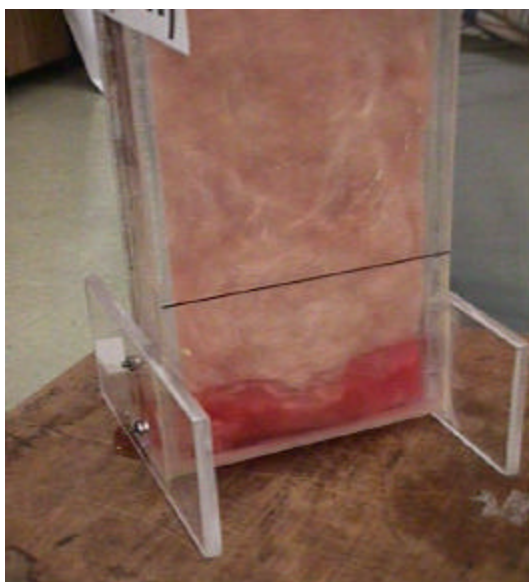
Figure B.46 - Initial test a few minutes after water entry

It has been observed that the lateral absorption of water by either the batt insulation or OSB is virtually negligible in comparison to the action of gravity, as all the water entering the cavity runs down on the sheathing board (i.e. front panel) to the base of the cavity in a matter of minutes. This observation is true for both experiments as shown in Figure B.46 and Figure B.47. Hence, it is concluded that the amount of water retained by the batt insulation and OSB sheathing board during the flow of accidentally entered water inside the insulation cavity from the top to the bottom of the cavity is insignificant.

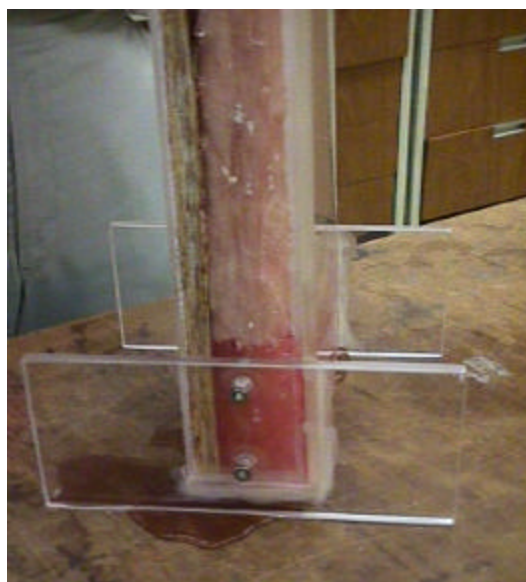
Figure B.47 - Test case No. 2 a few minutes after water entry

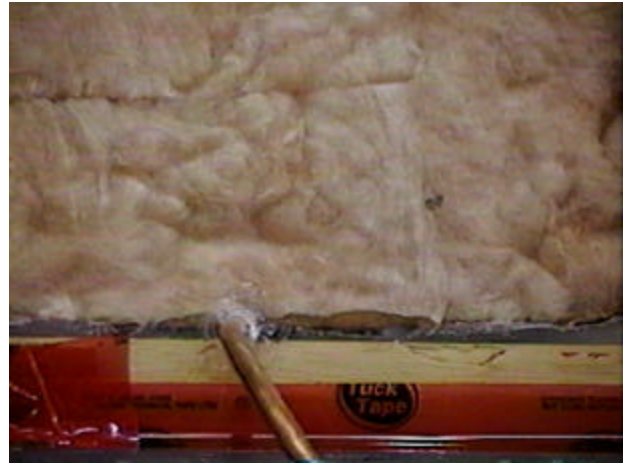
Figure B.50 - Stud cavity at bottom plate after 20 minutes of water accumulation

The accumulation of water is highlighted in the figure. It was observed, following each test and upon removal of the insulation from the cavity, that very little water was adsorbed by the sheathing board. These results essentially confirm those observations derived from the tests conducted with small-scale specimens.

Based on these observations made in both small-scale and full-scale tests, it would appear that initial conditions in hygrothermal simulations should place the water entering inside the stud cavity at the bottom of the cavity.
