Experiments of Sprinkler Protected Ceiling/Floor Assemblies in a Basement Fire Scenario

IRC-RR-308

Su, J.Z.; Taber, B.C.; Leroux, P.; Bénichou, N.; Loughheed, G.D.; Bwalya, A.C.

May 2011

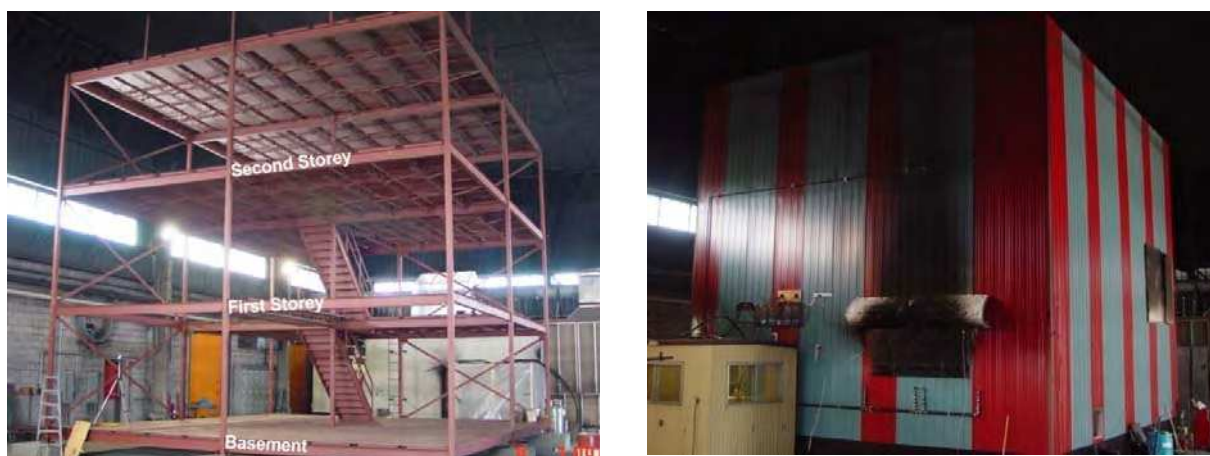
Figure 1. The test facility.

The experimental facility used represented a typical two-storey detached single-family house with a basement. Figure 1 and Figure 2 show an elevation view and a plan view, respectively, of the facility with basement, first storey and second storey. Each storey had a floor area of 95 m² and a ceiling height of 2.4 m. There was no heating, ventilating and air-conditioning or plumbing system installed in the test house, i.e., no associated mechanical openings.

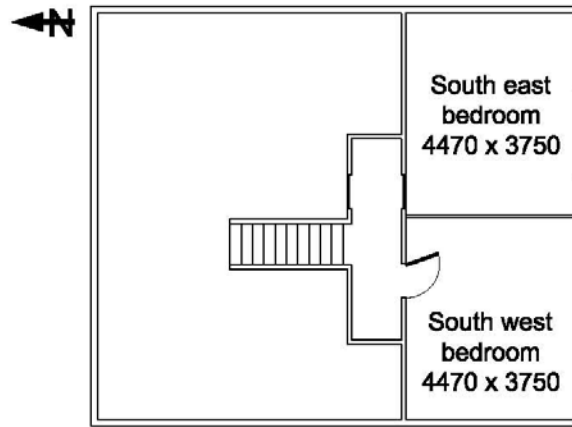
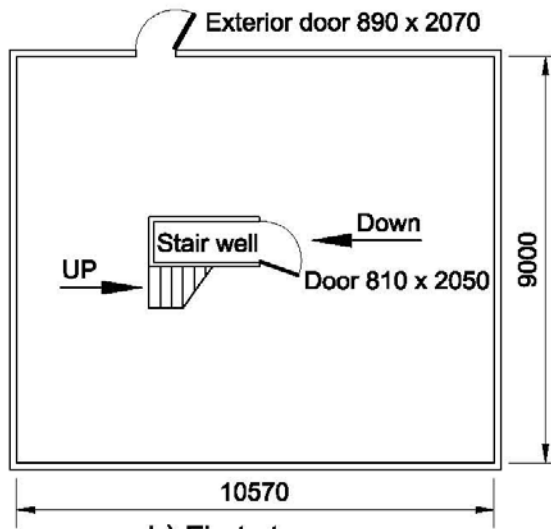
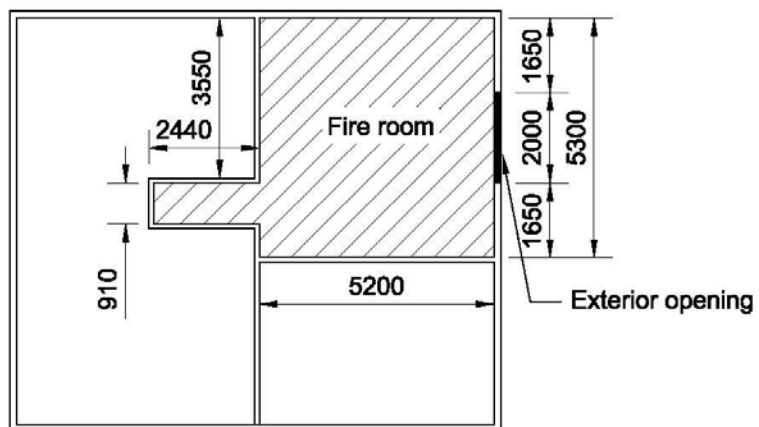
a) Second storey

b) First storey

c) Basement

Figure 2. Facility plan view (all dimensions in mm).

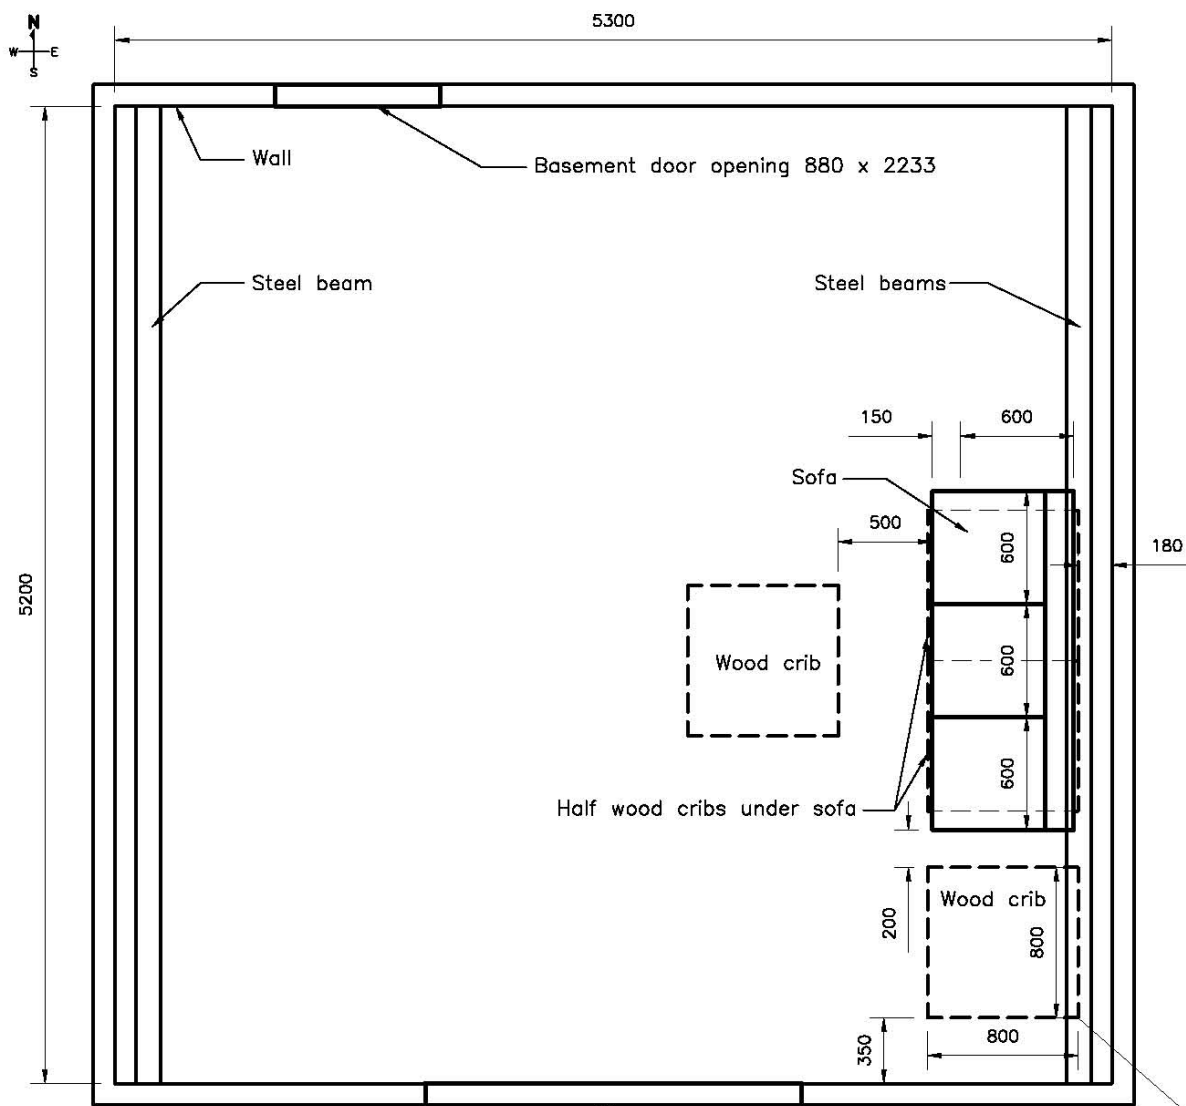
Figure 3. Layout of the fuel package in Test PF-06B (all dimensions in mm).

The fuel package was placed in the southeast corner of the fire room. This was a more challenging location, compared to the fire location used in Phase 1 and Phase 1B experiments. Figure 3 illustrates the placement of the fuel package in the basement fire room in Test PF-06B. Figure 4 and Figure 5 show relative locations of the fuel package, trusses and sprinkler in Test PF-06B. One large wood crib was located in the southeast corner (350 mm from the south wall and 180 mm from the east wall). The mock-up sofa with two small wood cribs underneath was located along the east wall (180 mm from the east wall, 200 mm from the corner crib). The other large wood crib was located 500 mm in front of the mock-up sofa. The mock-up sofa was ignited using a gas burner in accordance with the ASTM 1537 test protocol [14].

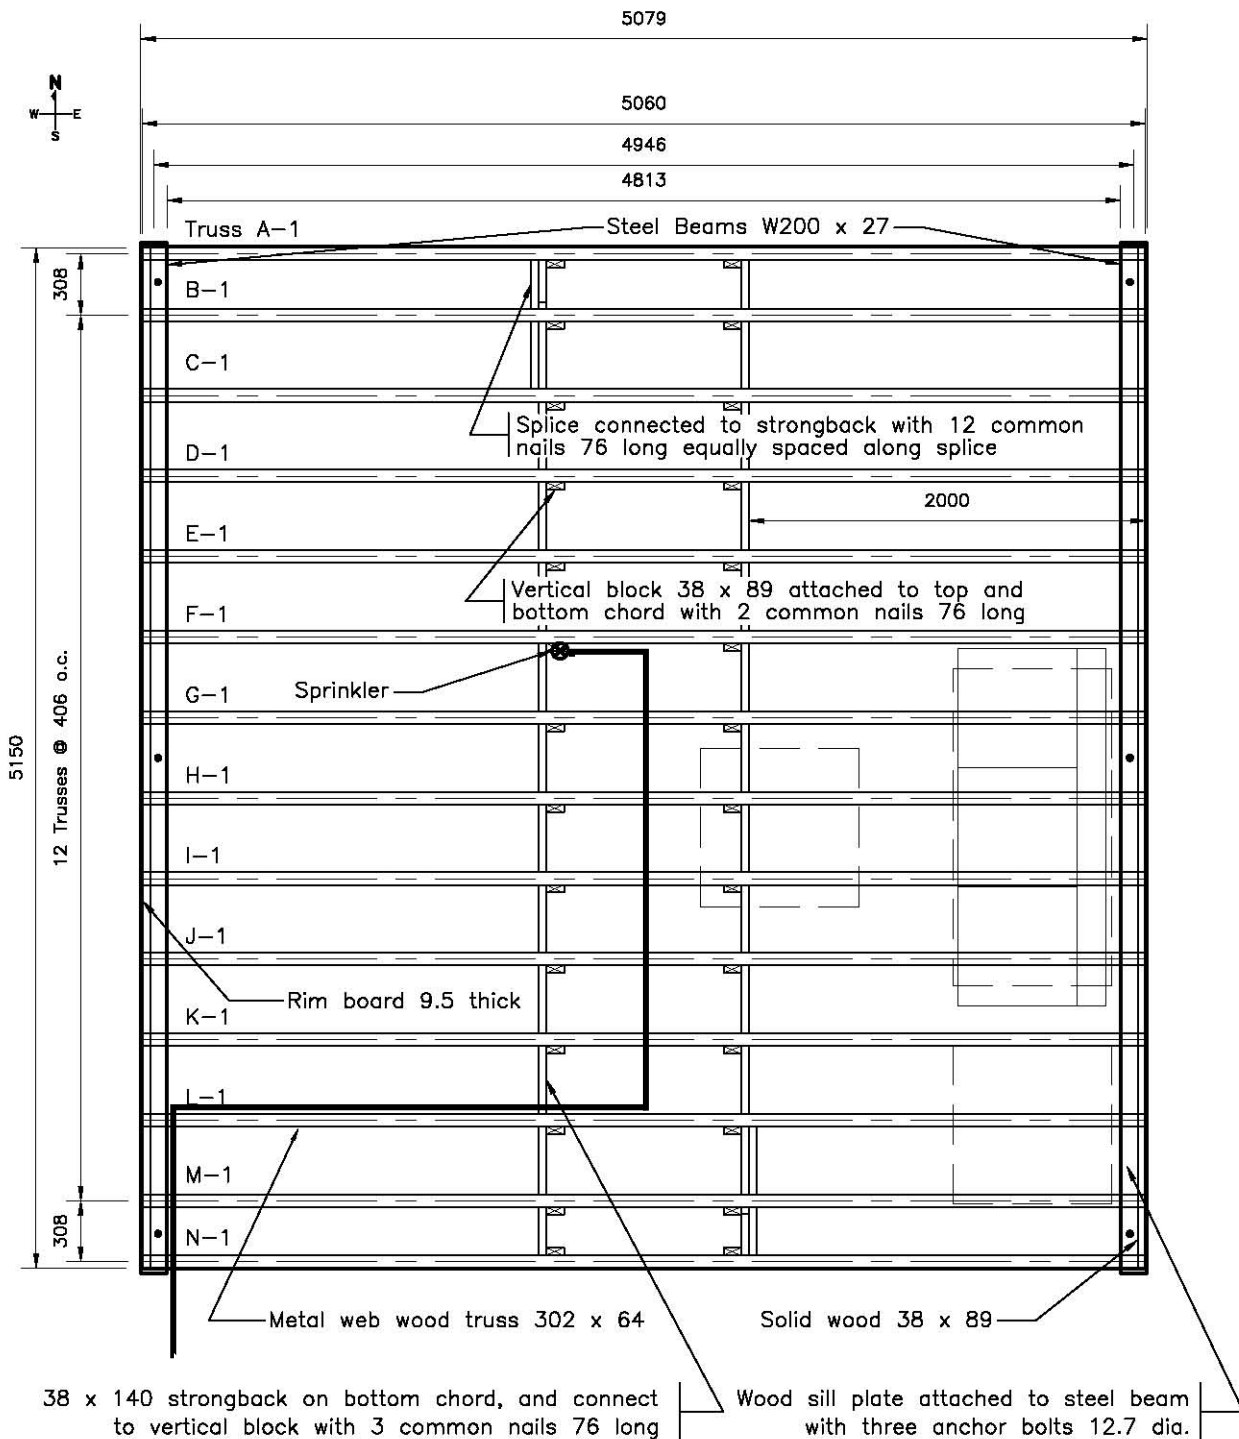
Note: Truss A-1 and N-1 shall be sheathed with 9.5 thick OSB rim board header nailed at 150 o.c. with 8d common nails

Figure 4. Metal-web wood truss assembly and relative locations for sprinkler and fuel package in Test PF-06B (all dimensions in mm).

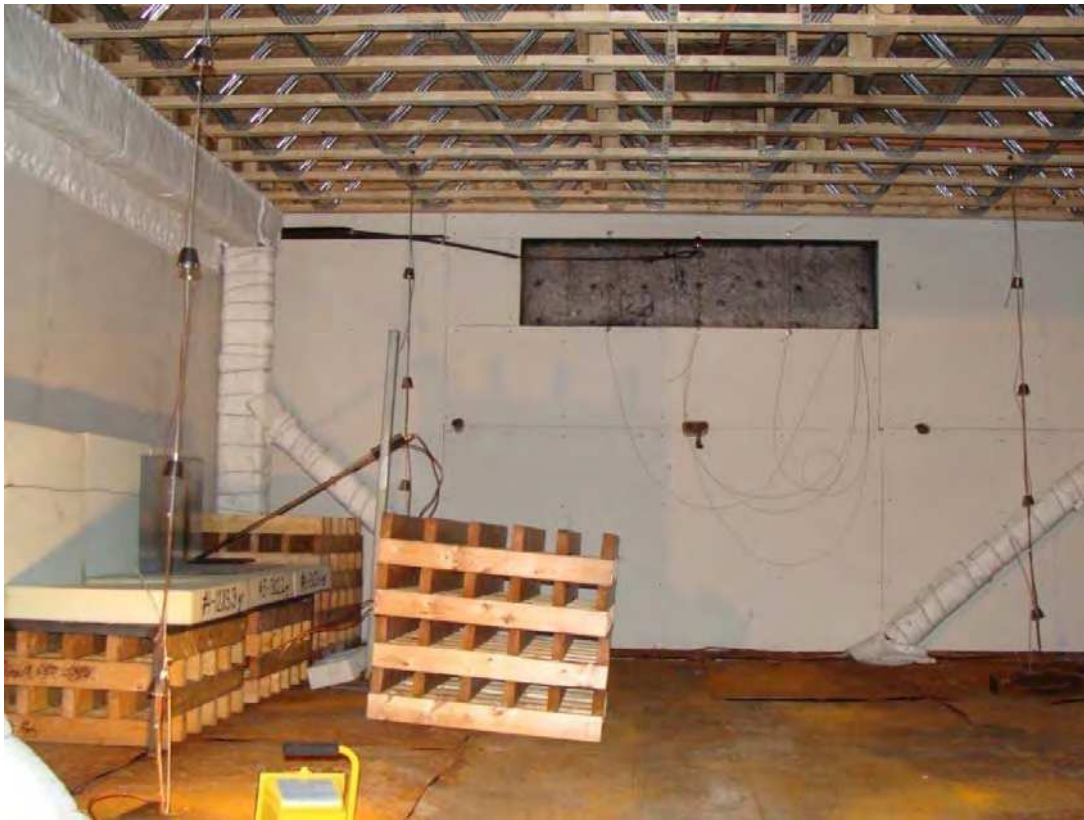
Figure 5. Layout of the fuel package in Test PF-06B.

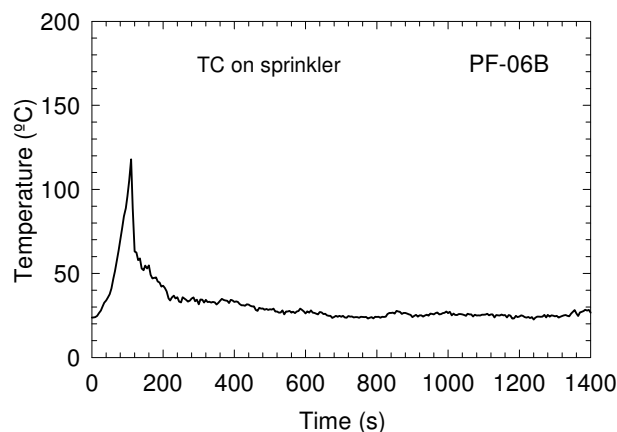
Figure 6. Temperature beside sprinkler in the basement fire room in Test PF-06B.

Figure 6 shows the temperature measured beside the sprinkler in the basement fire room after the mock-up sofa was ignited. The sprinkler was activated by the heat at 115 s and quickly controlled the fire. At 210 s and afterward, based on observation and video records, small visible flame was limited to two of the three foam blocks that were used as the backrest of the mock-up sofa. The sprinkler discharge continued for 1800 s (30 min).

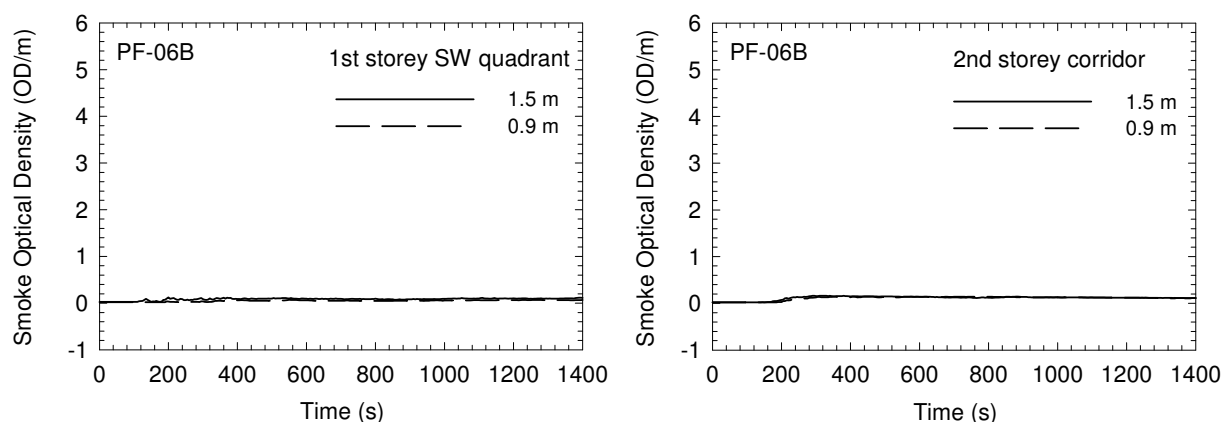
Figure 8. Smoke optical density measurements in Test PF-06B.

The optical density was measured at 0.9 and 1.5 m heights (simulating the height of the nose/mouth of an average height individual crawling and standing, respectively) above the floor on the first and second storeys. Figure 8 shows the optical density-time profiles; OD remained under 0.15 m^{-1} throughout the upper storeys during the experiment. At this smoke level, a normal person should still be able to see their surroundings.

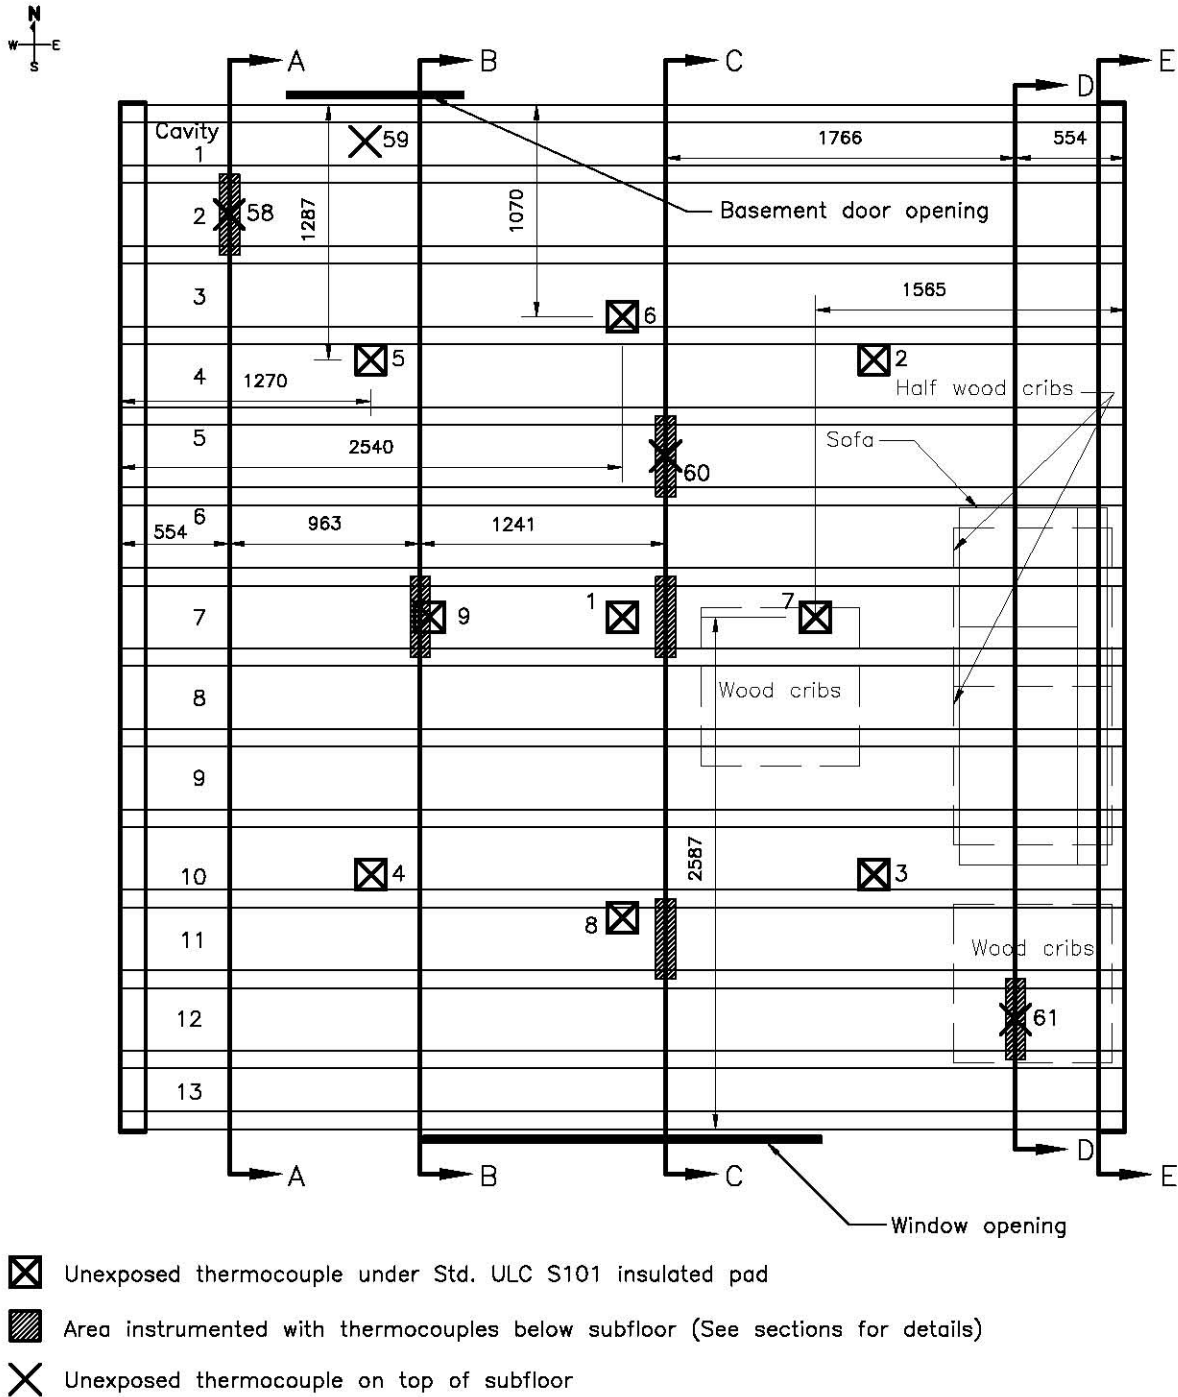
Figure 12. Thermocouples locations in the test assembly (Test PF-06B, all dimensions in mm).

The ceiling/floor assembly was instrumented with sixty-one Type K (20-gauge) chromel-alumel thermocouples to measure temperatures on the unexposed side and in the exposed cavities of the assembly, as shown in Figure 12 and Figure 13.

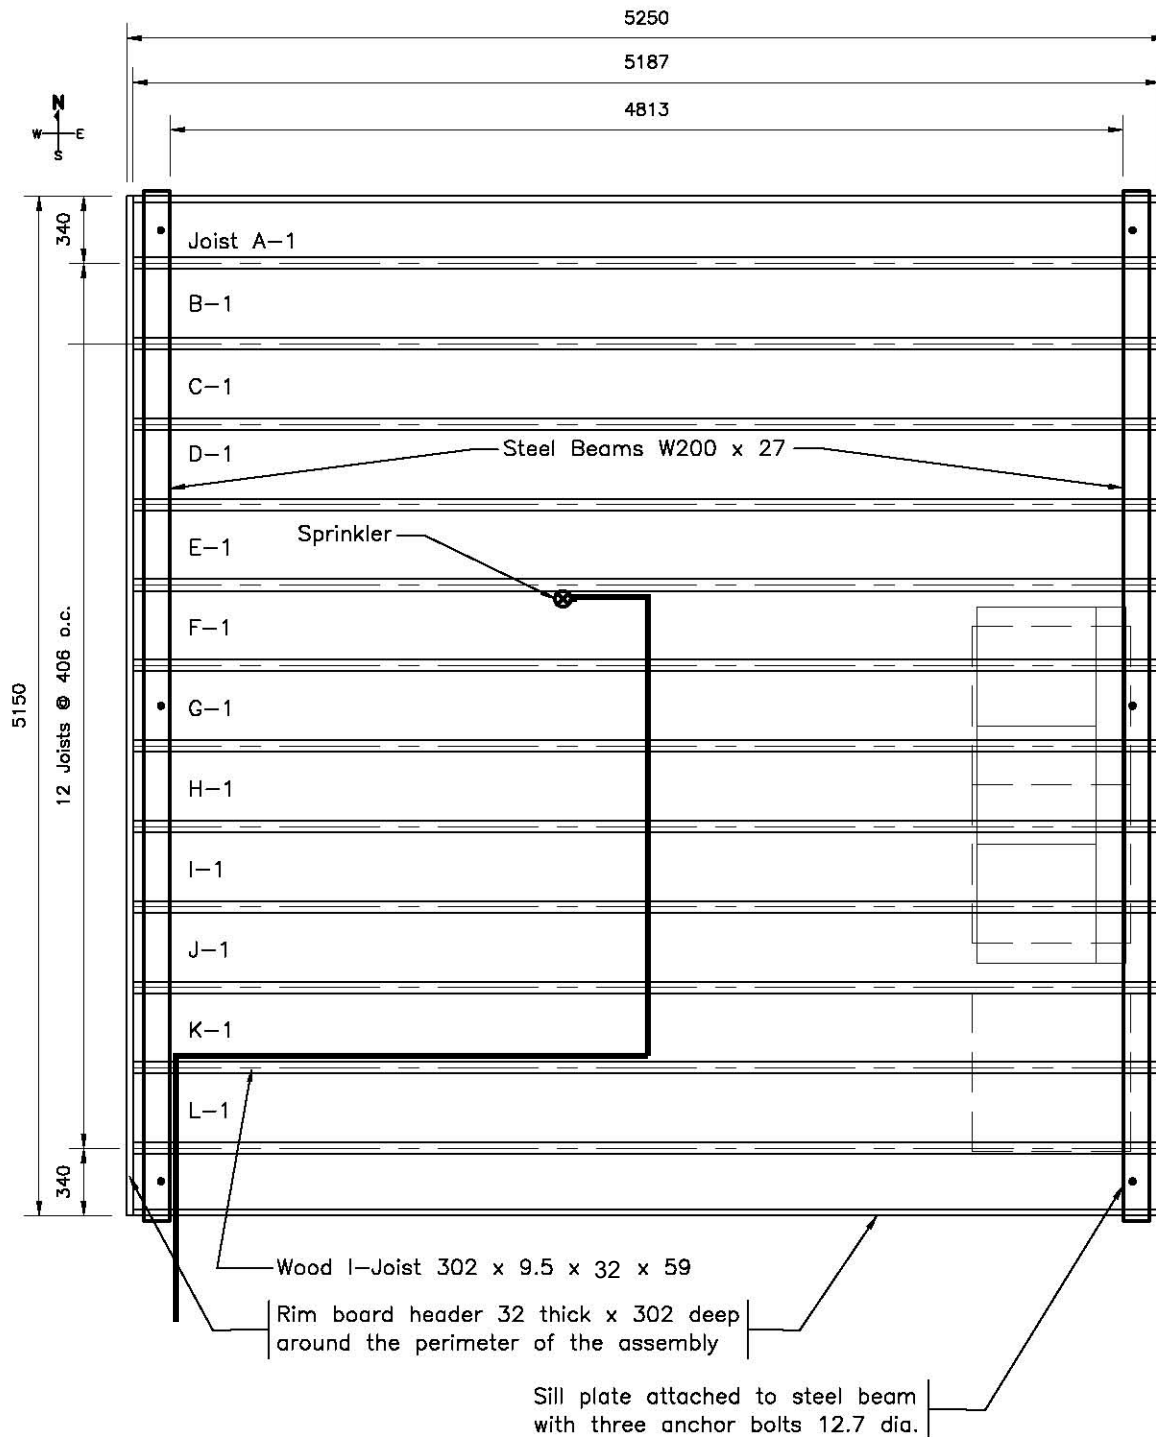
Figure 17. Sprinkler location related to wood I-joists and fuel package in Test PF-03C (all dimensions in mm).

Figure 16 illustrates the placement and arrangement of the fuel package and ignition source in the basement fire room in Test PF-03C. Figure 17 and Figure 18 show relative locations of the fuel package, wood I-joists and sprinkler in Test PF-03C. The fuel package was located in the southeast corner of the fire room. The mock-up sofa with two small wood cribs underneath was located along the east wall (180 mm from the east wall). The two large wood cribs were stacked on top of each other in the southeast corner (1.42 m high, 150 mm from the mock-up sofa, 350 mm from the south wall and 180 mm from the east wall).

The arrangement of the fuel package and ignition source produced a severe fire with an ultra-fast growth rate. Due to the increased height, the stacked wood cribs routed flame upward and resulted in a fire plume that quickly struck the assembly causing flames to spread along the channel between the two joists above the cribs. The flame reached a height of 2.4 m in 45 s from ignition. At 60 s, flame quickly spread along the channel created between the two I-joists J and K (see Figure 17) above the cribs.

At 366 s, it was observed that the exposed CPVC piping along I-joist K (see Figure 17) failed due to the heat at the ceiling, which resulted in the interruption of the water spray to the sprinkler. Then, the temperatures in the fire room increased quickly and exceeded 600°C, indicating flashover. Figure 20 also shows the heat flux measured at the west wall (near the centre, 2.05 m above the floor). The maximum heat flux was 38 kW•m⁻².

Cavity section C-11 was in the channel created between the two I-joists J and K (see Figure 17) along which the flame spread across the room ceiling, and cavity section D-12 was just above the fuel package. The temperature measurements at these locations indicate that the I-joists and OSB subfloor already started to burn before sprinkler activation. The water spray from the pendent sprinkler could not cover the space above it. The flames continued to spread in the ceiling space near the vicinity of the fire, and temperatures in cavities C-11 and D-12 exceeded 600°C at 120 s.

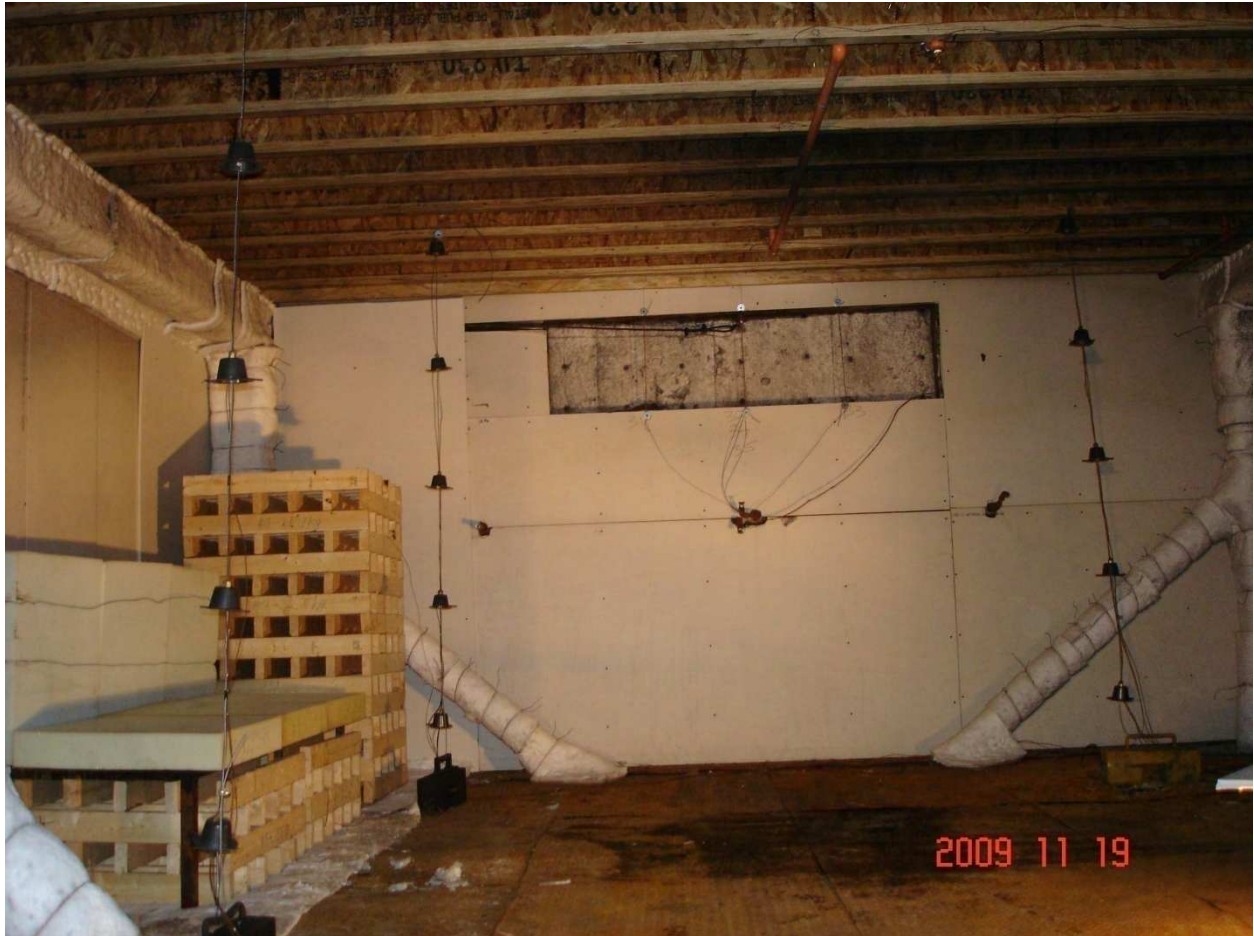
Figure 18. Sprinkler and CPVC piping relative to exposed wood I-joists and fuel package in Test PF-03C.

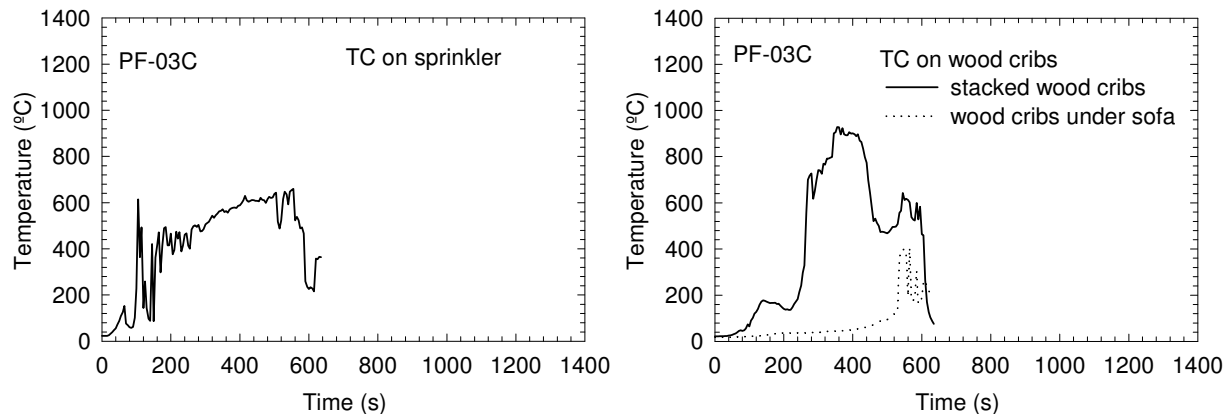
Figure 19. Temperatures on sprinkler and wood cribs in the fire room in Test PF-03C.

Figure 19 shows the temperatures measured beside the sprinkler and on the wood cribs. Figure 20 shows the temperature profiles measured in the basement fire room.

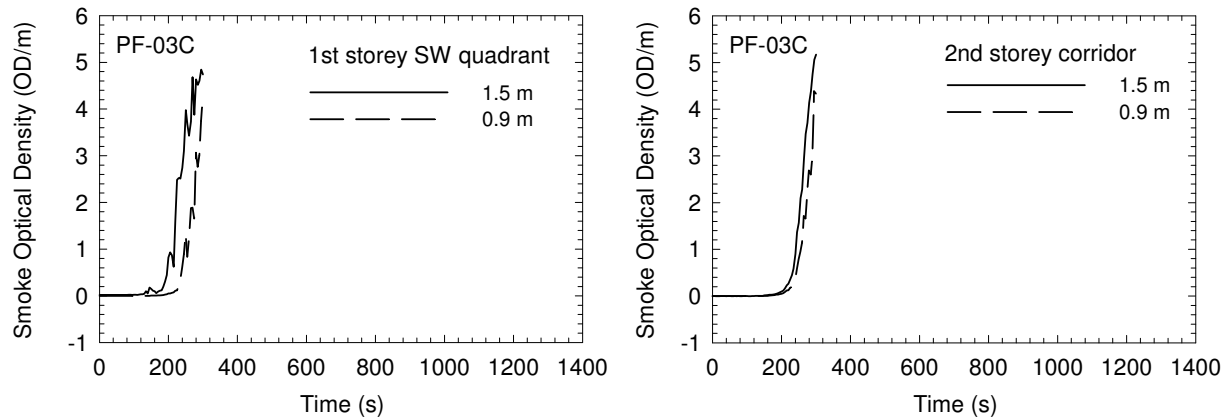
**Figure 21.** Smoke optical density measurements in Test PF-03C.

The optical density was measured at 0.9 and 1.5 m heights (simulating the height of the nose/mouth of an average-height individual crawling and standing, respectively) above the floor on the first and second storeys. Table 4 shows the times to reach OD = 2 m⁻¹, which are consistent with the video records, when visibility was lost. Figure 21 shows the optical density-time profiles.
