### **Evaluating the effectiveness of wall-window interface details to manage rainwater. Phase 1: watertightness, air leakage and rainwater management of CMHC specified assemblies**

Lacasse, M. A.; Rousseau, M. Z.; Cornick, S. M.; Manning, M. M.; Nicholls, M.; Nunes, S. C.

*Client Report (National Research Council of Canada. Institute for Research in Construction); no. B-1229.1, 2008-03-18*

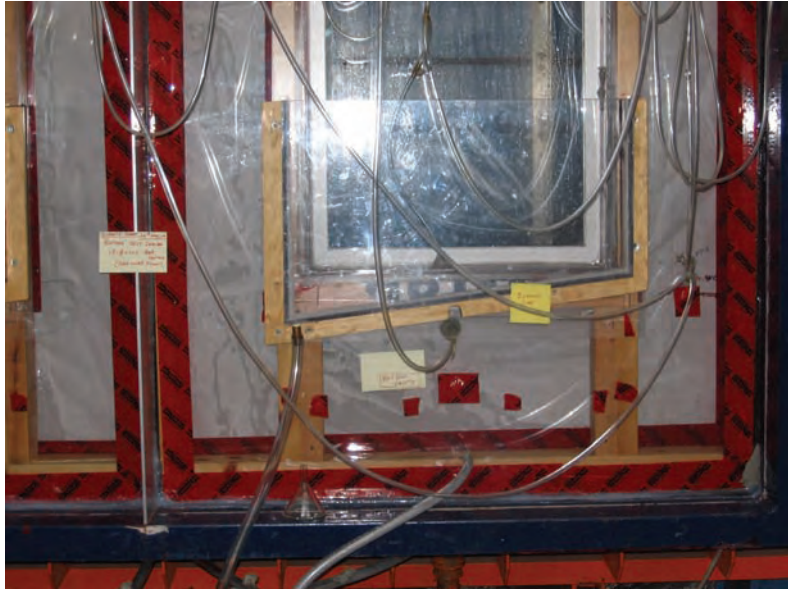
Figure 2-4: Collection trough used for the collection of water penetrating the window

A trough located at (1) in Figure 2-3 (b) was intended for the collection water that would penetrate the window between the lite and window frame; a picture of such a trough affixed to the back of the specimen, is shown in Figure 2-4. Such a trough, or variations thereof, was used for all four wall specimens.

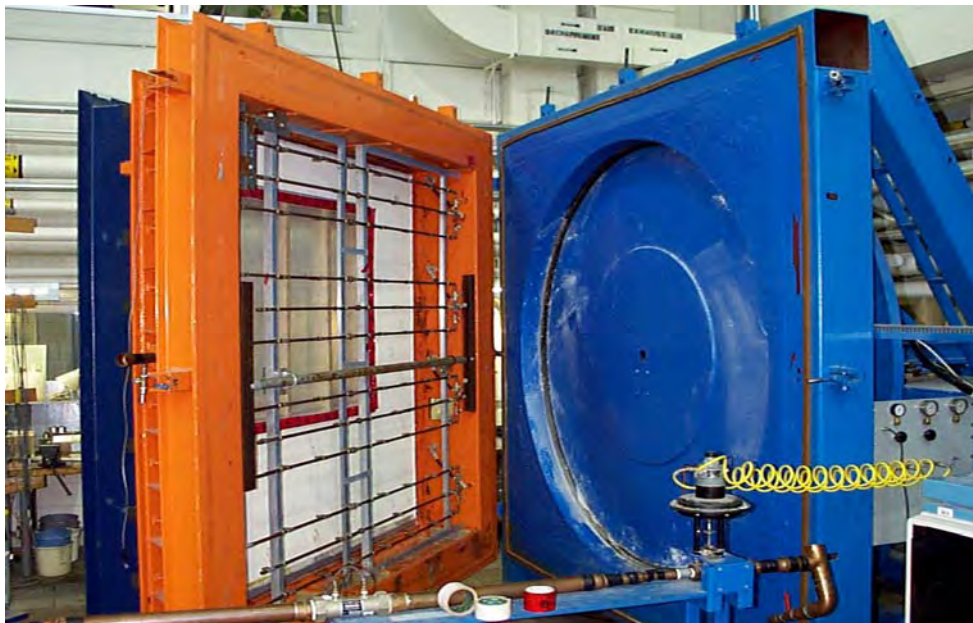
Figure 3-5: Inside view of apparatus showing orange test frame door onto which is affixed test specimen. This same frame contains water spray rack; individual water lines can be seen in photo. When test frame is closed and sealed to test rig, exterior cladding faces inside of apparatus (on right, coloured blue).

The facility used to conduct the tests was the Dynamic Wind and Wall Test Facility (DWTF) a more detailed description of which can be found in [2]. This facility, depicted in Figure 3-5, is capable of subjecting full-scale test specimens (nominal size 2.44-m by 2.44-m) to static or dynamic pressure fluctuations of over 2 kPa and spray rates of up to 8 L/(min-m<sup>2</sup>).

The apparatus also contains a pressure regulated water spray system that simulates the action of rain deposition on the cladding surface. Different water deposition rates are achieved by regulating the pressure level along specific lines of spray nozzles. Water spray rates can be regulated between 0.8 and 8 L/(min-m<sup>2</sup>). Water can be applied to the front face of the specimen in either full-spray format in which water is deposited evenly across the front of the specimen, or by cascading water from the top of the specimen in a continuous sheet of water; the latter method of cascading water was the one primarily used in this study (rate of water deposition is referred to as cascade rate, and is expressed in L/(min-m<sup>2</sup>)).

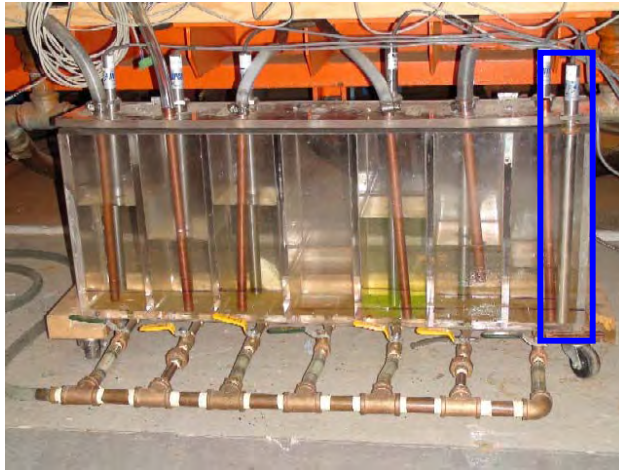
Figure 3-7: Bank of seven (7) calibrated water collection vessels; level sensor is shown on right of photo

A description of the location of the different troughs is provided in Chapter 2 (see: § Water Collection Troughs). The water that accumulates in these troughs is diverted by means of plastic tubing, to the respective collection vessels, shown in Figure 3-7. In each vessel, a capacitance level sensor (Intempco; model: LTX20-RP), provided information on the level of water in the vessel, to the nearest 0.1 mm, that was recorded to the DWTF's data acquisition system. For each of these vessels, the change in water level obtained from sensor readings was calibrated, from weight measurements, to a change in volume in the vessel. This volume change was continuously monitored such that the rate of volume change in the vessel was, in turn, attributed to the rate of water collection to the respective trough and was recorded in terms of ml/min.

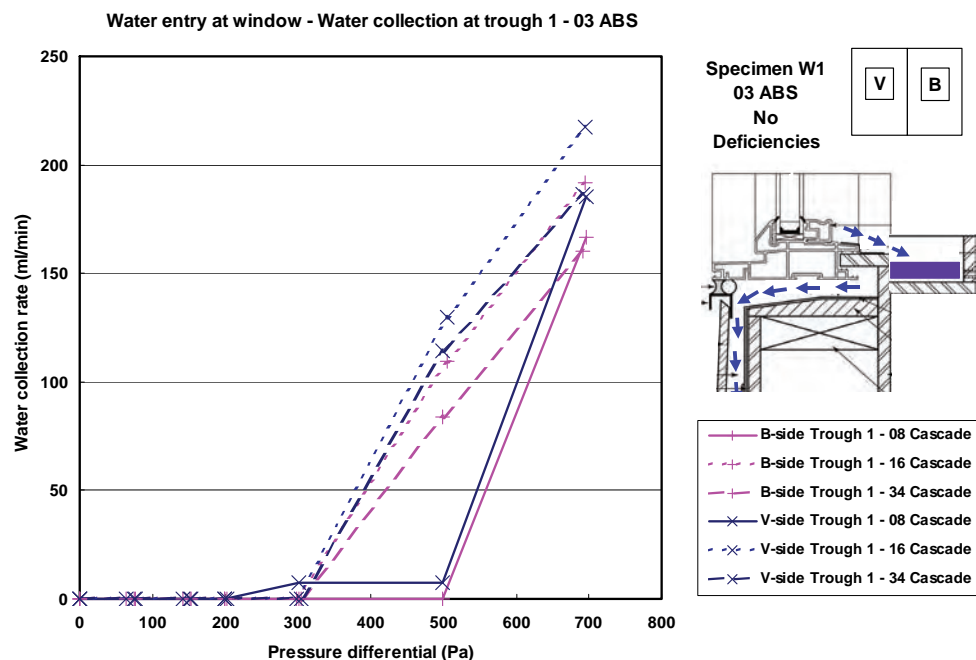
Figure 4-7: Specimen W1 – as built: Collection at Trough 1, 03 ABS

Water entered through the windows onto the interior windowsill starting at 300 Pa pressure differential and reached approximately 200 ml/min at the highest pressure differential (Figure 4-7). The windows on both sides of the wall performed similarly. Results from water entry at the window were only obtained for a 03 ABS leakage condition. The tests undertaken at a 08 ABS leakage condition were only conducted up to a pressure differential of 300 Pa and at this pressure difference, only small amounts of water ( $< 12$  ml/min) entered through the window frame.

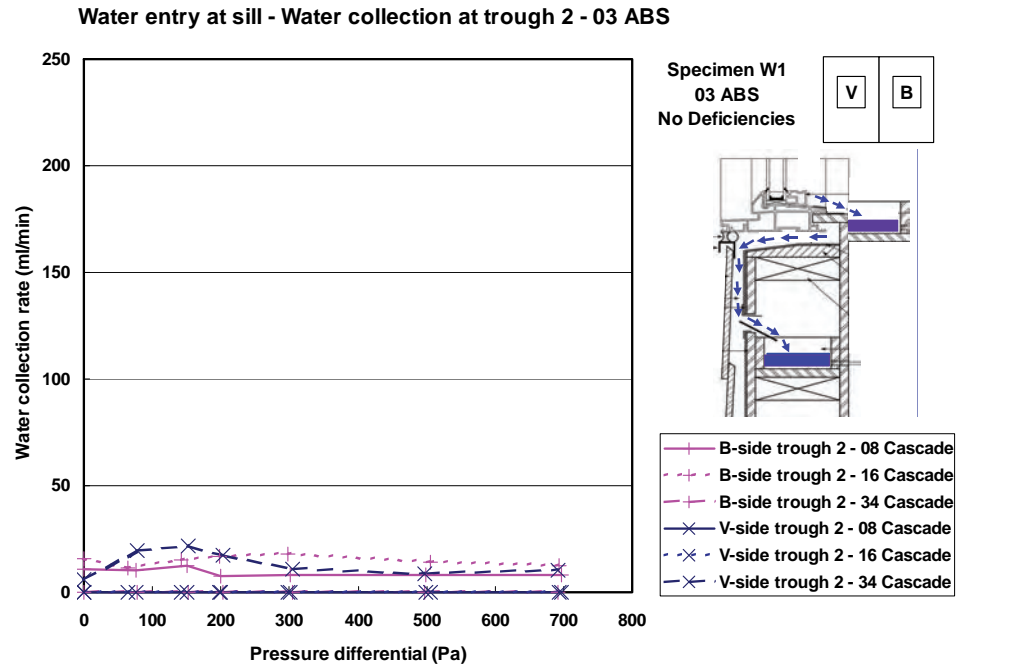
Figure 4-8: Specimen W1 – as built: Collection at trough 2, 03 ABS

At a 03 ABS leakage condition, as provided in Figure 4-8, water was collected to trough 2 on the B-side only at the two lowest cascade rates (0.8 and 1.6 L/(min-m<sup>2</sup>)). By contrast, water was collected to trough 2 on the V-side only at the highest cascade rate (3.4 L/(min-m<sup>2</sup>)). When water did enter, rates were small (ca. 10-20 ml/min) and relatively constant across the full range of applied pressure differentials.

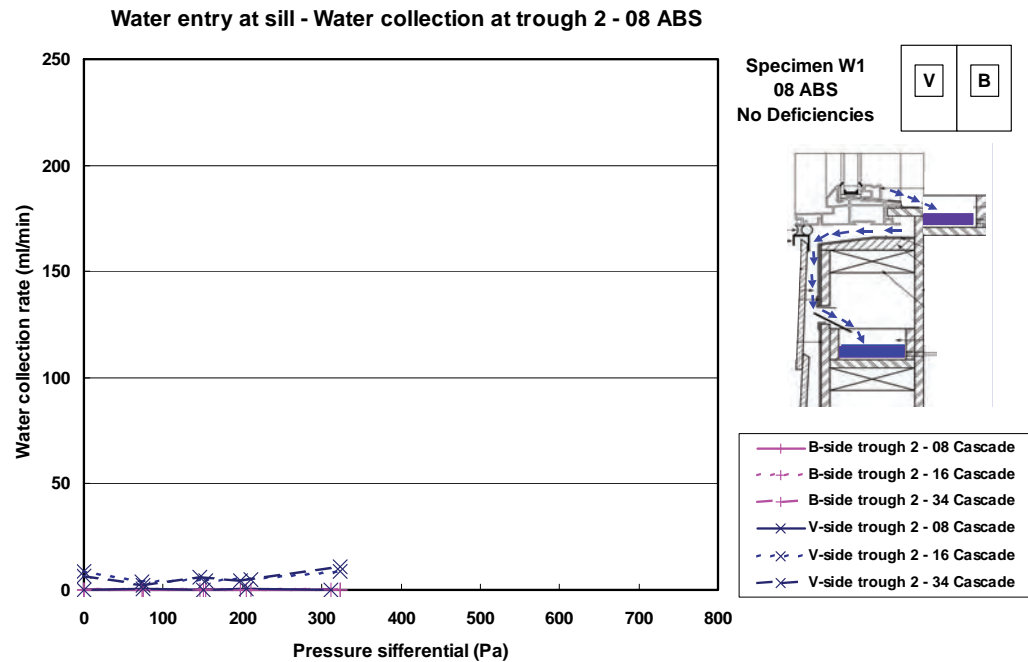
Figure 4-9: Specimen W1 – as built: Collection at trough 2, 08 ABS

At the higher ABS leakage, given in Figure 4-9, water was only collected in trough 2 on the V-side of the wall. Water collection rates were again small, up to a maximum of 11 ml/min, and did not vary with change in pressure differential. It should be noted that water entry rates below 5 ml/min were discarded as these represented the limit to which the apparatus could accurately estimate the rates of water collection from the respective troughs.

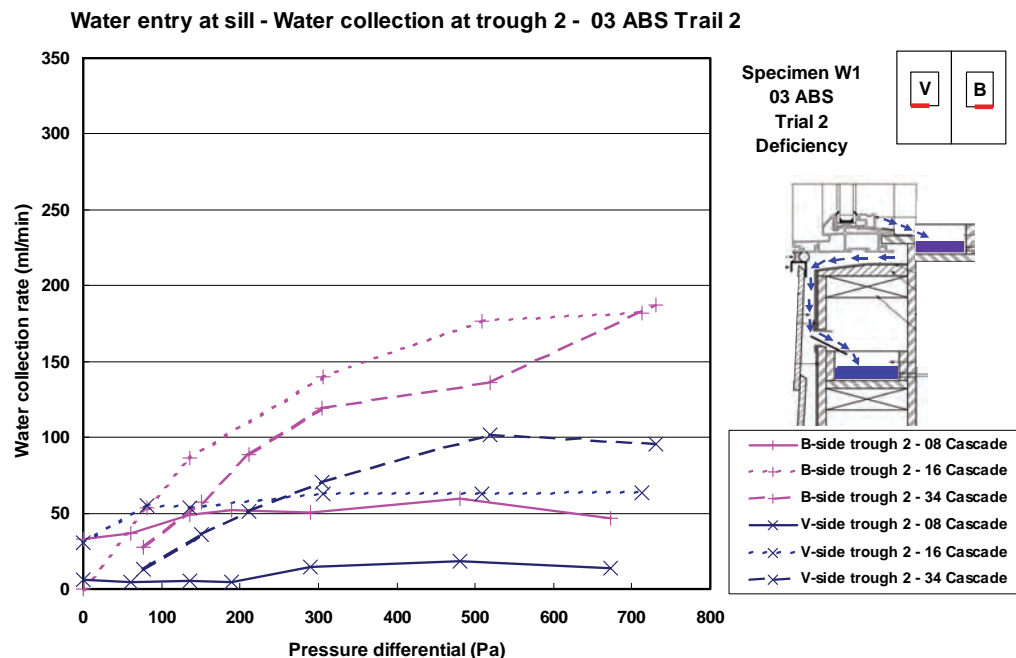
Figure 4-10: Specimen W1 – Trial 2: Collection at trough 2, 03 ABS

At a 03 ABS leakage condition (Figure 4-10), the water collection to trough 2 on both sides of Specimen W1 increased significantly when compared to the corresponding results derived from the as-built case; up to 180 ml/min on the B-side of the wall, and up to 100 ml/min on the V-side. This suggests that between ca. 1.5 and 2.7 L of water flowed over a 600-mm wide band of sheathing membrane over a 15 min. period.

Water collection rates showed a dependency on pressure differential and cascade rate; the largest water rates occurring at the highest applied pressure differential, and the highest cascade rates.

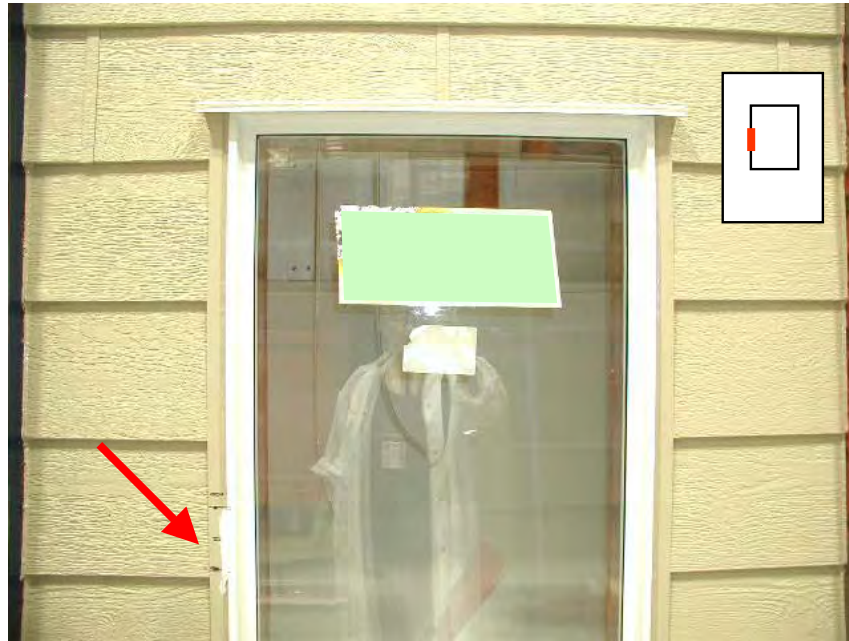
Figure 5-4: Location of deficiency (3) in Trial 1 as shown in Figure 5-3

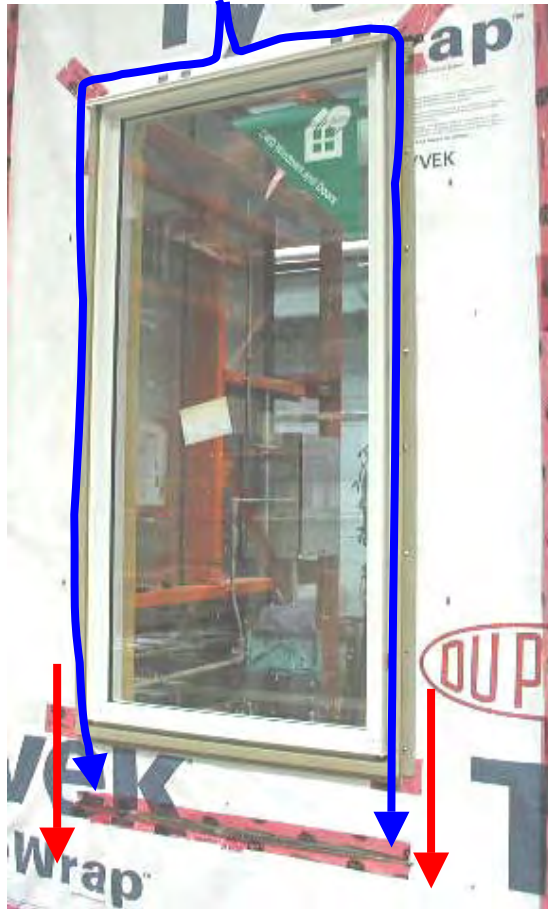
Figure 5-14: Potential path of water to reservoir collection tray during test Trial 3

along the exterior of the window flange at the head, down the jambs and to the reservoir (blue path in Figure 5-14), or pass through the waterproofing layer and over the flange at the head of the window, down the jambs to the subsill, and to the collection trough. The first scenario is the most likely, as no water leakage was visually observed at the head of the window on the interior of the wall, or on the subsill. As in the previous test Trial, it is possible that no water entry was observed on the V-side of the wall because water followed a path along the inside of the cladding, or passed on either side of the reservoir opening.

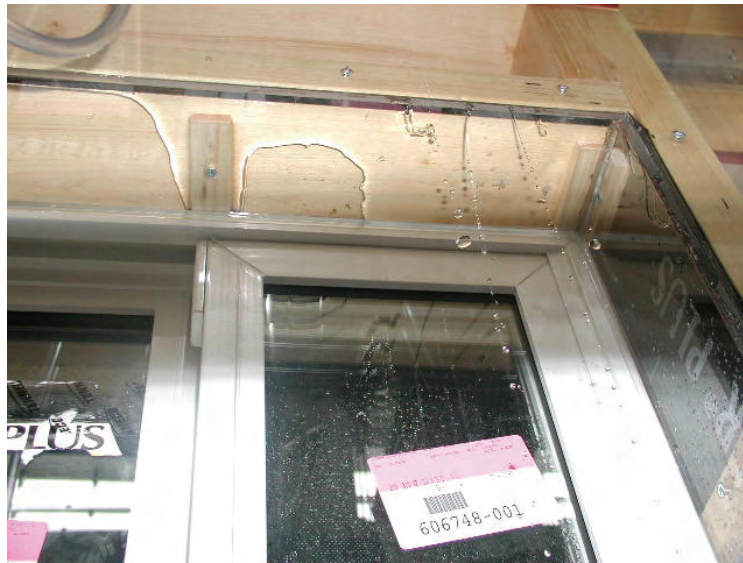
Figure 7-22: View of B-side rough head from below

During tests on Specimen W4, water was observed at the head of the window on the B-side of the wall (see Figure 7-22), whereas no water was observed on the V-side of the wall. Following the initial tests on Specimen W4, the wall was deconstructed to identify possible paths of water collection at the window head. This revealed that the self-adhered membrane on the B-side window had lost adhesion to the sheathing membrane and created “fish mouths” at various locations around the perimeter (Figure 7-23). These fish mouths provided a path for water ingress, helping to channel the water over or around the window flange (Figure 7-24). The formation of these fish mouths also offered an explanation as to why the subsill water collection was similar on both sides of the wall; an added layer of self-adhered membrane on the B-side did not provide enhanced protection against water entry. Fish mouths may develop from differences in the degree of flexibility and “memory” of the more rigid self-adhered membrane in relation to the substrate.

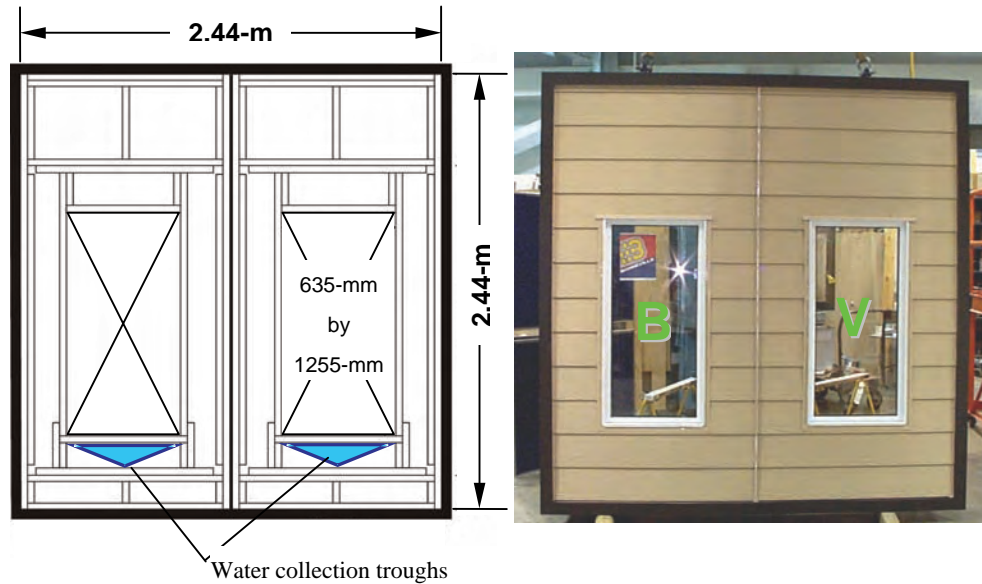
Figure 8-1: (Left) Typical layout of wall specimen framing for investigation of water management response of two side-by-side wall-window interface details (B and V-sides). Water collection troughs are located beneath the windowsill. (Right) Elevation view of exterior cladding of specimen

Accordingly, the test specimens were configured to permit comparisons among the different interface details when subjected to simulated wind-driven rain conditions in the DWTF. Wall specimens were designed to permit side-by-side comparison of two wall-window interfaces details (Figure 8-1). Hence, each 2440 mm by 2440 mm wall specimen included two large openings of 635-mm by 1255-mm, in each of which was placed a 610 mm by 1220 mm window together with a set of wall-window interface details. These details included those located at the head, the jambs and the sill. Half the specimen included a “base-case” (B-side), the other a “variation” (V-side), which typically could be an “upgrade” of detailing the interface that may or may not be common but nonetheless presented a research interest. Entry of water around either window opening was collected in troughs located behind the cladding and beneath the respective sills. Water was also collected at the window, just beneath the sill level, on the interior side of the specimen.

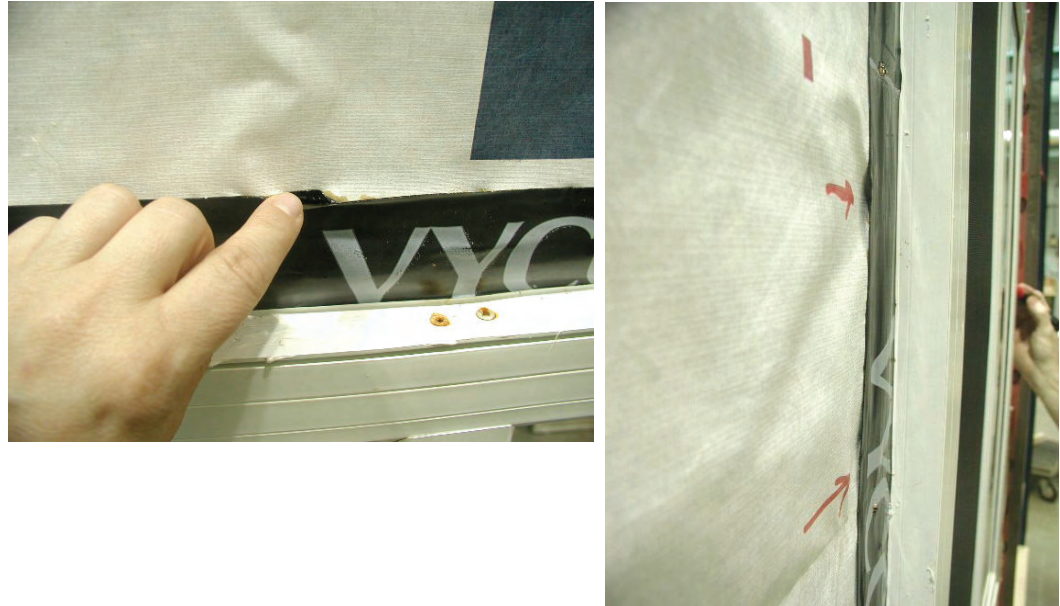
Figure 8-7: Location of delamination, and in some cases, loss of cohesion between plies of the self-adhered flashing membrane

Observations during testing as well as after the de-construction of the V-side of the test specimen indicated that delamination of the self-adhered membranes from its substrate occurred early on in the test sequence (Figure 8-7). Following which, those areas where the membrane delaminated became points for water accumulation (funnels) and eventual ingress past the second line of protection (i.e., the sheathing membrane) of the wall system. Indeed, several small funnels

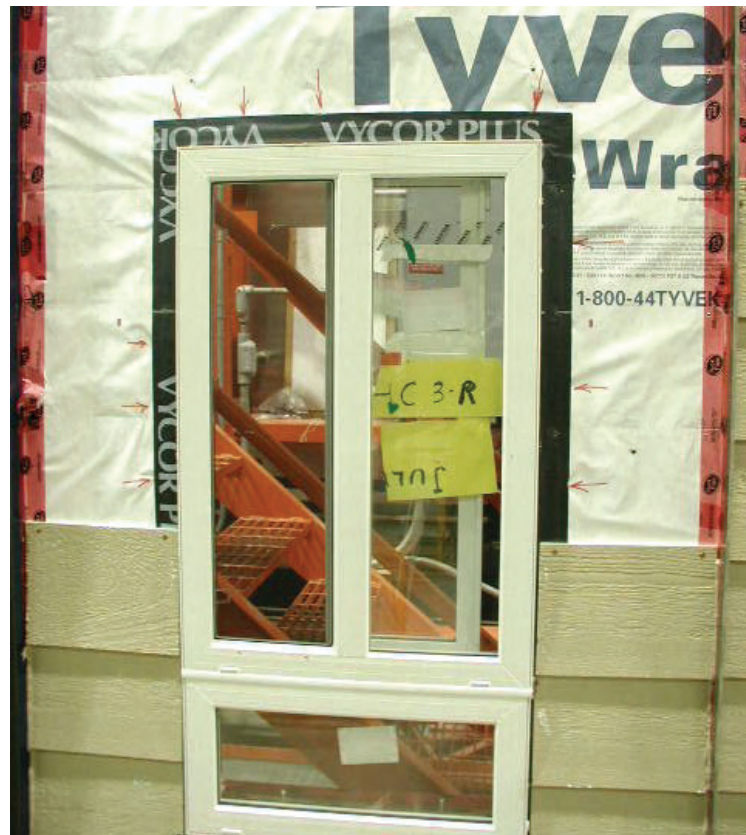
Figure 8-8: Locations (red arrows) along the interface between the window and sheathing board where the flashing membrane delaminated from the sheathing membrane and formed funnels in which water accumulated

developed over the length of the joint (Figure 8-8).<sup>†</sup> Once water passes beyond the second line of protection there is potential for water entrapment in areas where moisture-sensitive materials may be present and where also, drying potential may be reduced. Hence, premature deterioration of the moisture sensitive components of the wall may result from such water ingress.

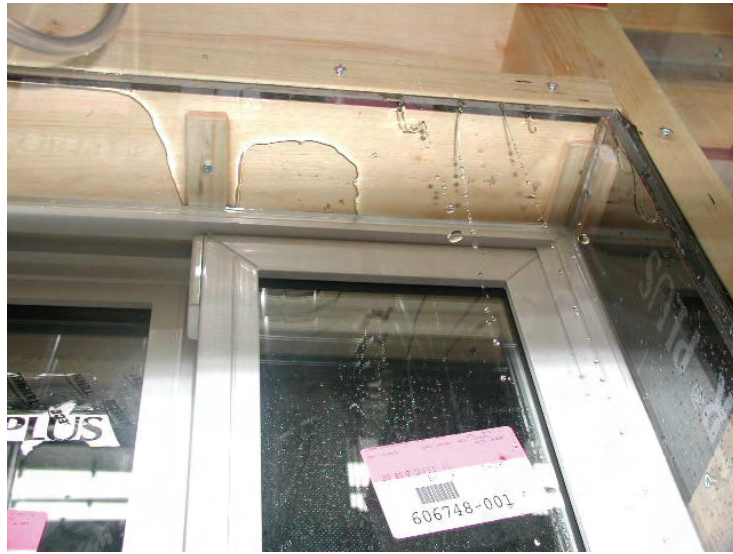
View of window head from below

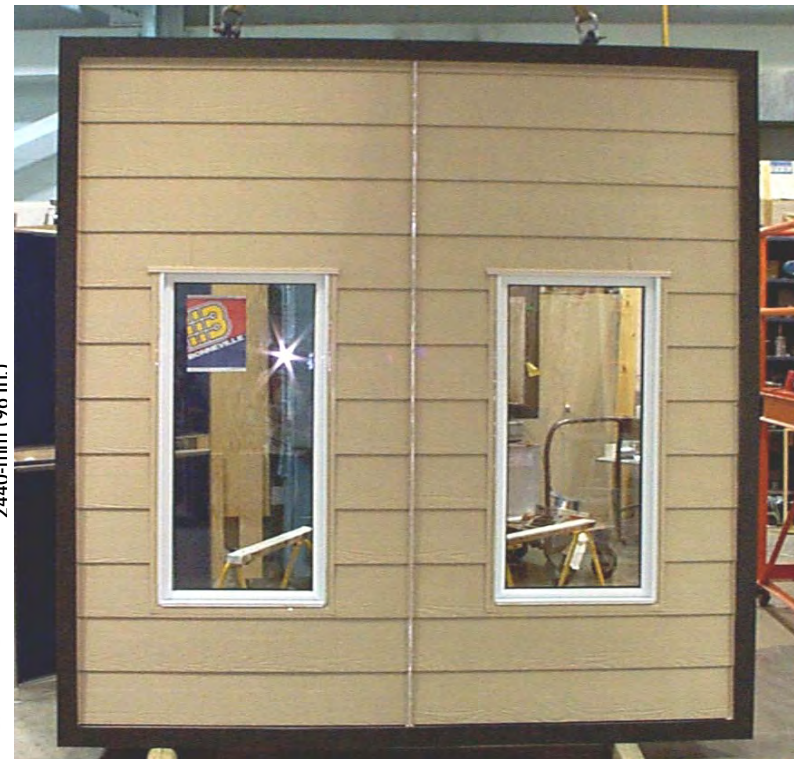
Figure A3-1: Typical layout of the wall Specimen for comparative investigation of the water management response of two side-by-side wall/window interface details (left). Elevation view of the exterior cladding of the Specimen completed (right).

As the objective of the experimental work consisted of comparing the ability of different wall/window detailing to manage rainwater, the wall Specimens have been designed to allow side-by-side comparison of two wall/window interfaces details. Each 2440-mm by 2440-mm (8 ft. by 8 ft.; nominal size) wall Specimen includes two large openings. Each of these openings includes a window along with a set of wall-window interface details for the head, the jambs and the sill (Figure A3-1). The size of the windows is nominally, 610-mm wide by 1220-mm high (2 ft by 4-ft). The window width was selected so that two “window plugs” could be housed in the wall Specimen, a requirement for side-by-side comparison. The window height was maximized at 1220-mm, considering that about 610-mm of opaque wall above the window plug was needed to get a water cascading effect over the window head. Half of the Specimen includes a “best current practice wall/window interface detail” and the other half includes a more typical variation or an “upgraded” way of detailing the interface that may or may not be common but present a research interest.

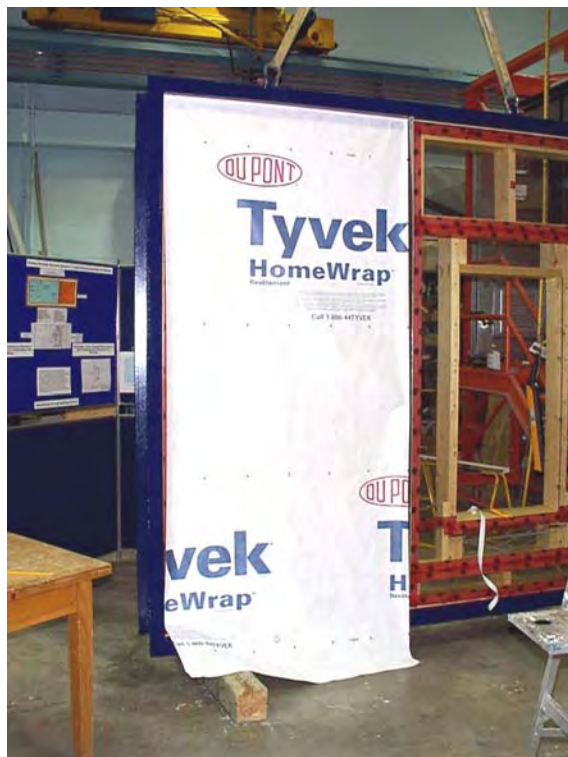
Figure A4-8: Laying out the spun-bonded polyolefin membrane

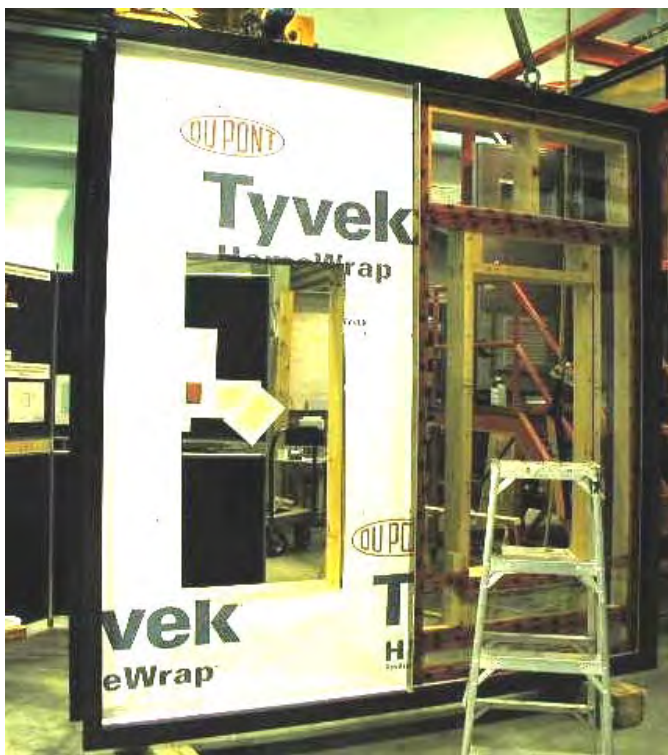
Figure A4-9: Membrane in place cut at the perimeter of the rough opening

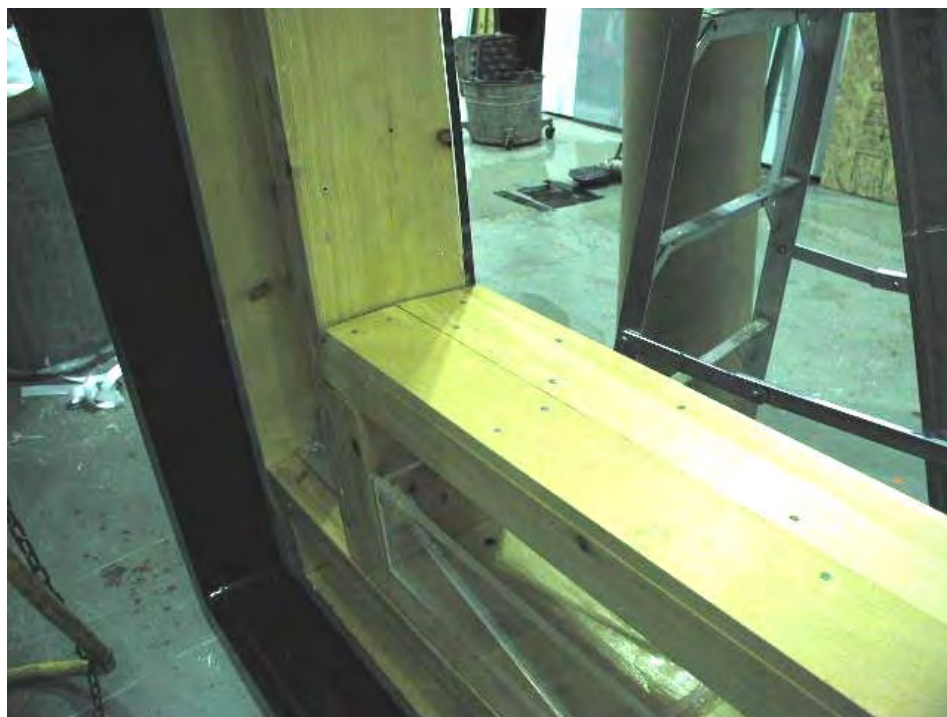
Figure A4-10: Sloped rough sill

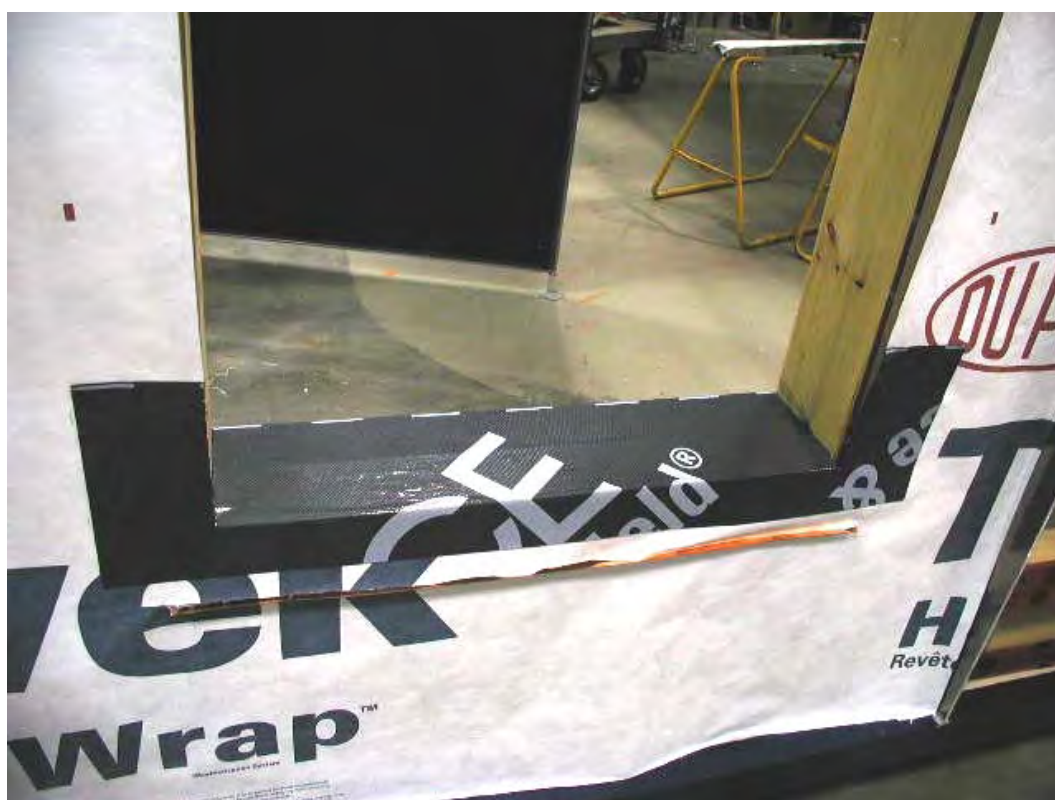
Figure A4-11: Installation of flashing membrane onto the rough sill

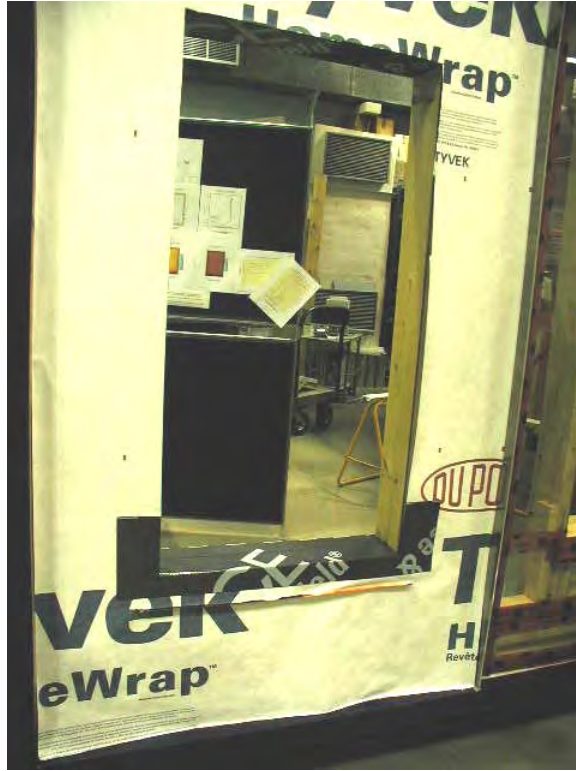
Figure A4-12: Protection of the rough sill with waterproof membrane

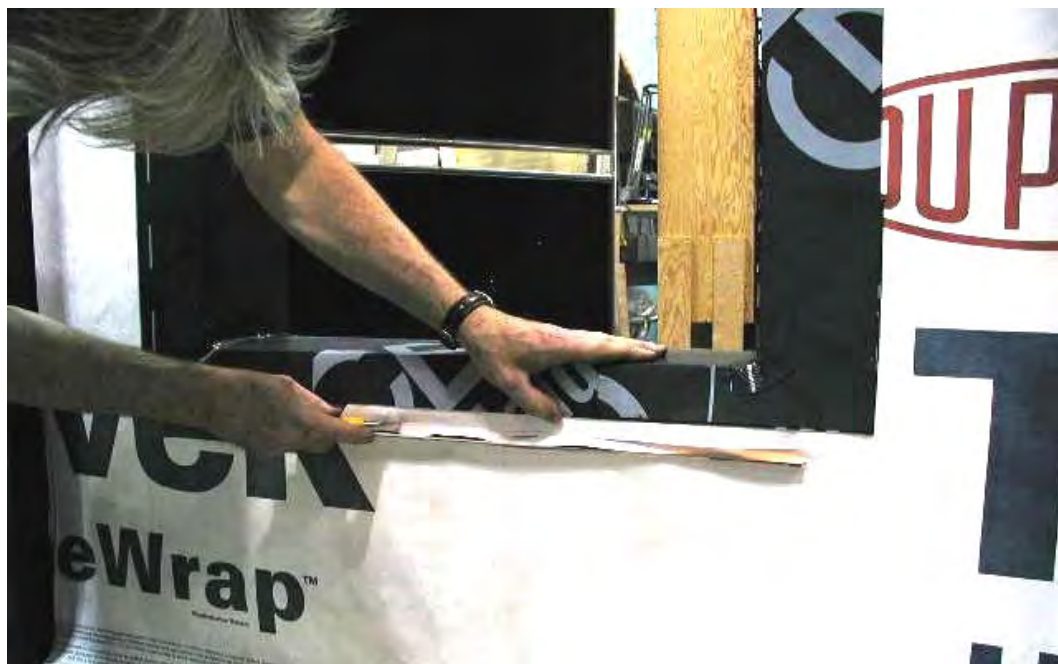
Figure A4-14: Slot for the water collection trough for water running down from the rough sill on the WRB membrane

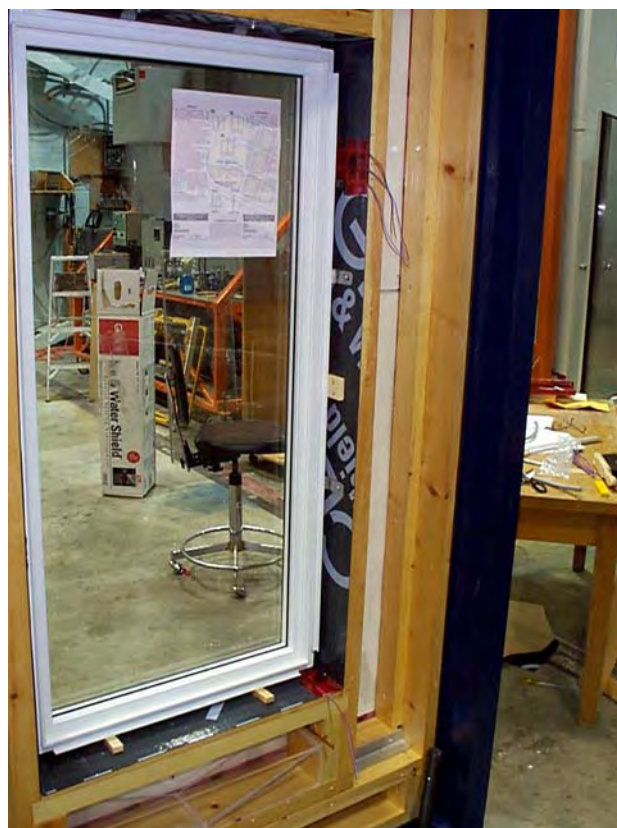
Figure A4-15: View of jamb, sill and head treatment with waterproof membranes at the wall/window interface

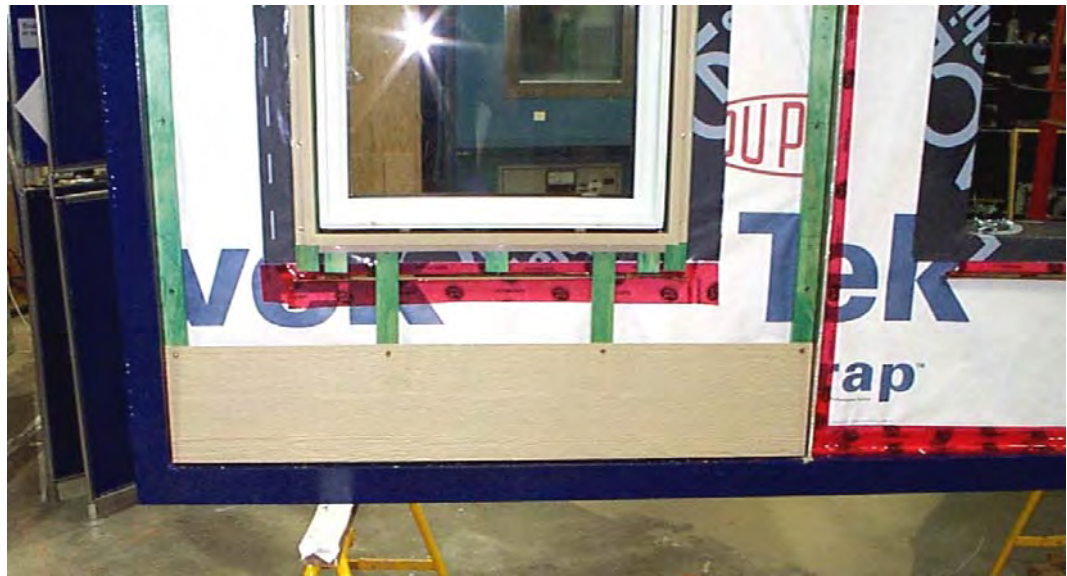
Figure A4-17: Detailing at the sill of the wall/window interface. Same for both halves of the Specimen

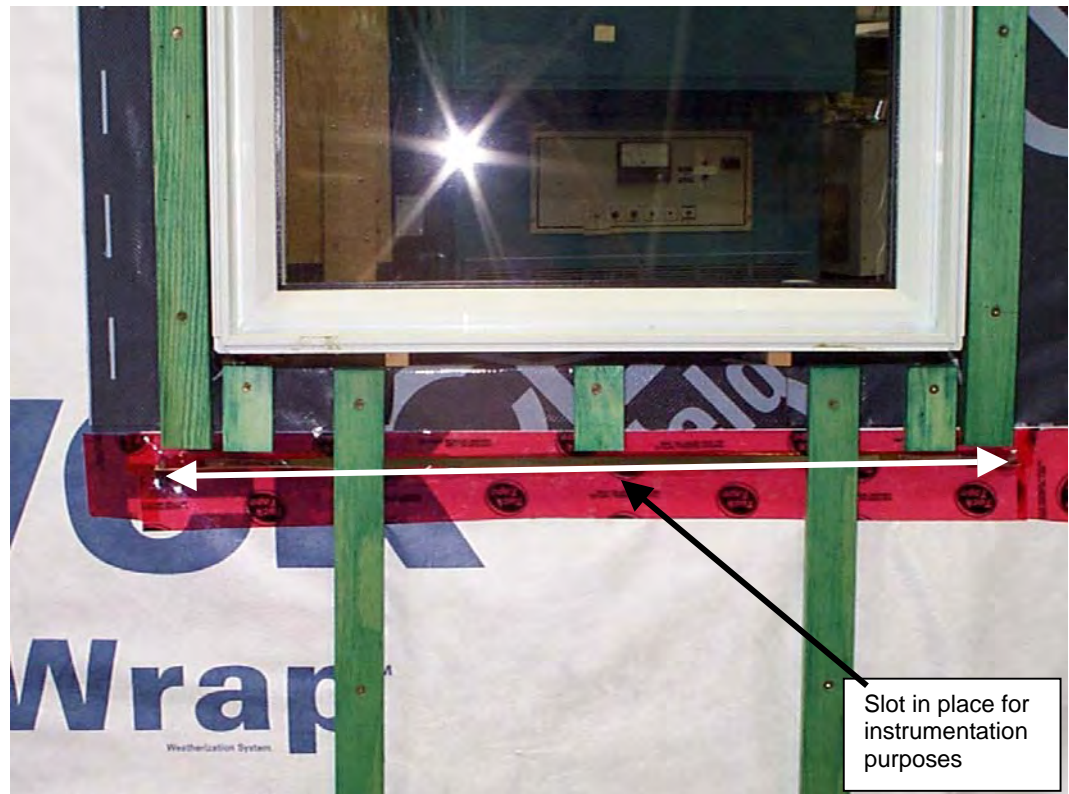
Figure A4-18: Elevation view of the wall/window joint at the sill

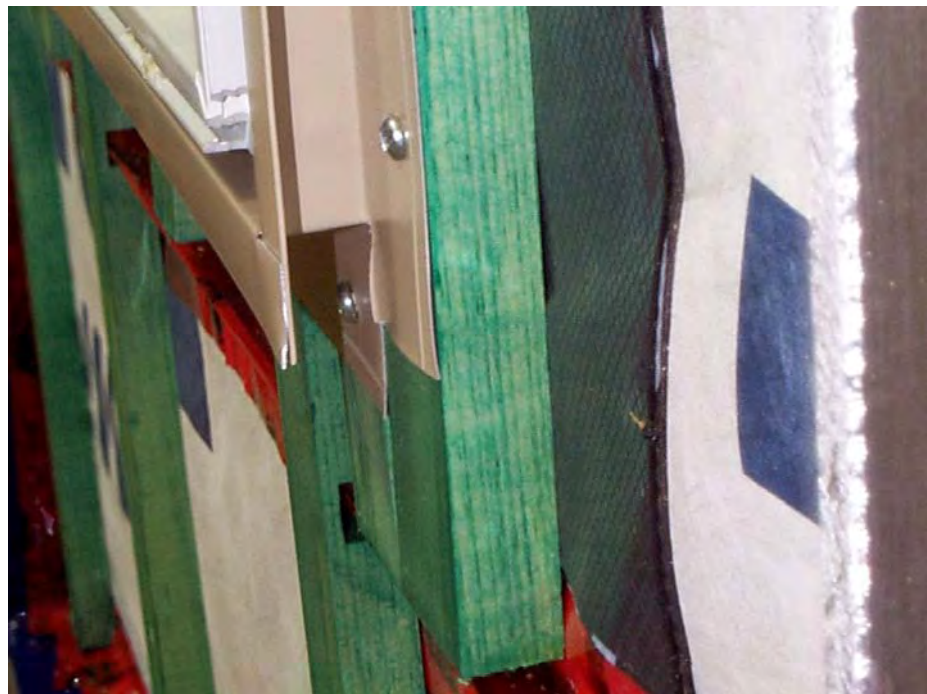
Figure A4-19: View of the bottom corner of the J-trim installation on the furring strips at the sill/jamb corner

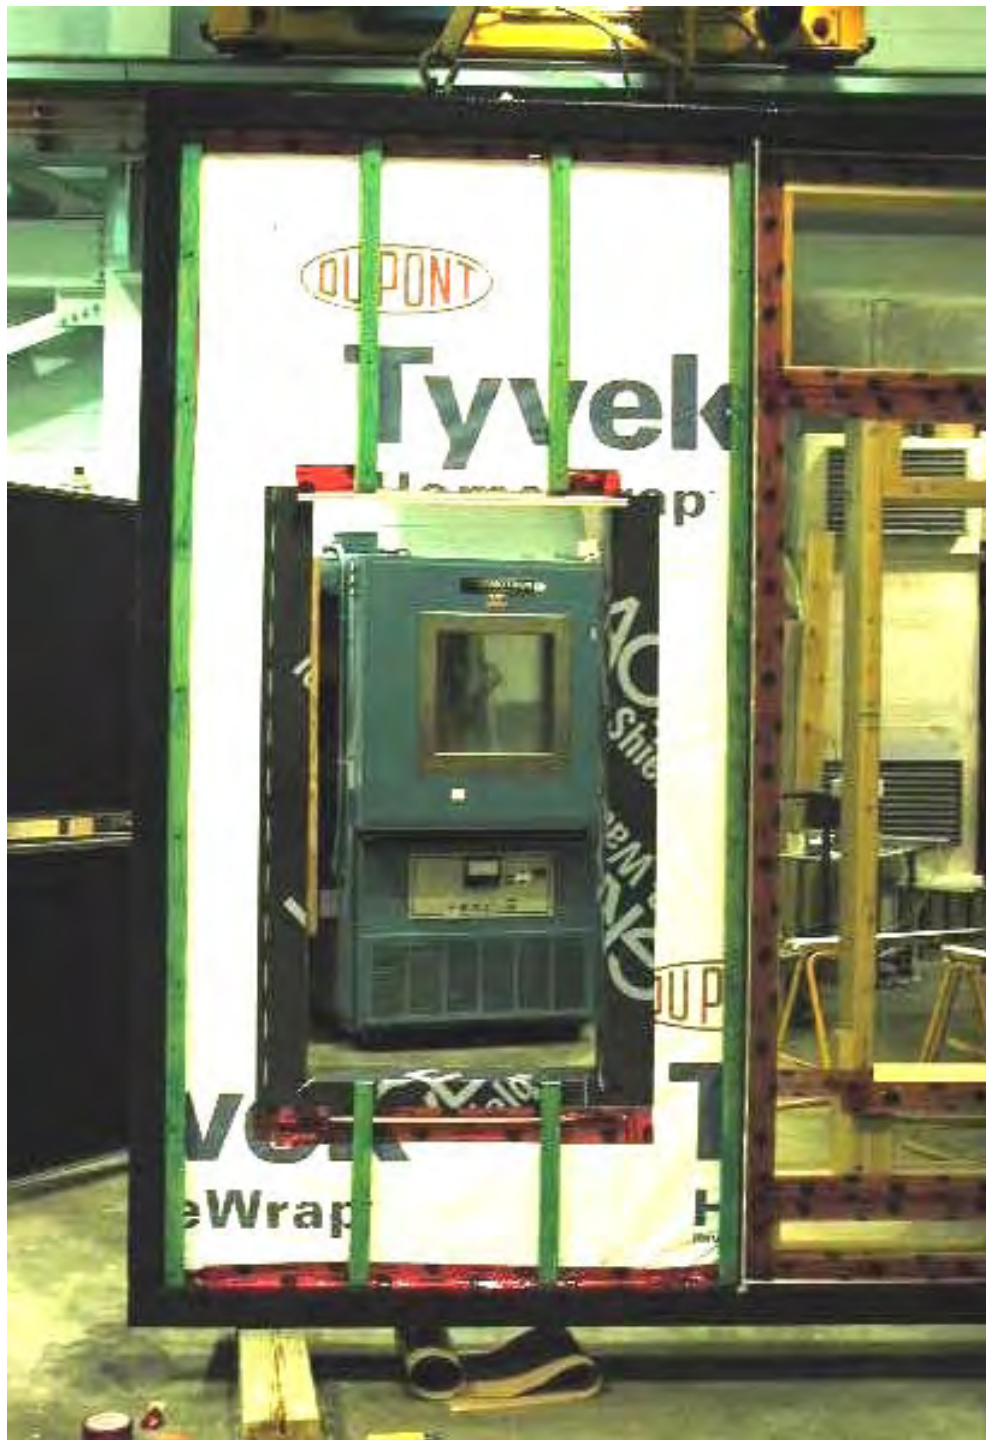
Figure A4-20: B-side half of the Specimen is ready for siding installation

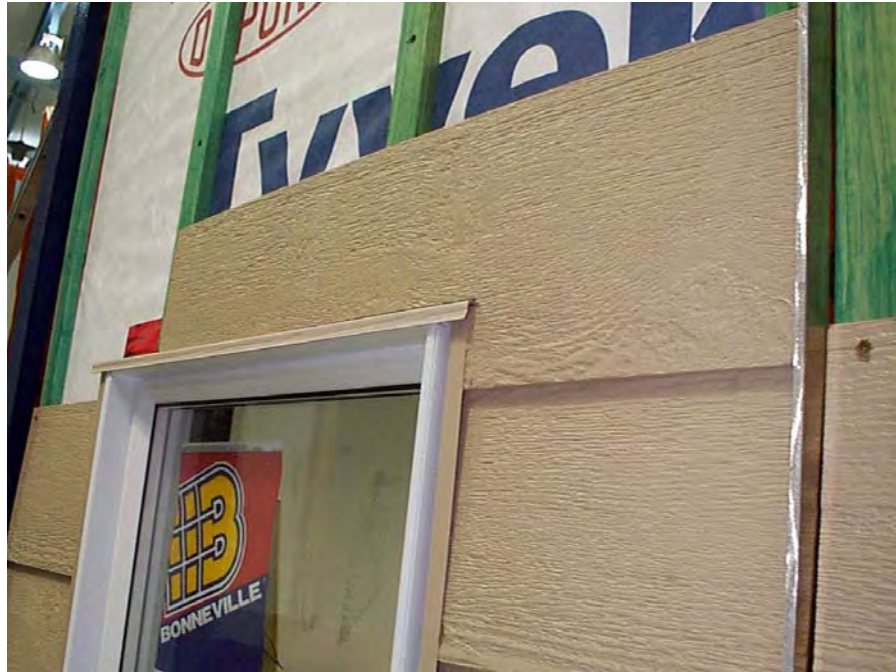
Figure A4-23: Upper corner of the wall/window interface detail

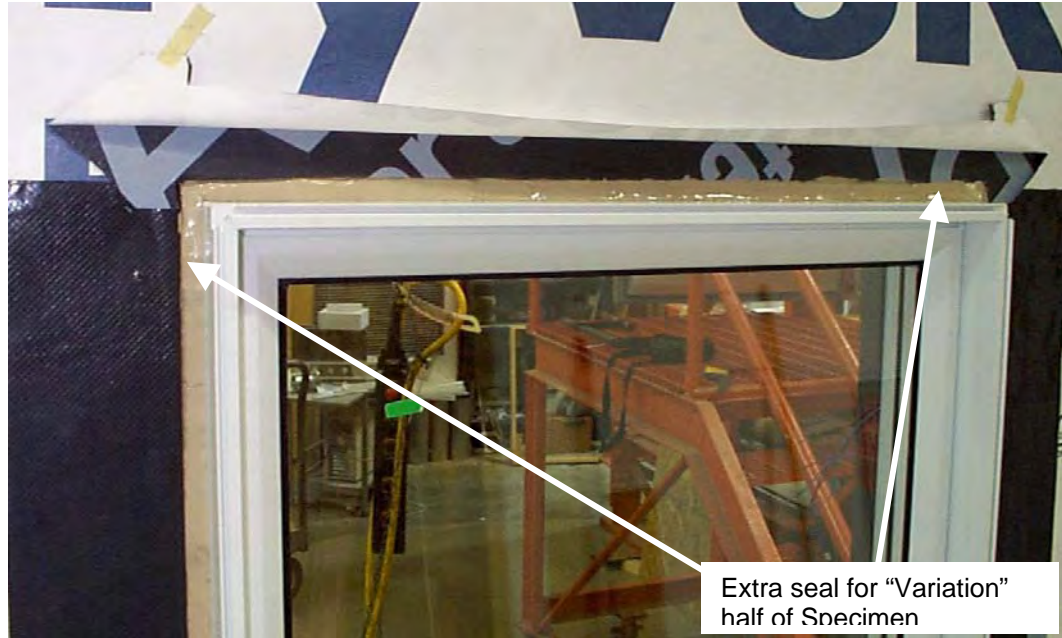
Figure A4-25: Additional sealant and backer rod was placed at the jambs and head of the junction between the window frame and the waterproof membranes, in the plane of the sheathing board. This intends to provide a secondary seal against water entry in case the external bead of sealant fails during service life.

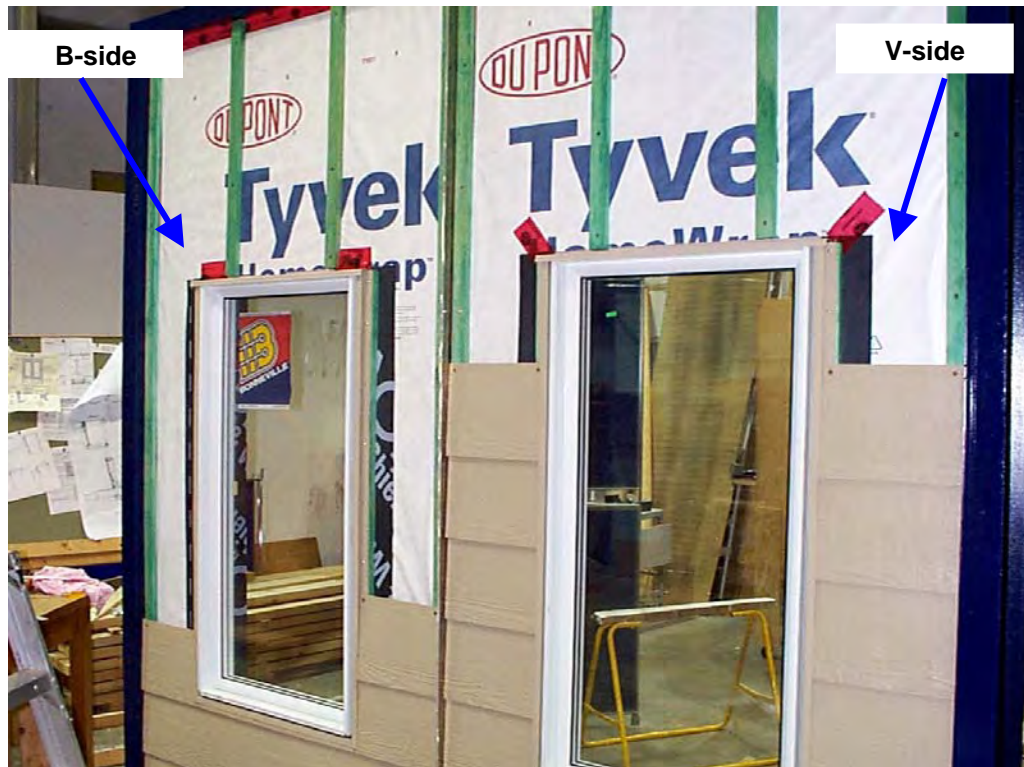
Figure A4-26: Installation of hardboard siding

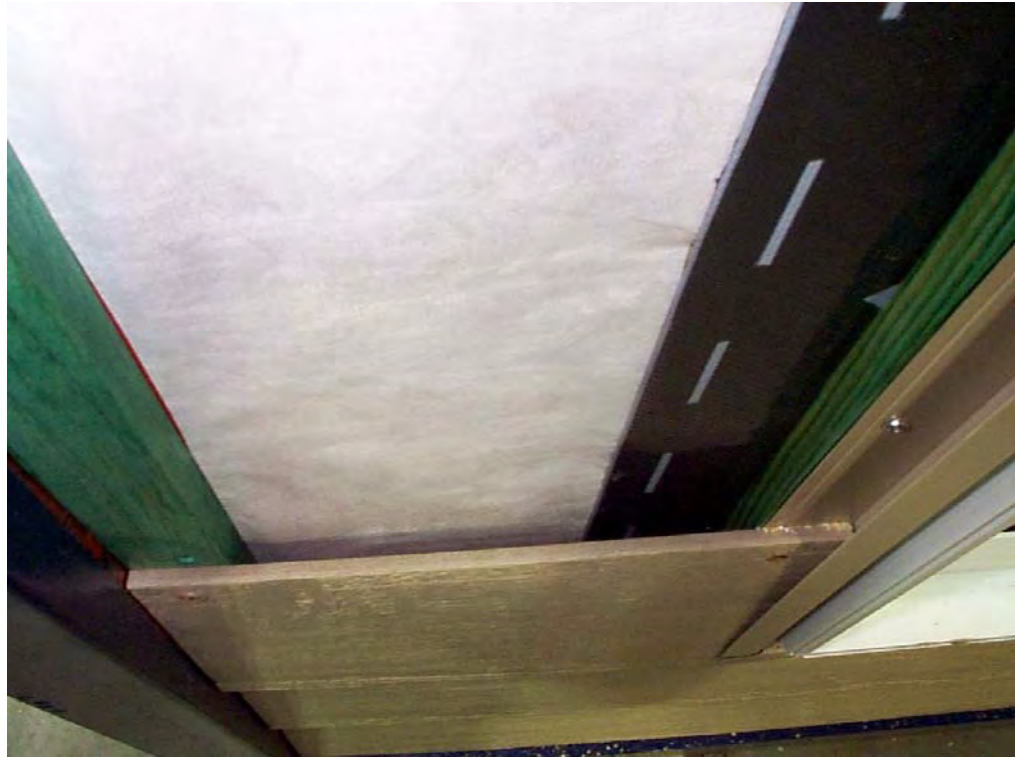
Figure A4-27: Descending view of the air space behind the siding
