### **Evaluating the effectiveness of wall-window interface details to manage rainwater. Phase 1: watertightness, air leakage and rainwater management of CMHC specified assemblies**

Lacasse, M. A.; Rousseau, M. Z.; Cornick, S. M.; Manning, M. M.; Nicholls, M.; Nunes, S. C.

*Client Report (National Research Council of Canada. Institute for Research in Construction); no. B-1229.1, 2008-03-18*

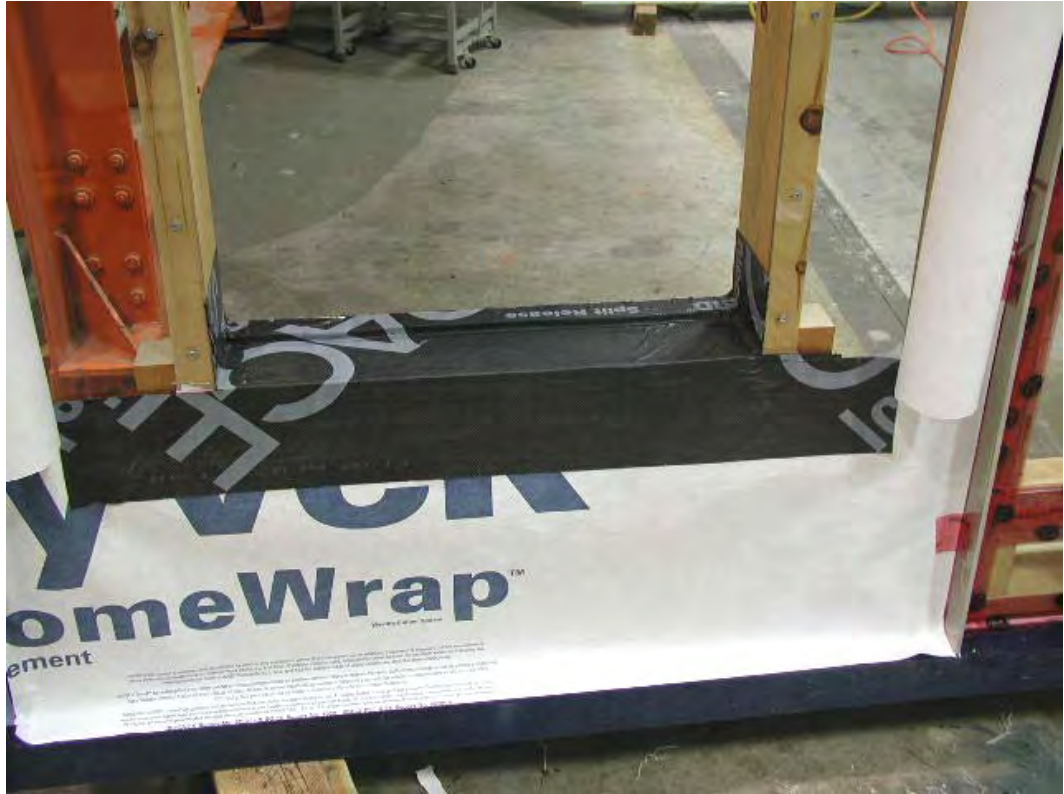
Figure A5-8: Specimen W2 B-side – Detail at sill and lower part of jamb

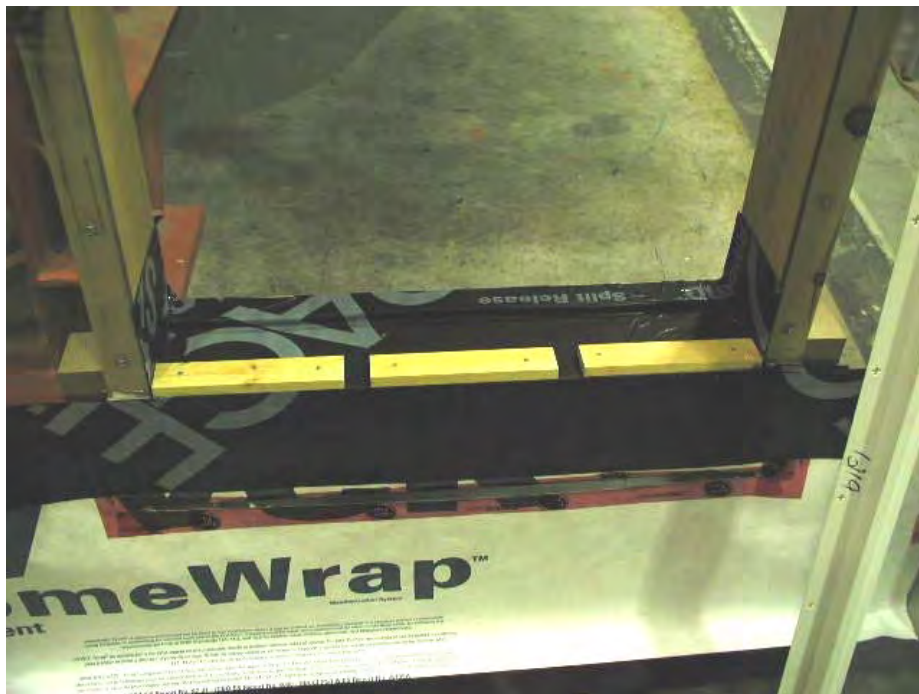
Figure A5-9: Specimen W2 B-side – Placement of wood shims at the sill, over the self-adhesive membrane

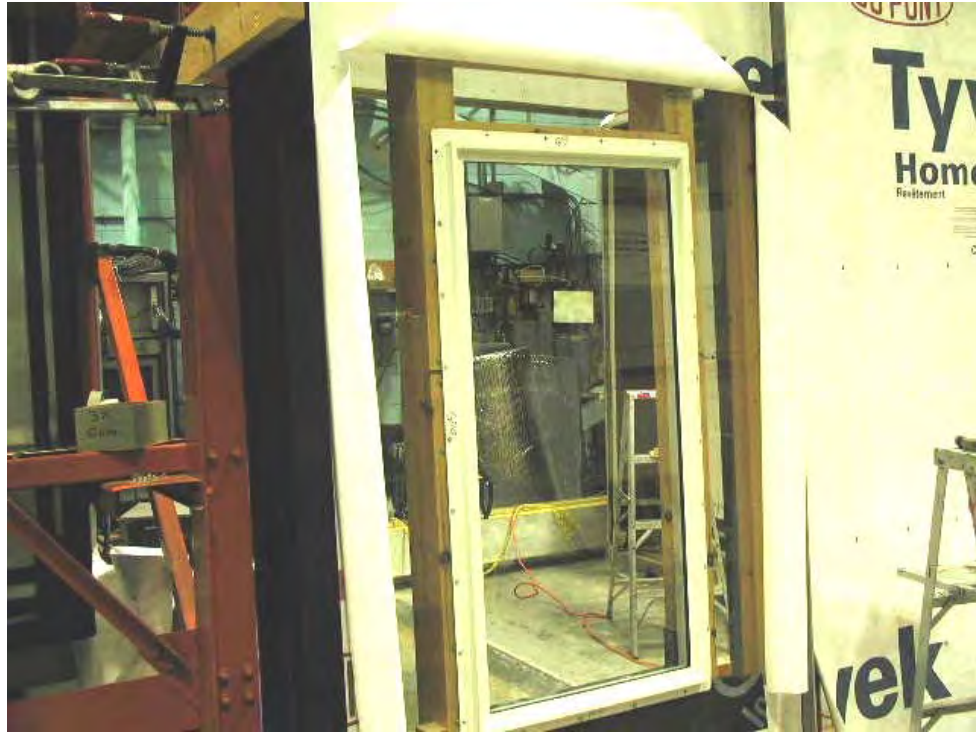
Figure A5-10: Specimen W2 B-side – Fastening of the flanged window to the structure, over the clear acrylic sheet acting as sheathing board

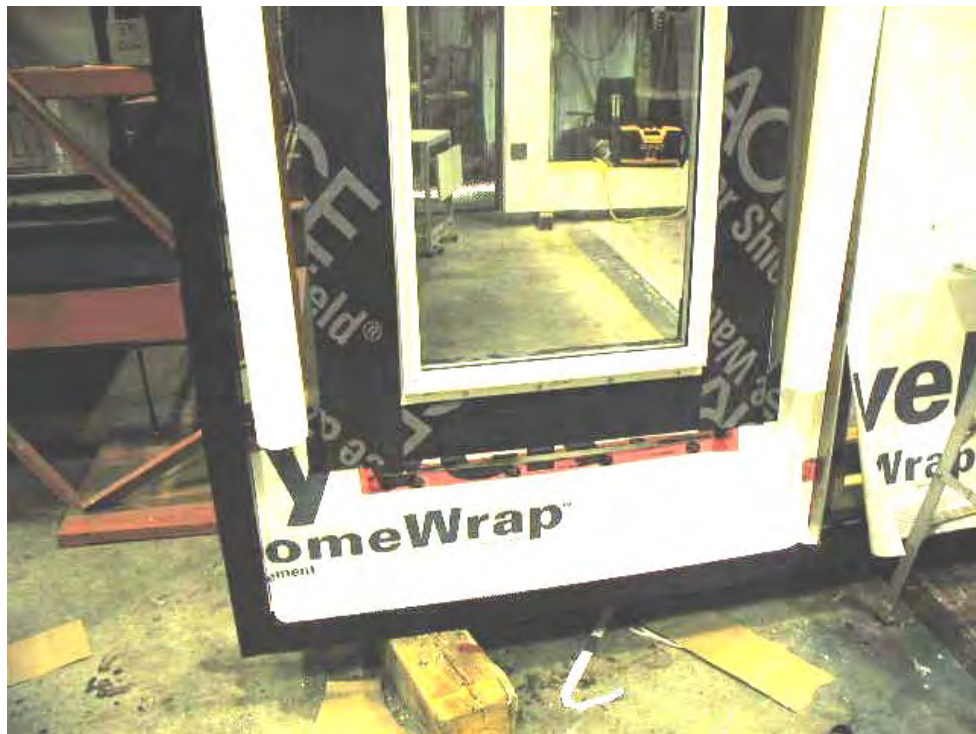
Figure A5-11: Specimen W2 B-side – Installation of the self-adhesive membrane at jambs and head, sealing the flange to the sheathing board

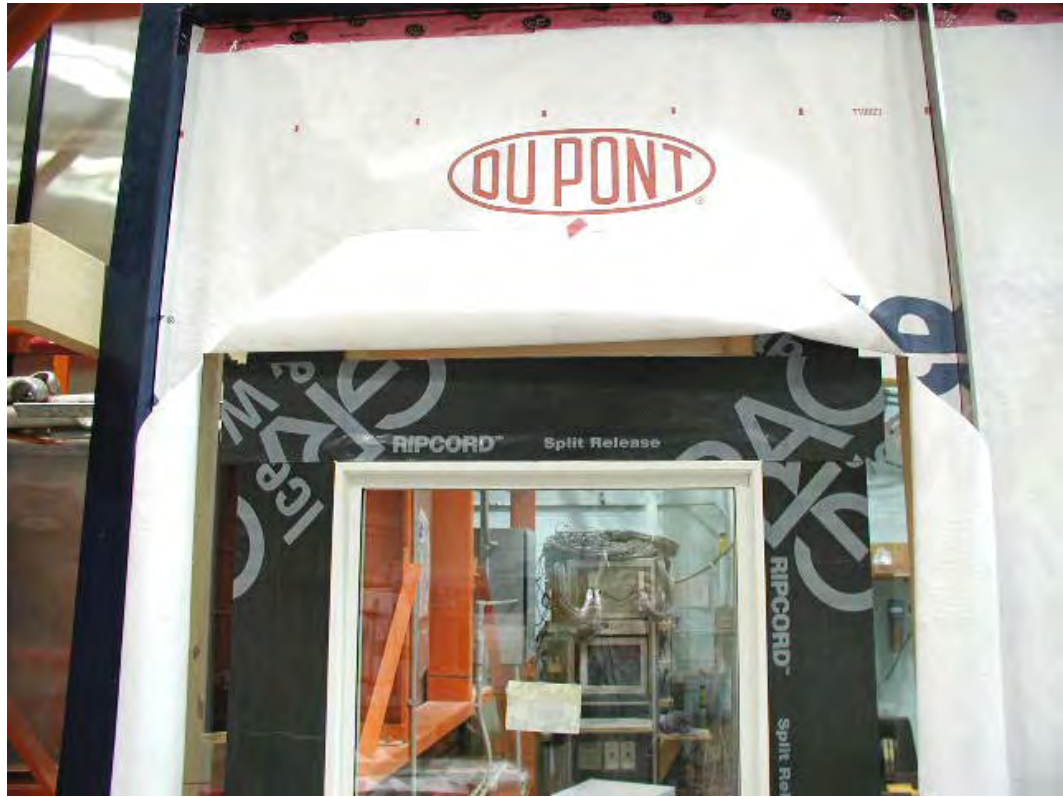
Figure A5-12: Specimen W2 B-side – Placing of the waterproof self-adhesive membrane at the head, over the jamb membrane and over the window flange

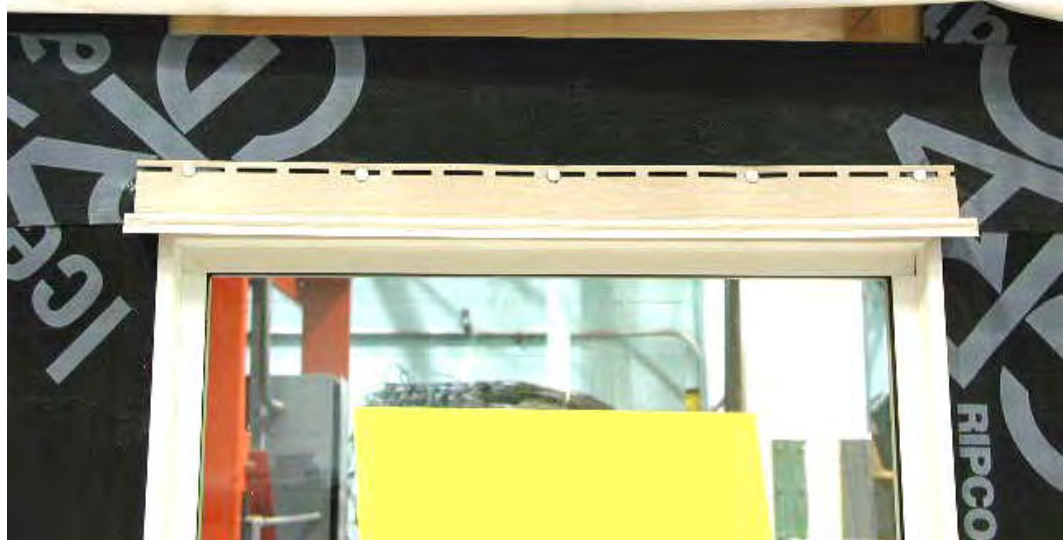
Figure A5-13: Specimen W2 B-side – Placement of the rigid head flashing (drip cap), extending 25 mm (1 in.) on each side

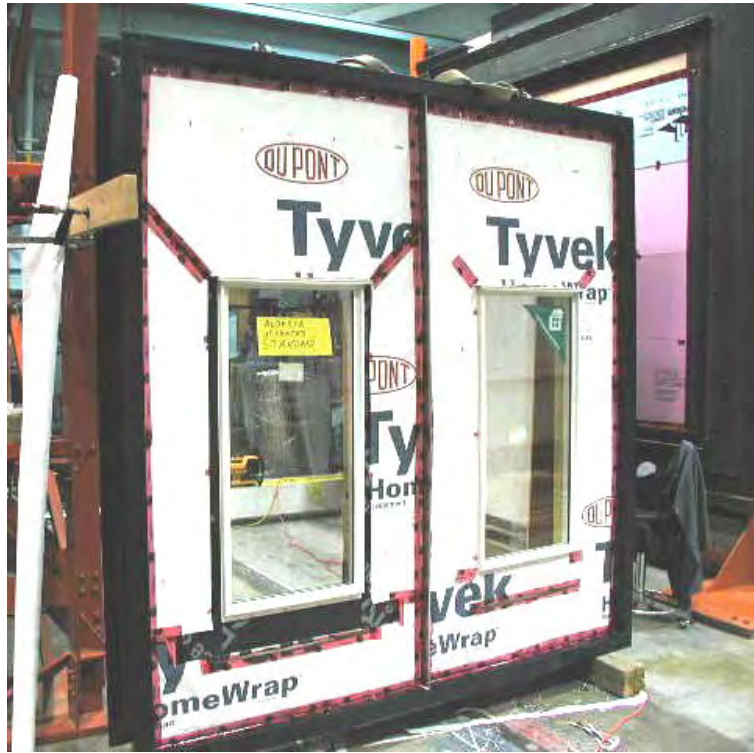
Figure A5-14: Specimen W2 B-side (left of photo) – Water resistive membrane installation completed

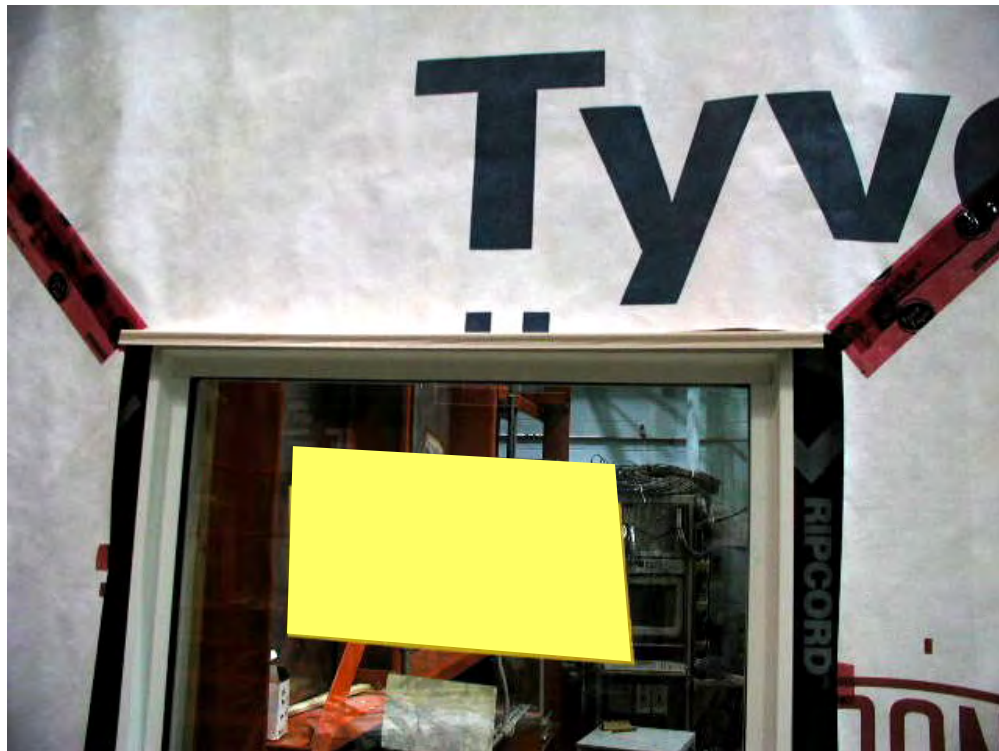
Figure A5-15: Specimen W2 B-side – Water resistive membrane completed

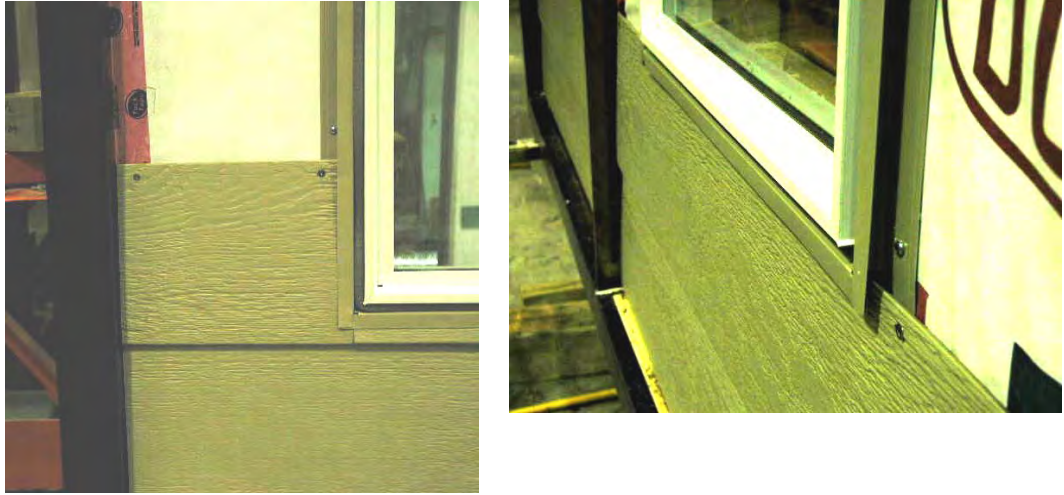
Figure A5-16: Specimen W2 B-side (left side) – Hardboard siding installation with J-trim at sill and jamb (not at the head)

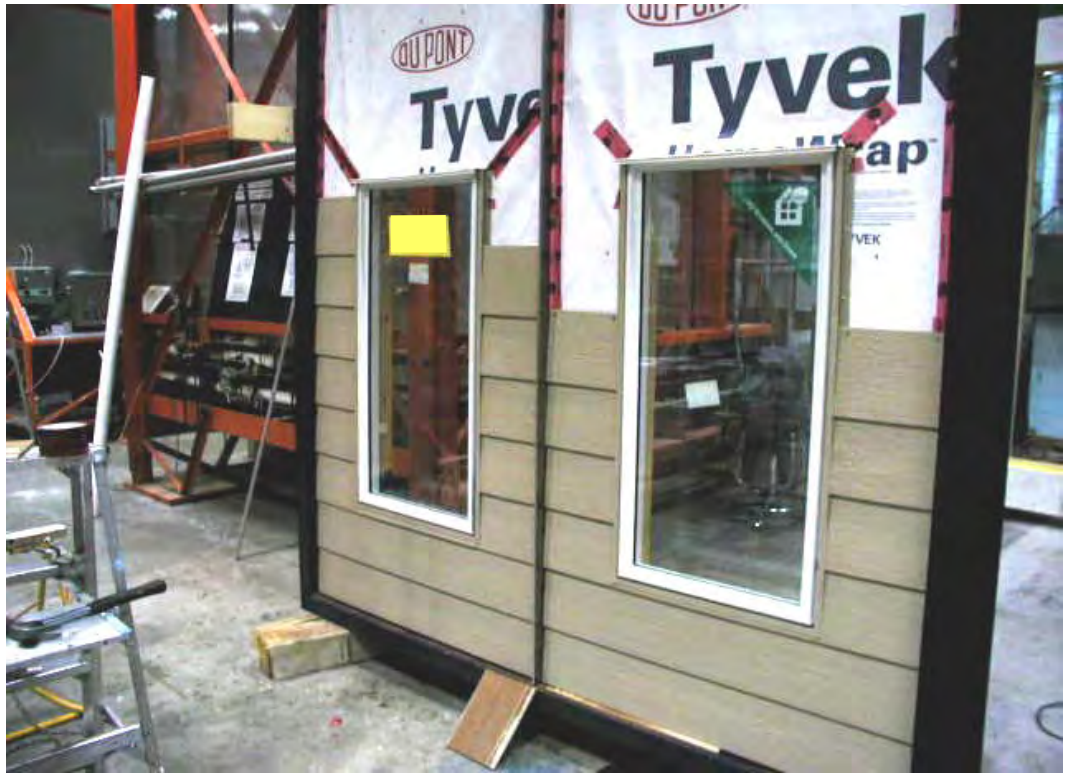
Figure A5-18: Installation of the hardboard siding on both halves

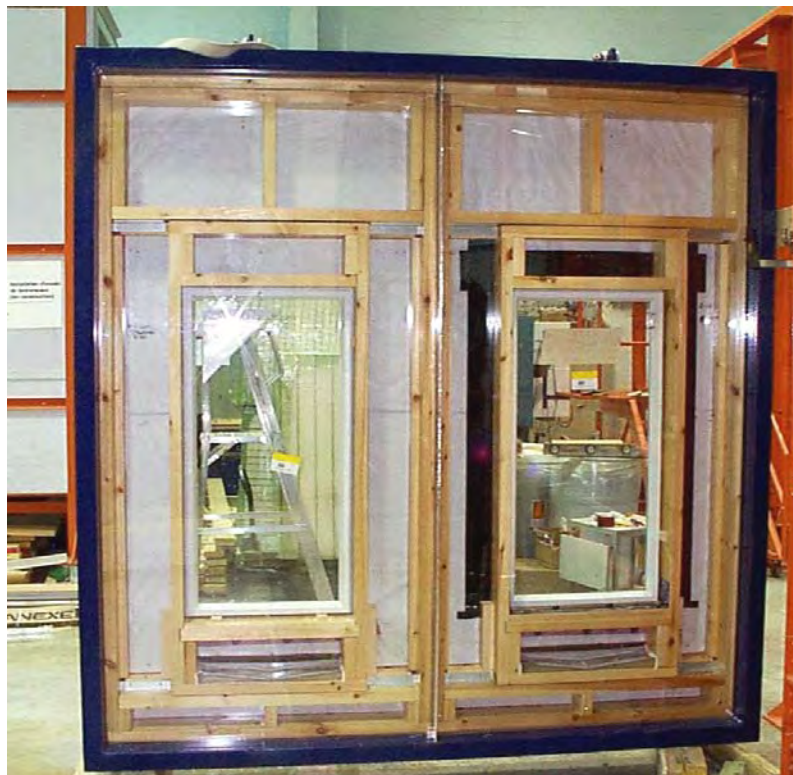
Figure A5-19: Rear view of the two halves of the Specimen (B-side on the right)

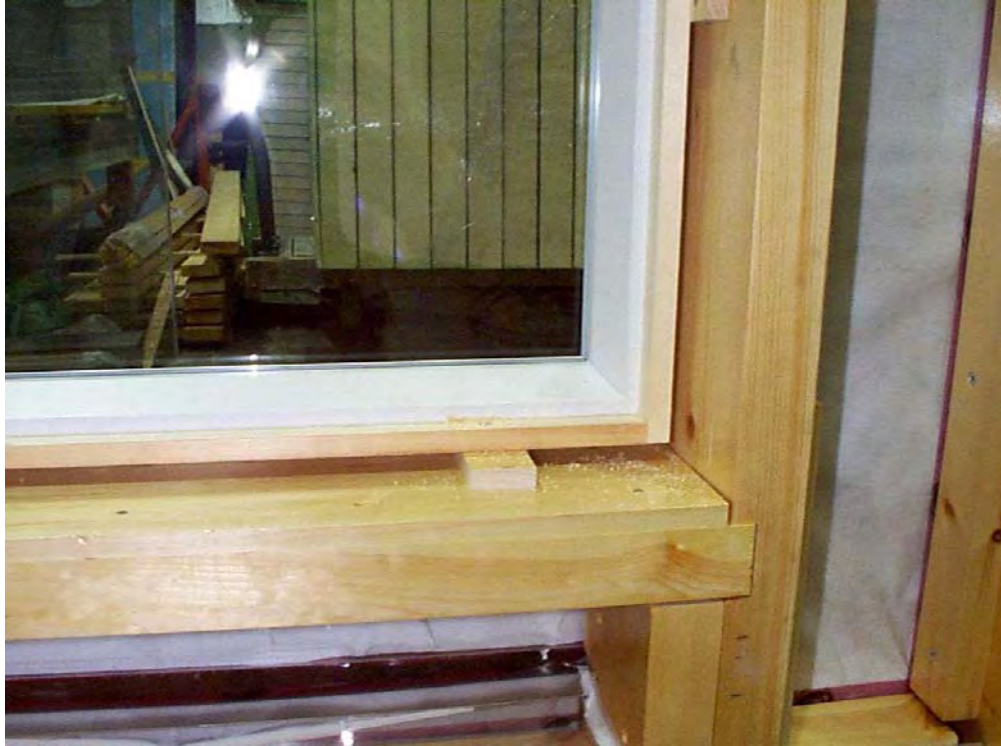
Figure A5-20: Rear view of the Specimen W2 V-side – no membrane protecting the wood members making up the rough opening

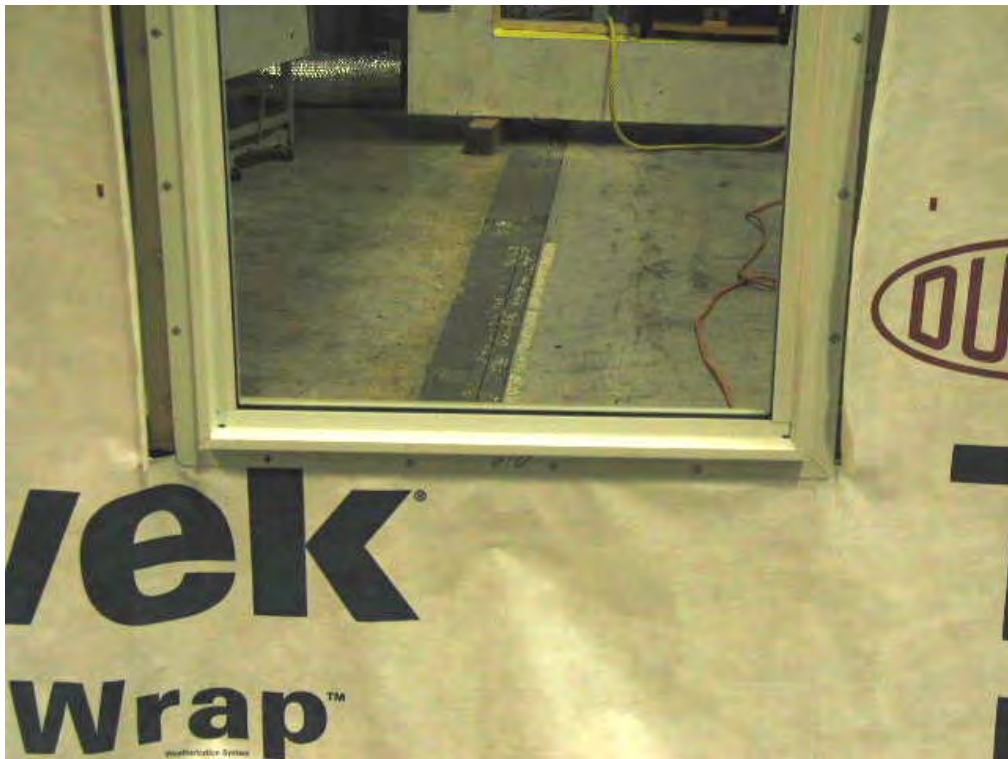
Figure A5-21: Specimen W2 V-side – Window flange is over the WRB at sill, and under the WRB at the jambs and head

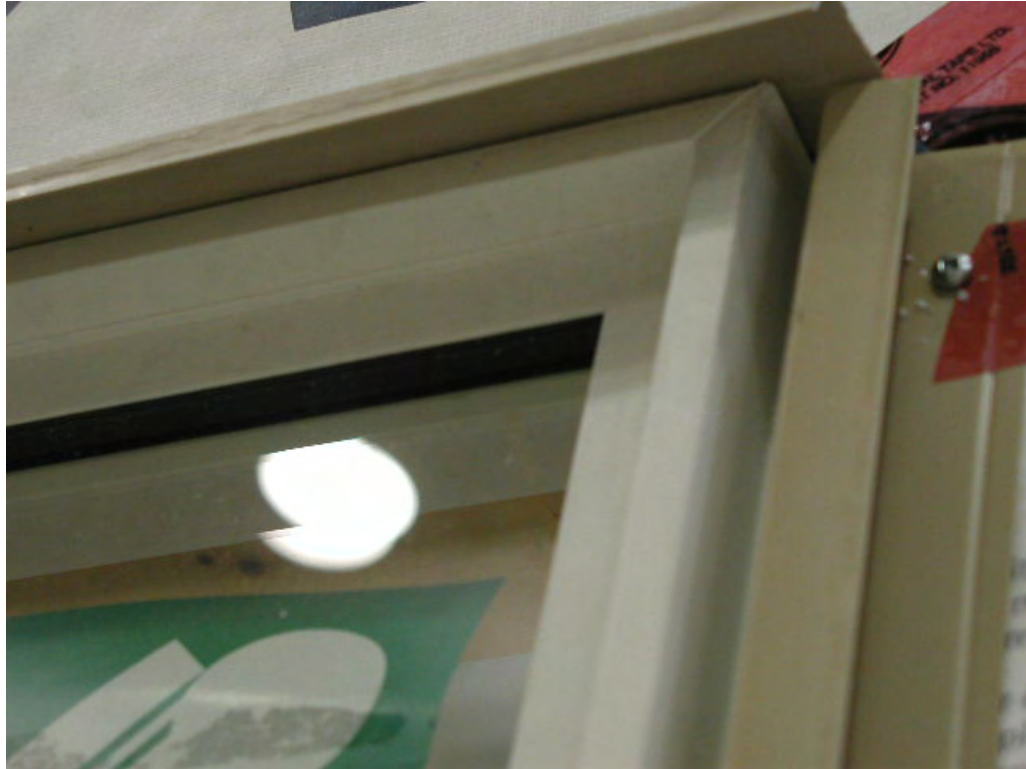
Figure A5-22: Specimen W2 V-side – View of the frame corner, drip flashing and J-trim, prior to installation of backer rod and sealant

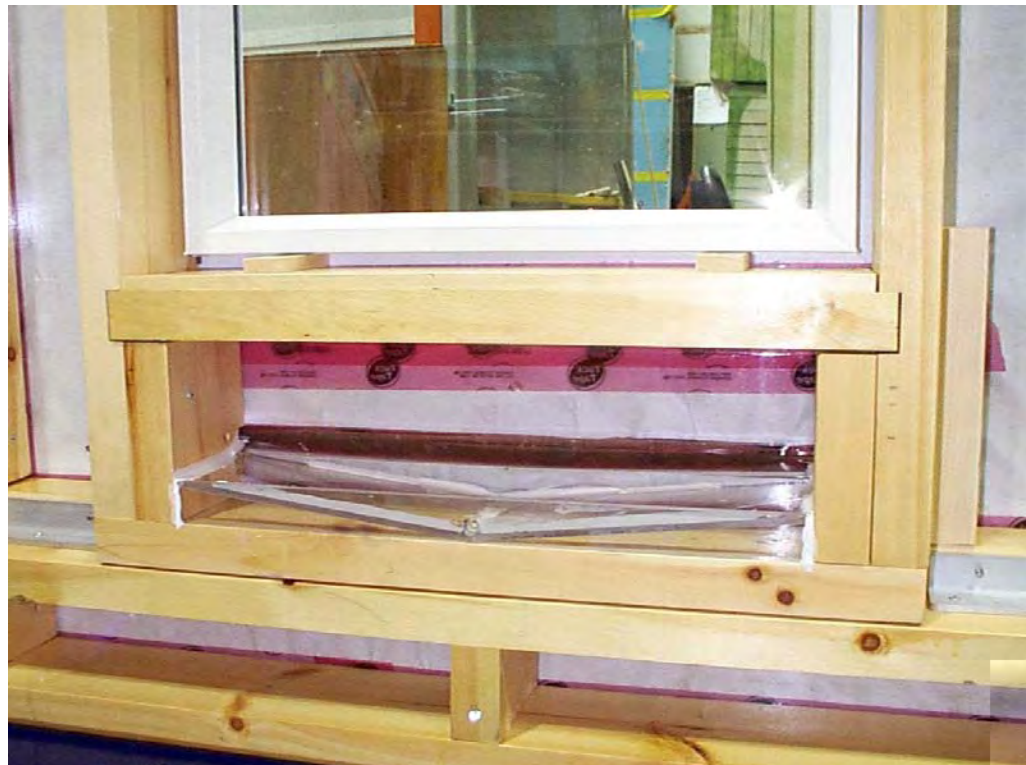
Figure A5-23: Specimen W2 V-side – View of the trough used to collect water

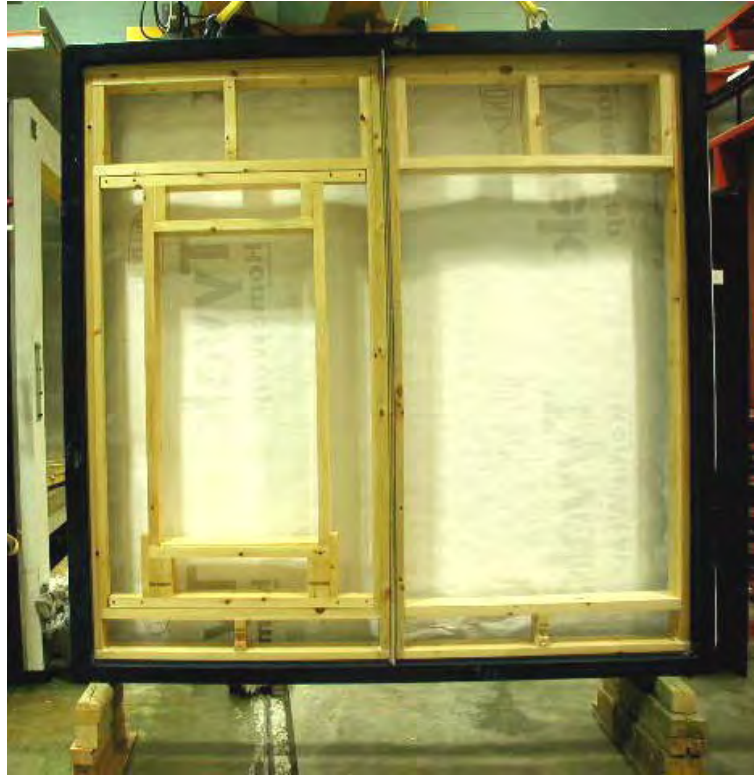
Figure A6-6: Framing for the left hand side of the wall Specimen is completed. Right side is in progress

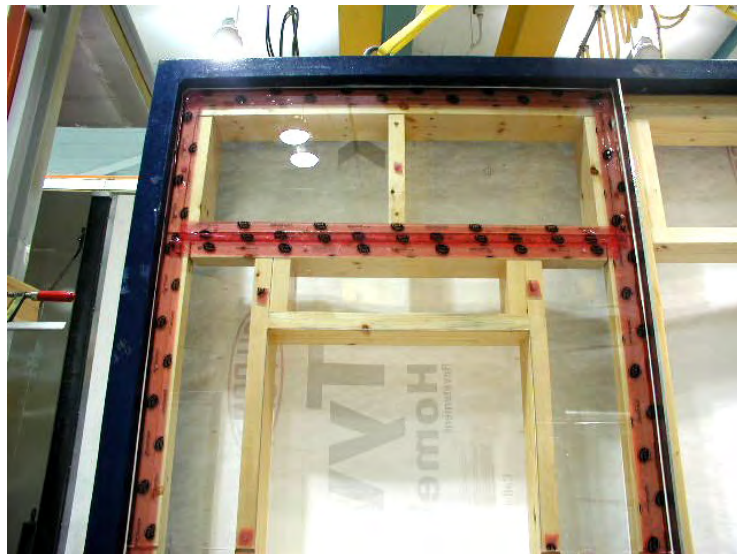
Figure A6-9: Installation and sealing of the clear acrylic sheet in upper part of the Specimen

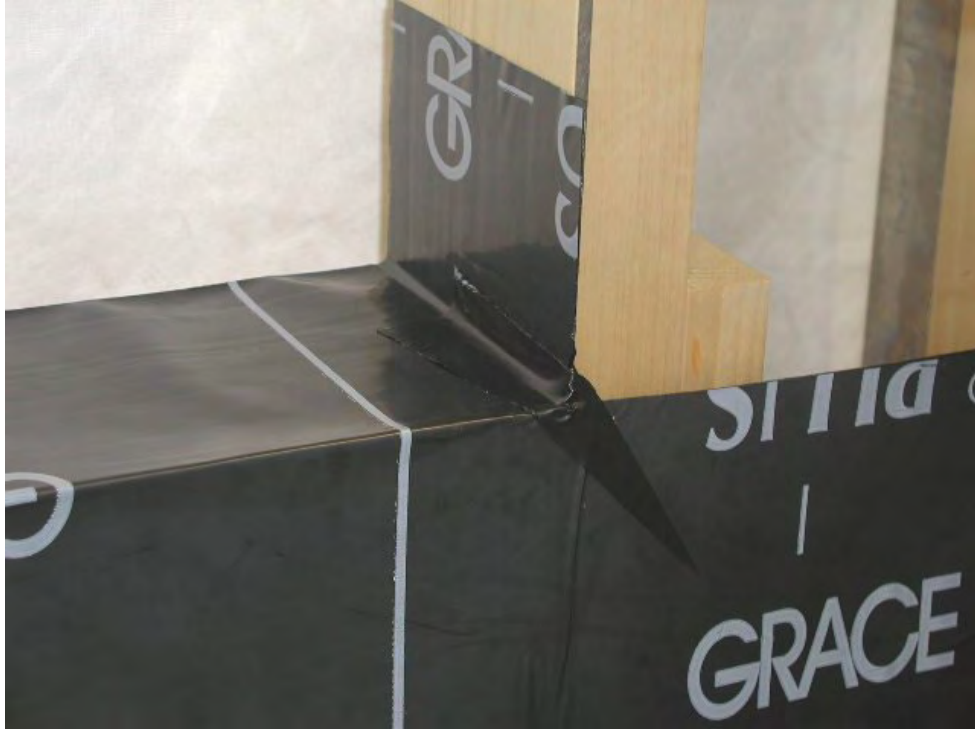
Figure A6-11: Specimen W3 B-side – Installation of the waterproof membrane onto the subsill, over the sheathing board below and up rough jambs (150-mm). Corner piece of waterproofing membrane also applied.

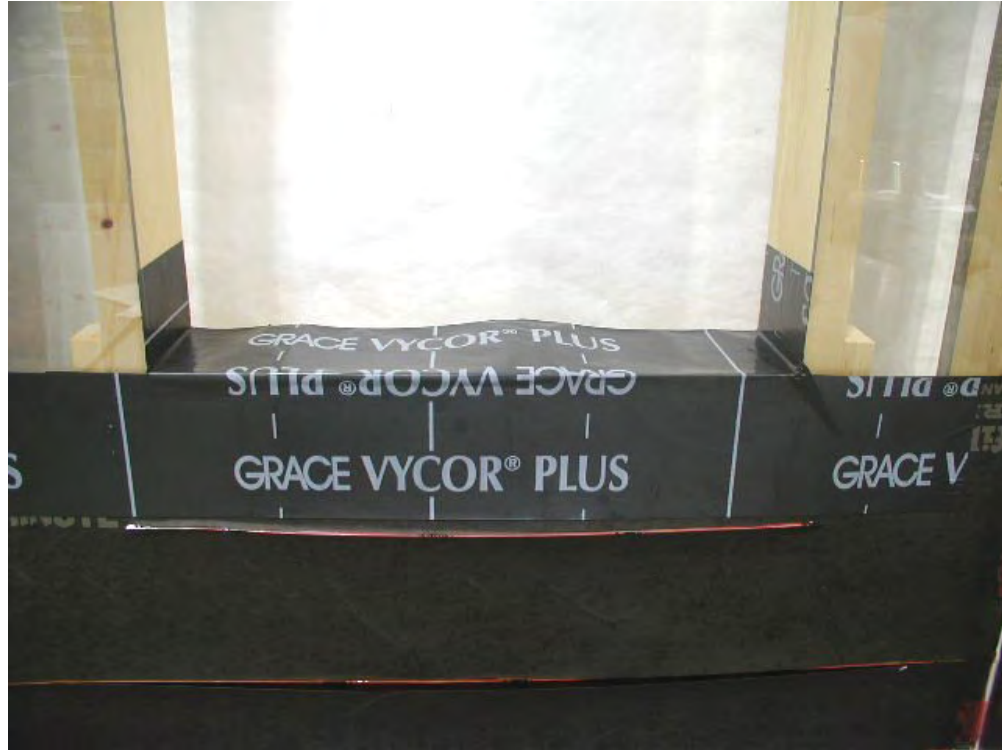
Figure A6-12: Specimen W3 B-side – Waterproof membrane installed, lapping down over the first course of building paper by 150-mm

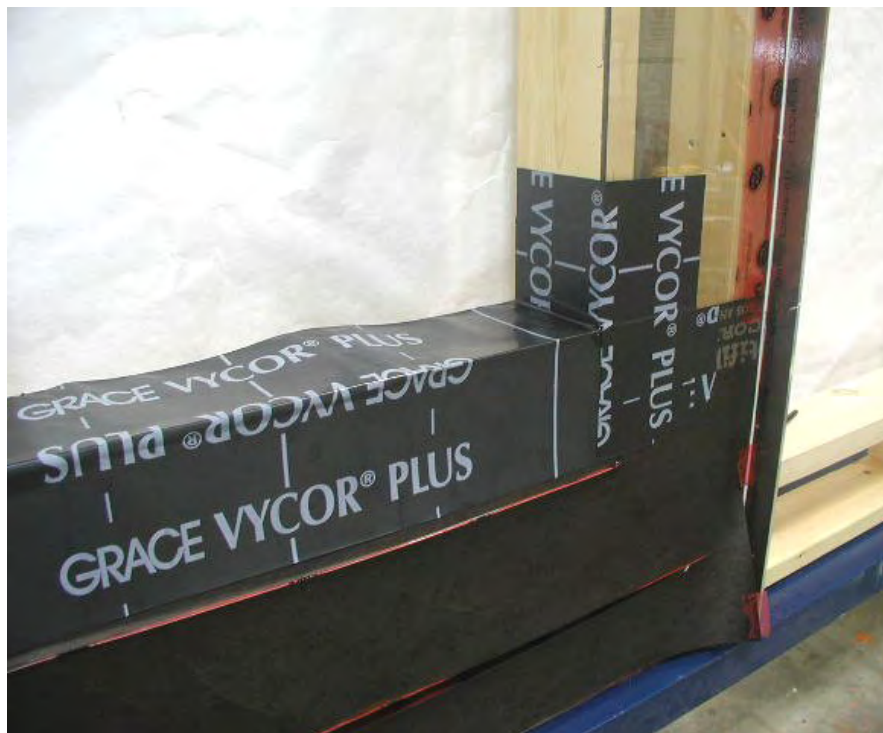
Figure A6-13: Specimen W3 B-side – Strip of waterproof membrane installed at jamb (150-mm high), lapping over the sill membrane

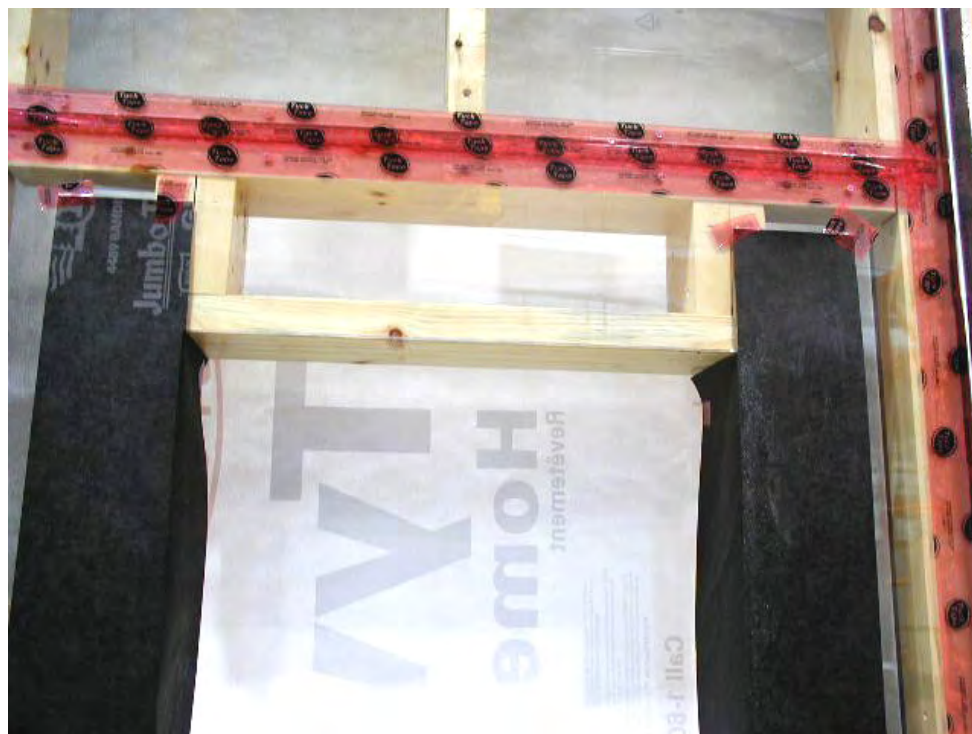
Figure A6-14: Specimen W3 B-side – Installation of strips of building paper at rough jambs

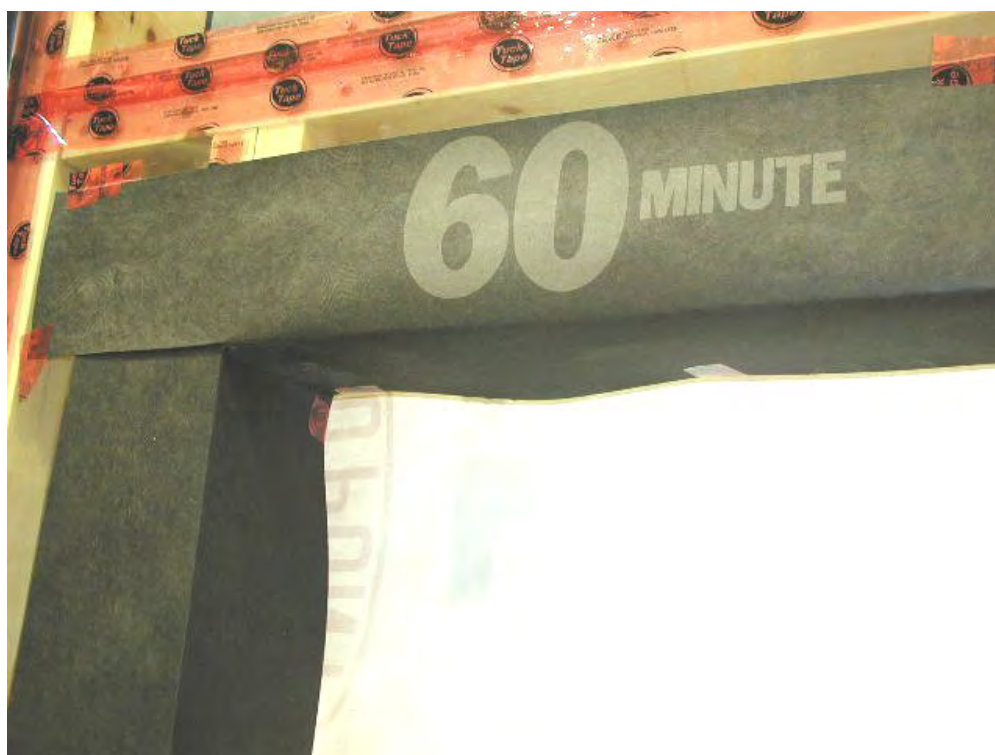
Figure A6-15: Specimen W3 B-side – Installation of strips of 60 minute building paper at rough head

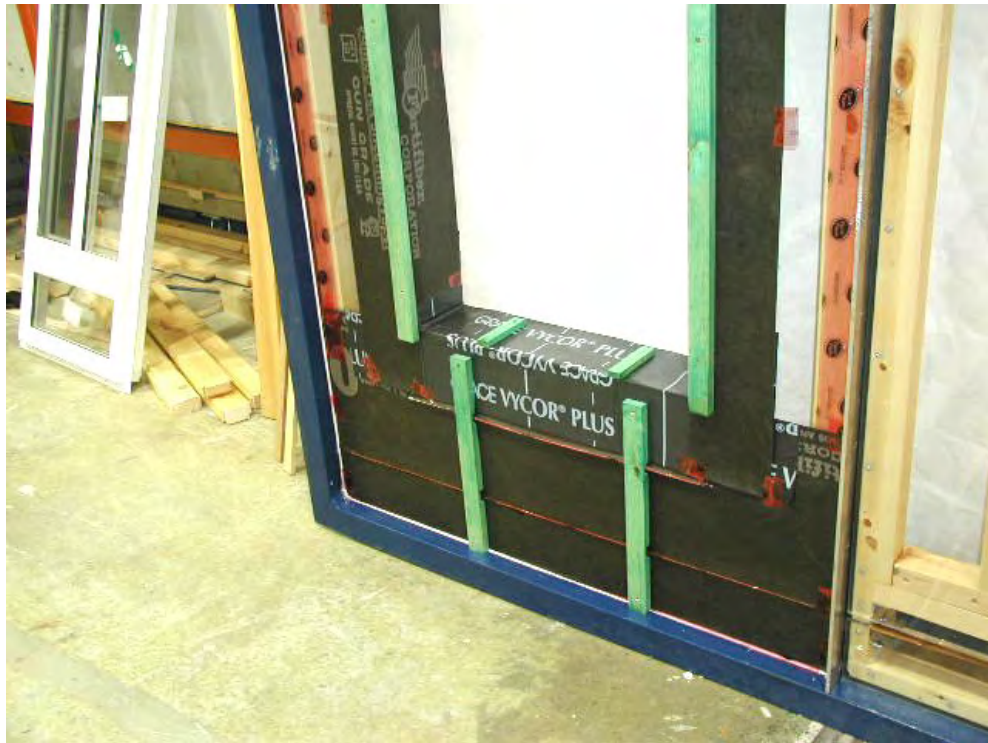
Figure A6-16: Specimen W3 B-side – Installation of the furring strips prior to window installation (Left side of Specimen only)

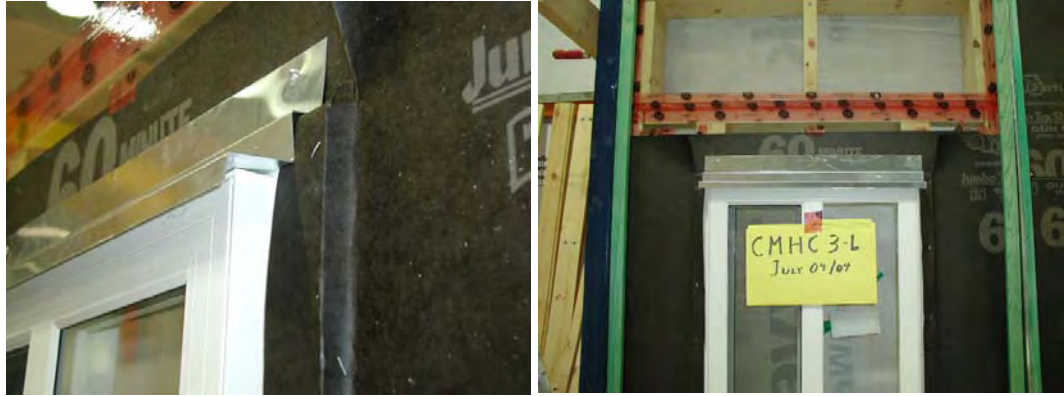
Figure A6-17: Stepped drip cap flashing accommodates window recessed from the back up wall (Specimen W3 B side)

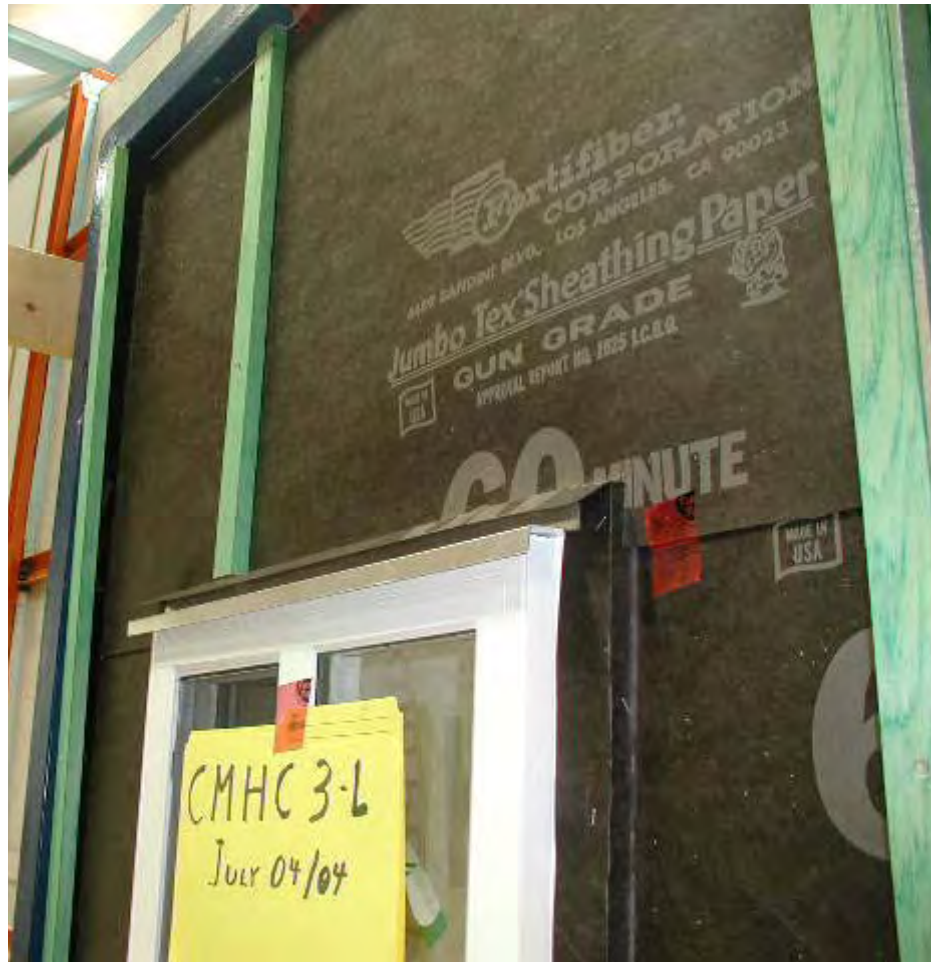
Figure A6-18: Installation of the drip cap flashing and WRB building paper over it (Specimen W3 B side only)

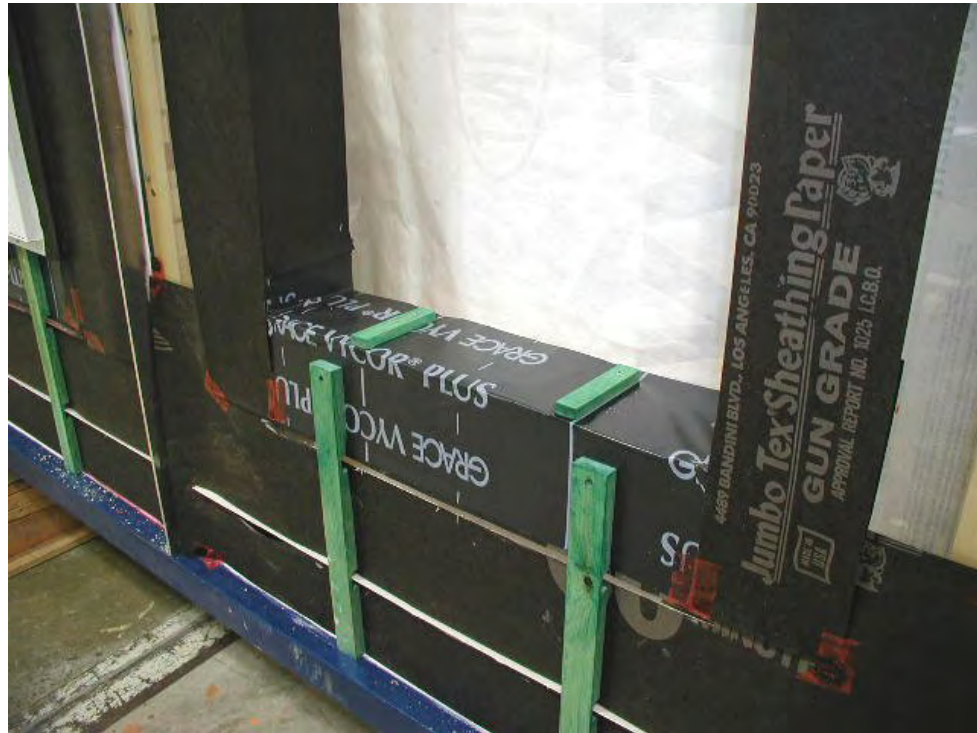
Figure A6-19: Specimen W3 B side: installation of furring strips (19 mm) and shims (12 mm)

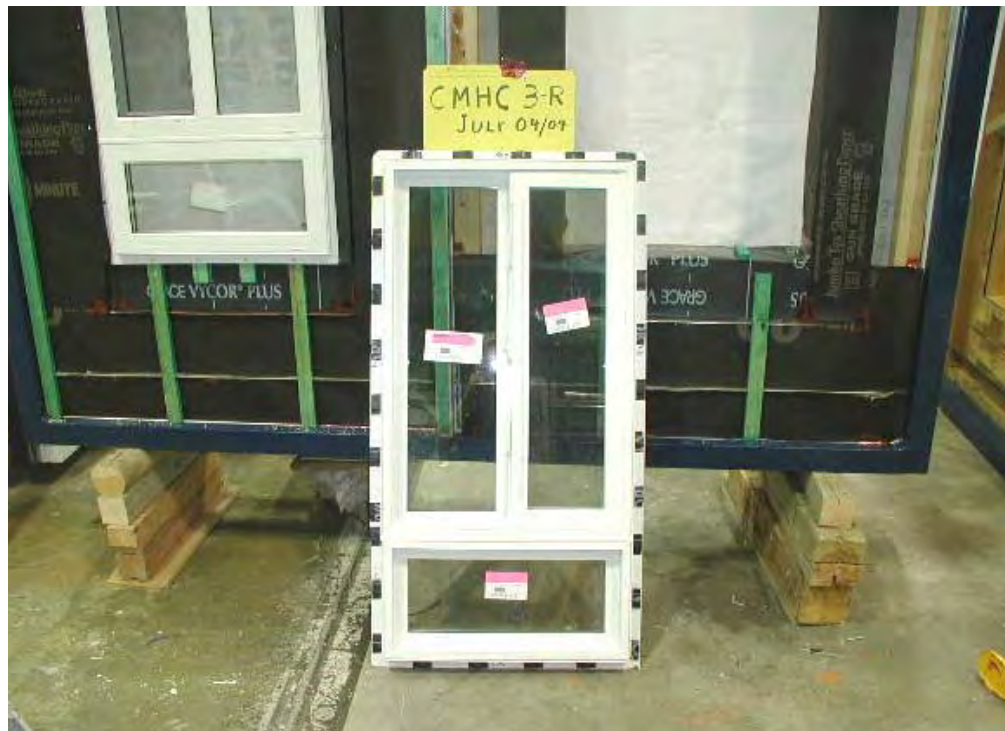
Figure A6-20: Window flange with spacers, designed to create a drainage space at the rough sill (Specimen W3 V side only)

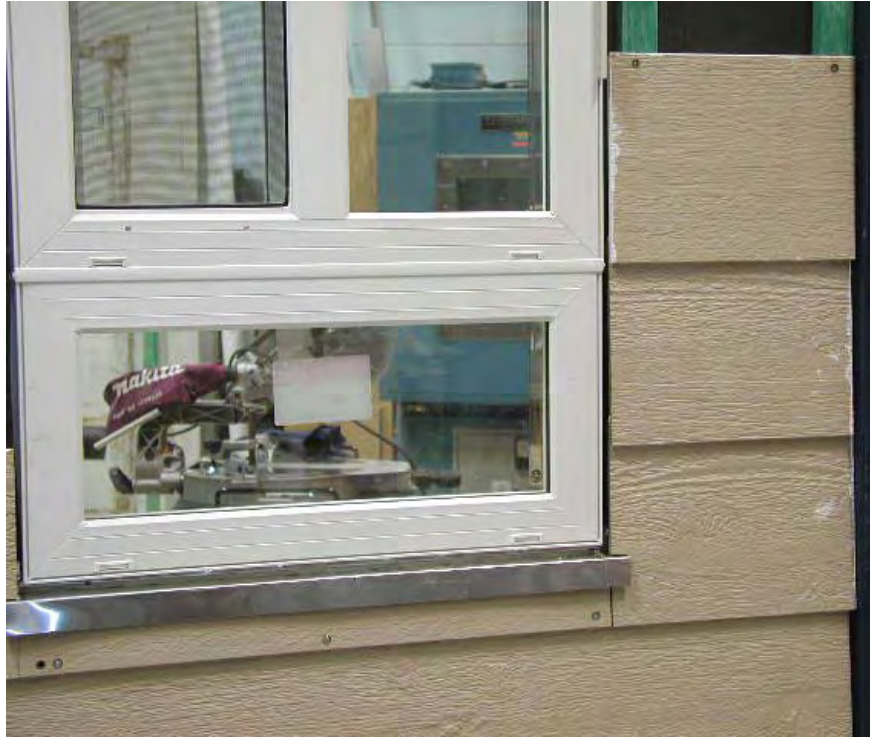
Figure A6-21: Siding installation. 10 mm gap left at the jambs and sill for a backer rod and sealant

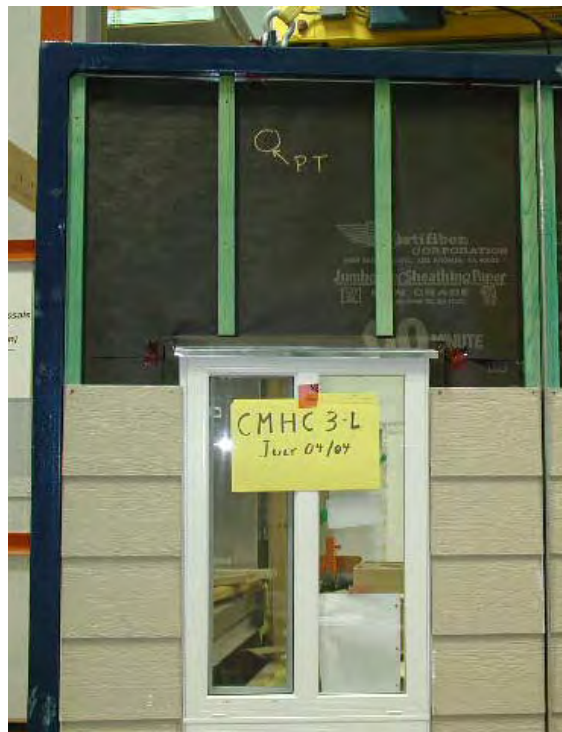
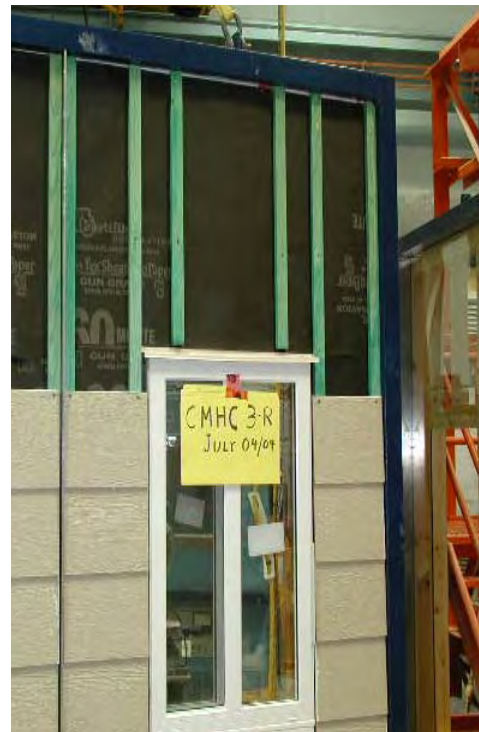
Figure A6-22: Installation of siding on Left and Right sides of Specimen. Siding back-primed and painted (one coat).

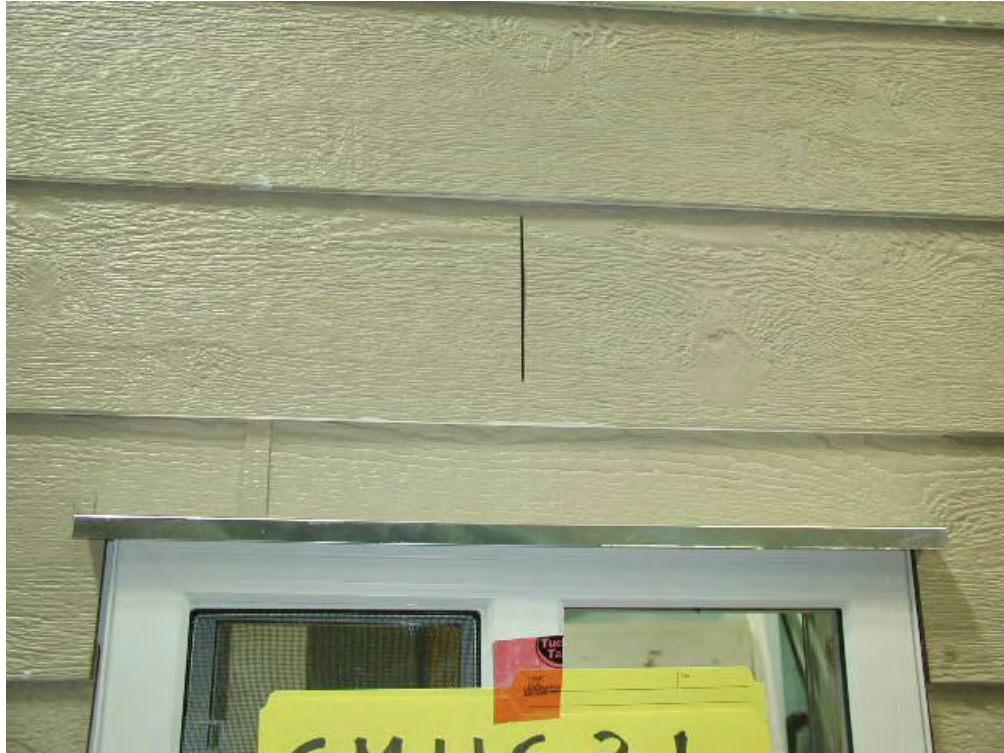
Figure A6-23: Saw cut (3mm thick by 150 mm long) in the hardboard siding, acting as a deficiency potentially allowing water ingress above the window

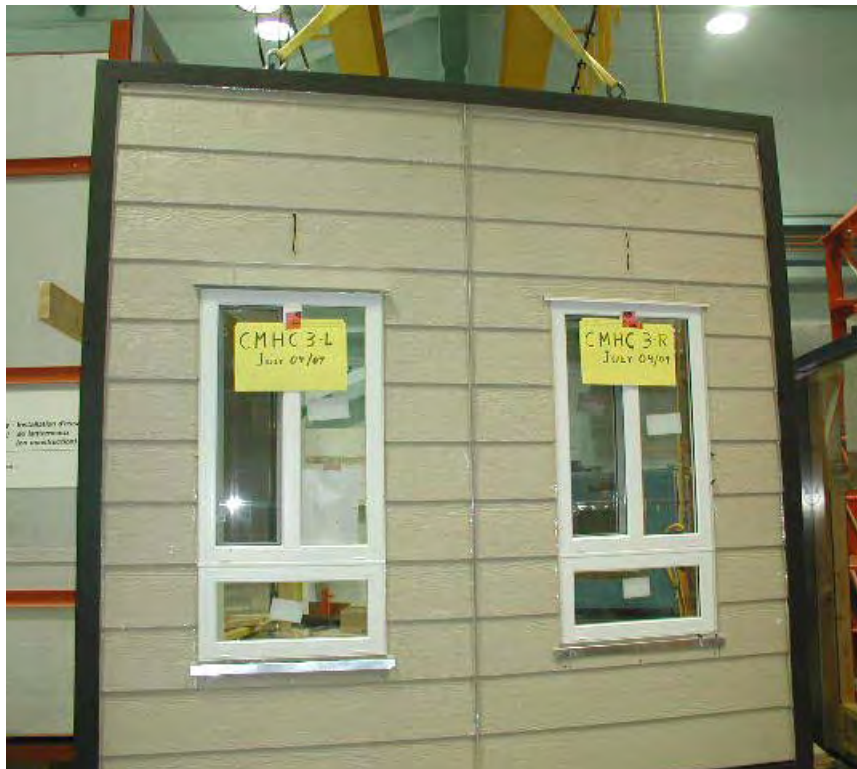
Figure A6-24: Completed Specimen; view from exterior side
