### **Evaluating the effectiveness of wall-window interface details to manage rainwater. Phase 1: watertightness, air leakage and rainwater management of CMHC specified assemblies**

Lacasse, M. A.; Rousseau, M. Z.; Cornick, S. M.; Manning, M. M.; Nicholls, M.; Nunes, S. C.

*Client Report (National Research Council of Canada. Institute for Research in Construction); no. B-1229.1, 2008-03-18*

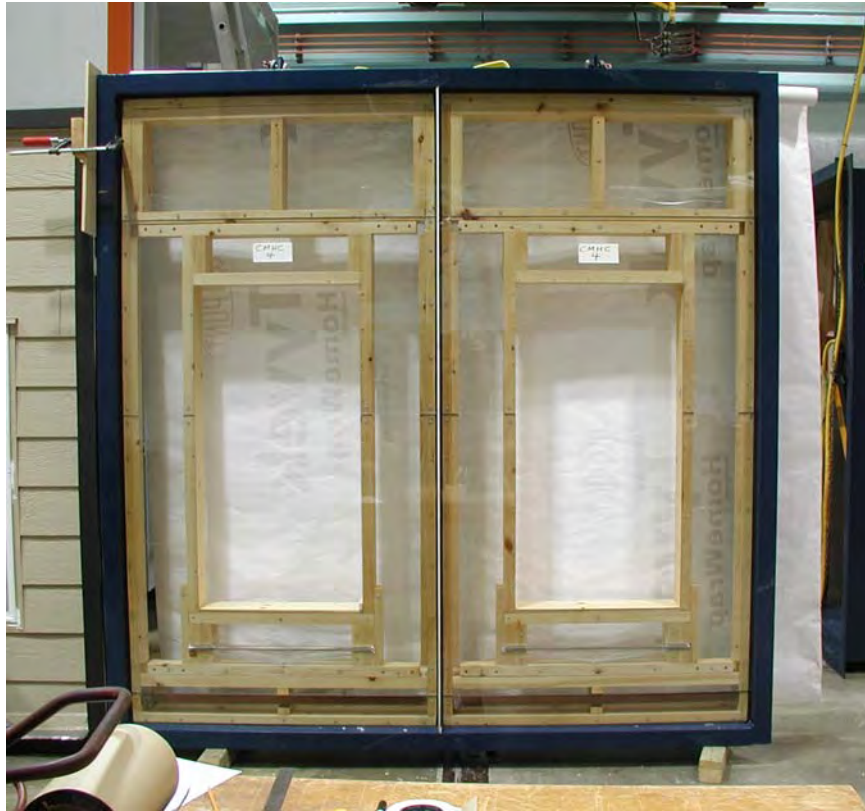
Figure A7-6: Framing is no different than what was done for the other three Specimens

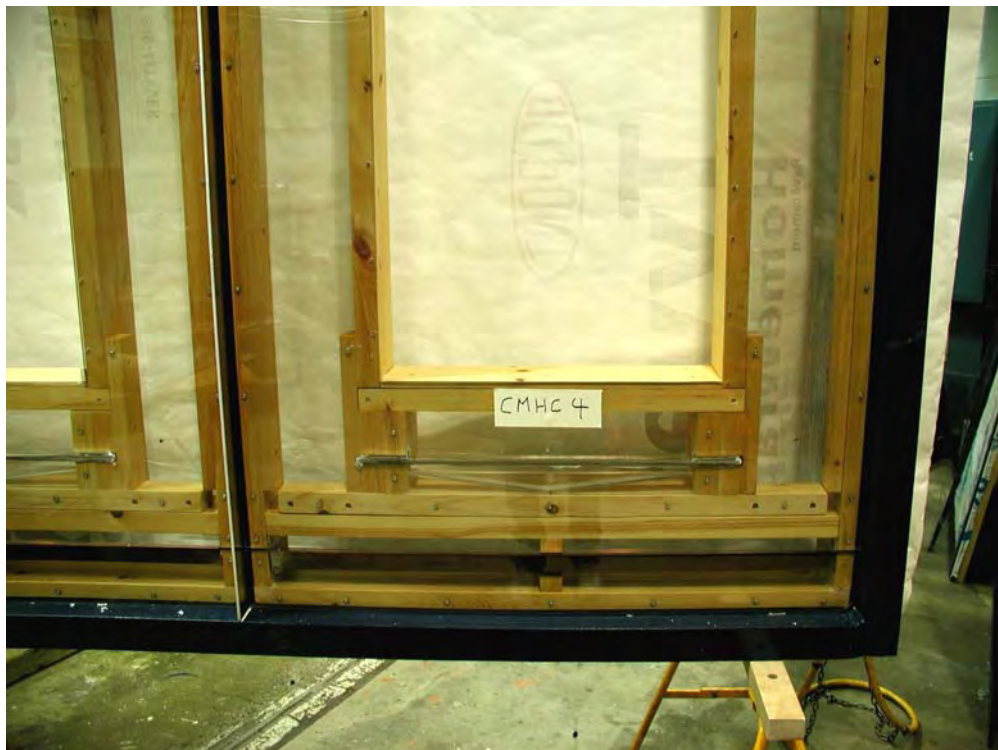
Figure A7-7: Water collection trough under the rough sill in place

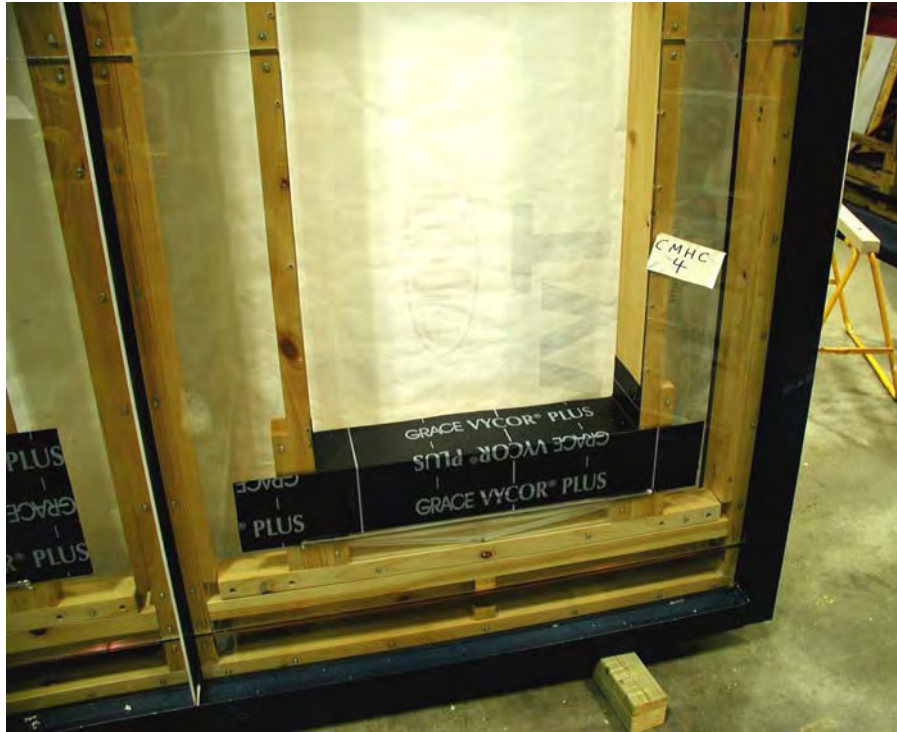
Figure A7-8: Installation of waterproof membrane at the rough sill

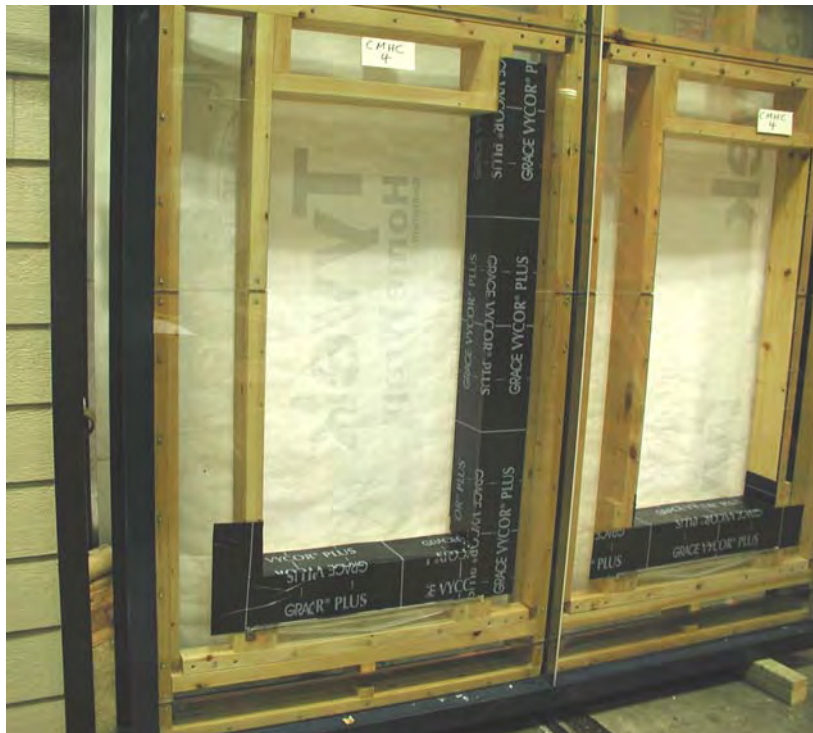
Figure A7-9: Installation of waterproof membrane at the jambs, lapping over the sill membrane

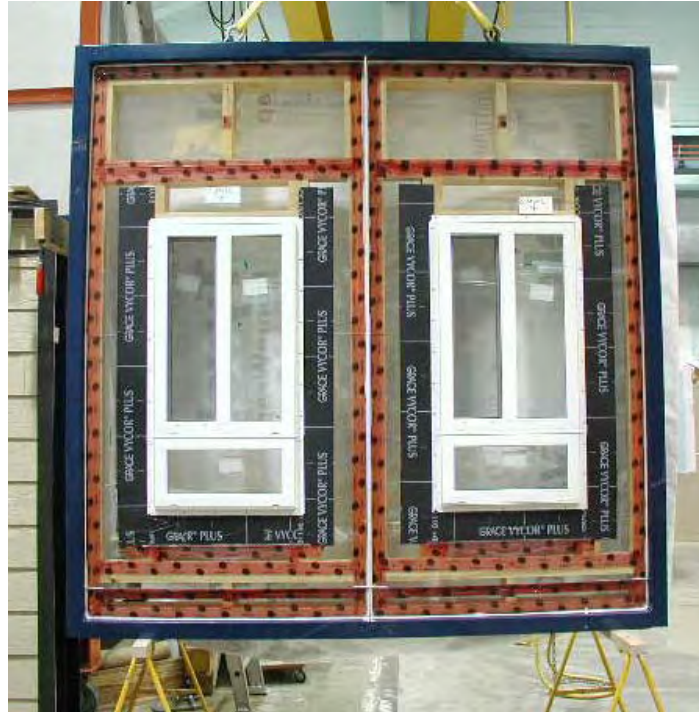
Figure A7-10: Window installation

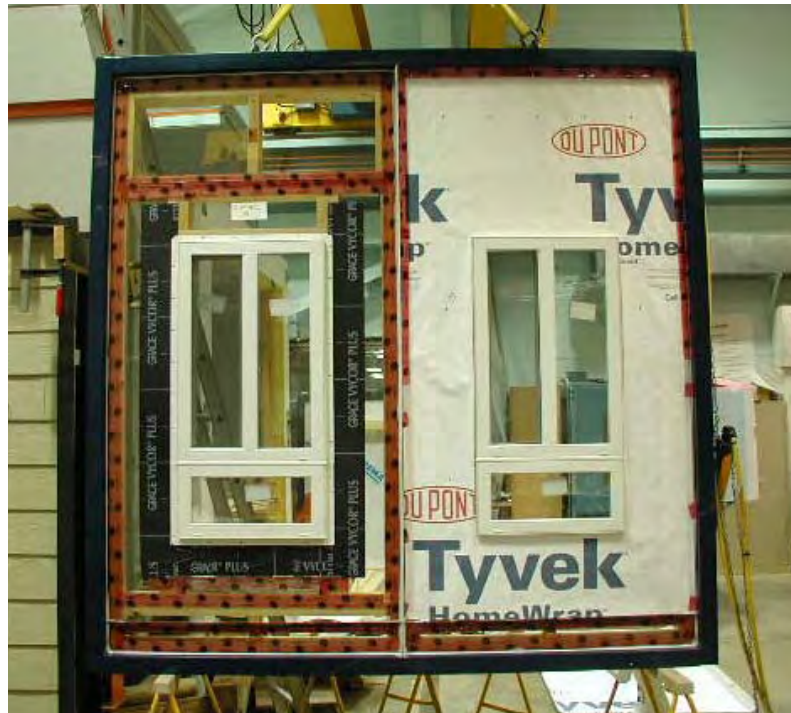
Figure A7-11: Installation of WRB membrane on the right side of Specimen

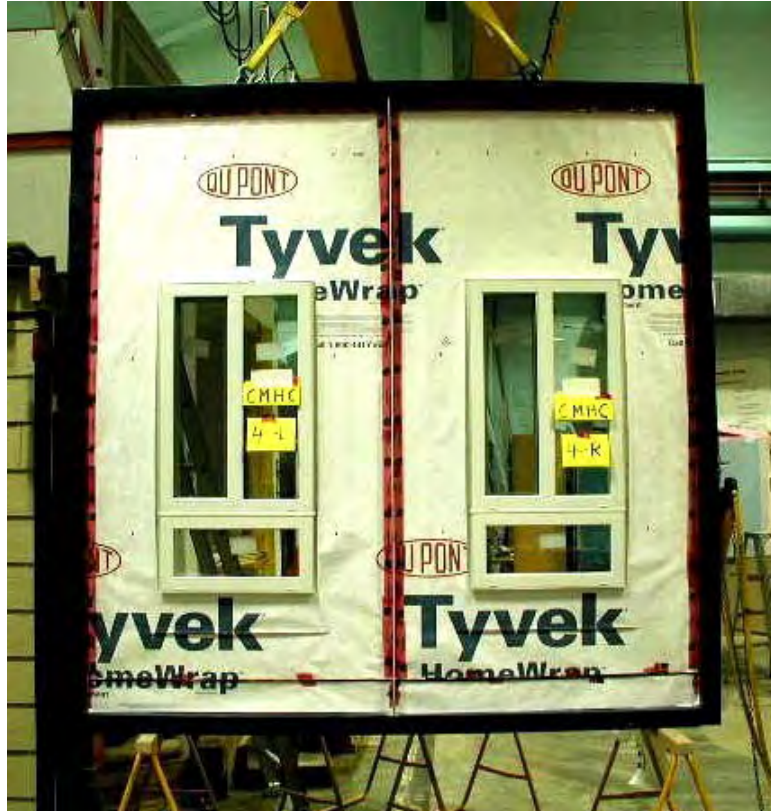
Figure A7-12: Specimen W4 WRB installation

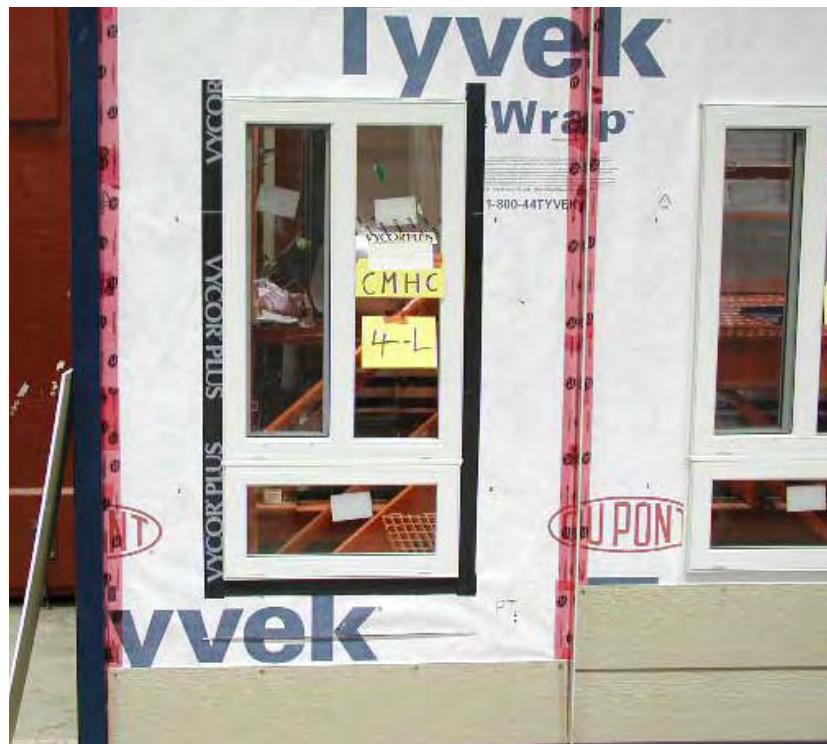
Figure A7-13: Specimen W4 B-side only: Installation of a strip (50-mm) of waterproof membrane sealing the WRB to the window flange

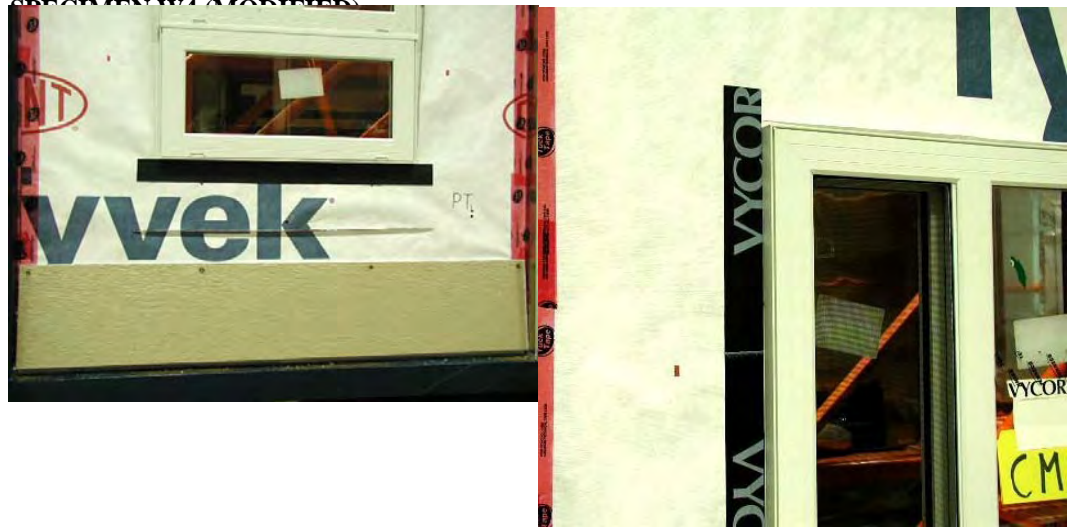
Figure A7-14: Specimen W4 B-side only – Self-adhered membrane installation at sill, and at jambs

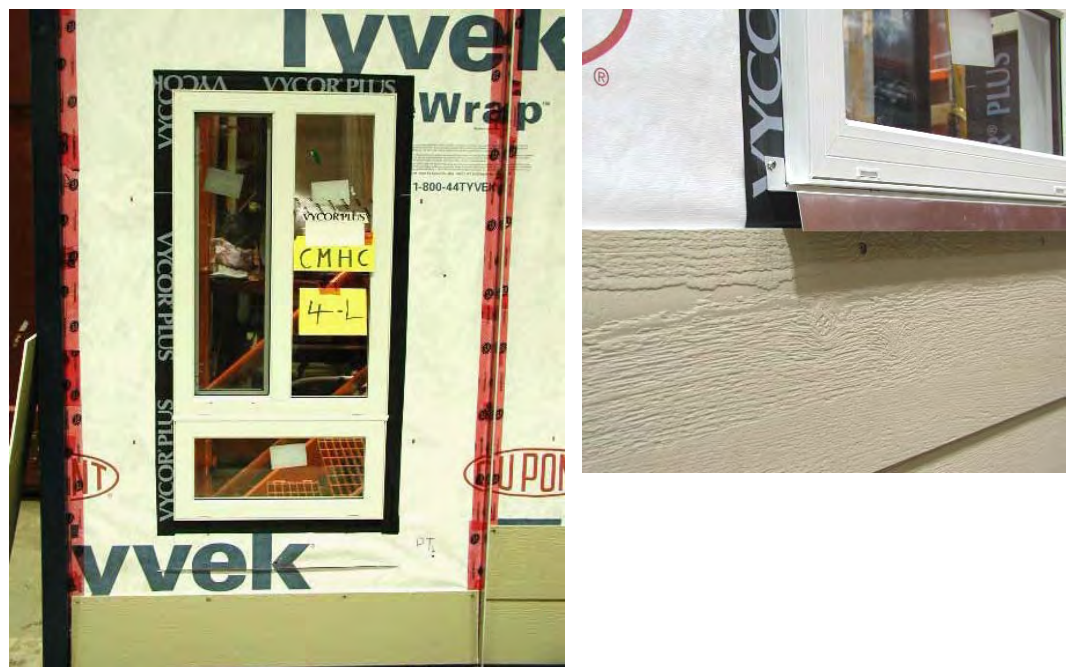
Figure A7-15: Specimen W4 B-side – Self-adhered membrane installed at the perimeter of window frame and WRB junction

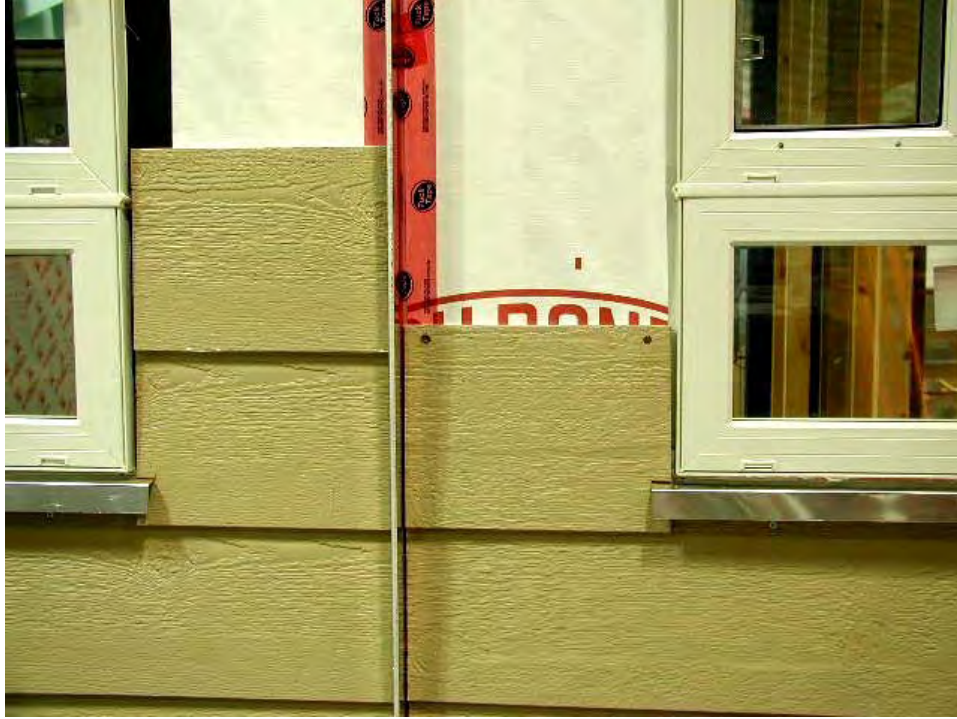
Figure A7-16: Specimen W4 At jambs and head siding was installed 5-mm away from frame of window and spaced 10-mm away from metal drip edge

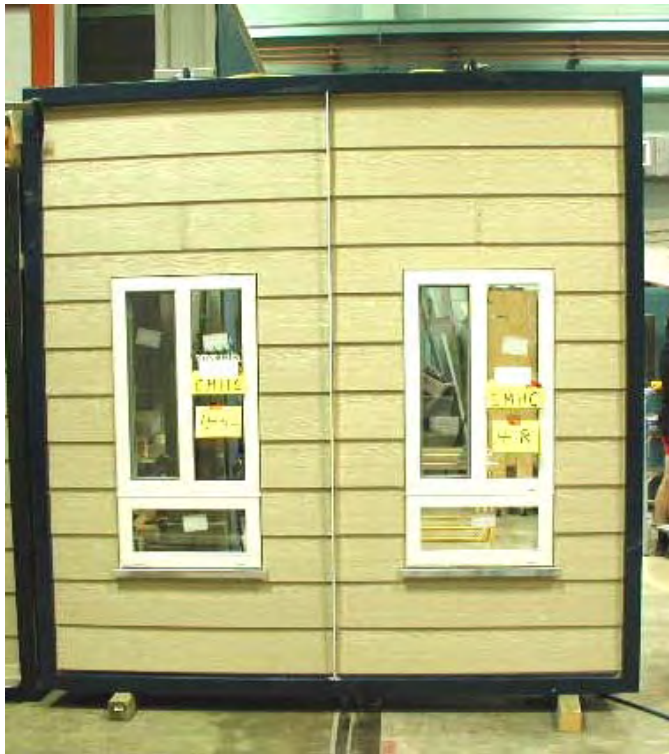
Figure A7-17: Specimen W4 Completed Specimen; view of exterior (V-side on right, B-side on left)

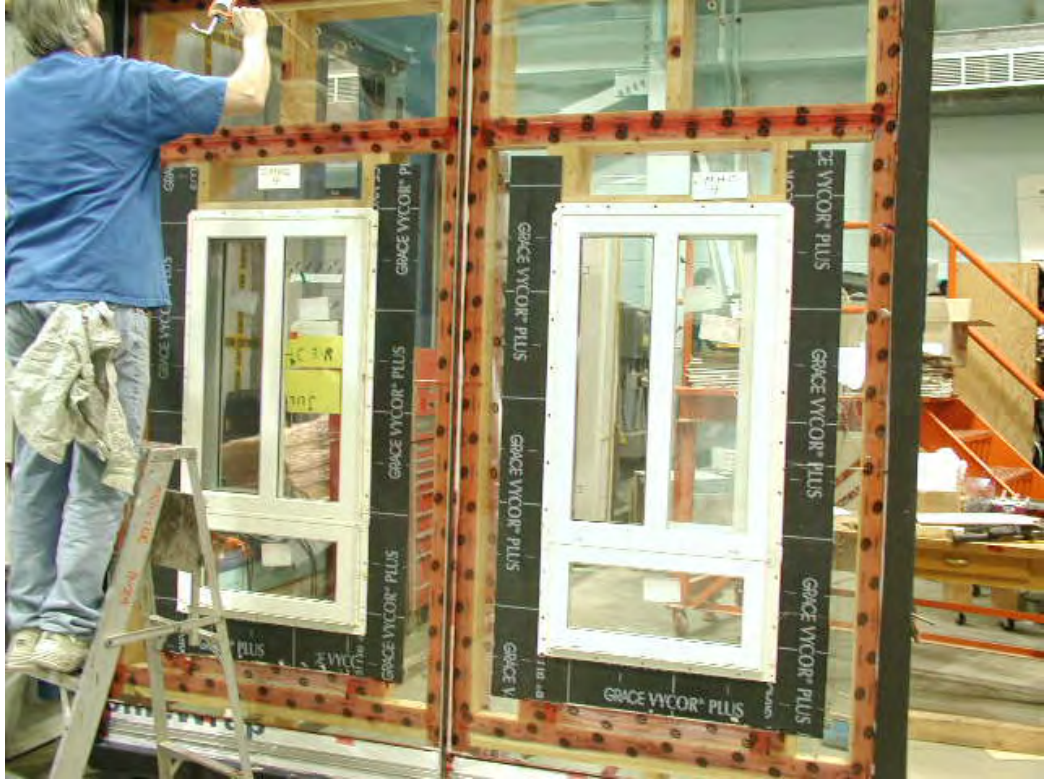
Figure A7-22: Modified Specimen W4 – Installation of the self-adhered membrane on both sides of Specimen

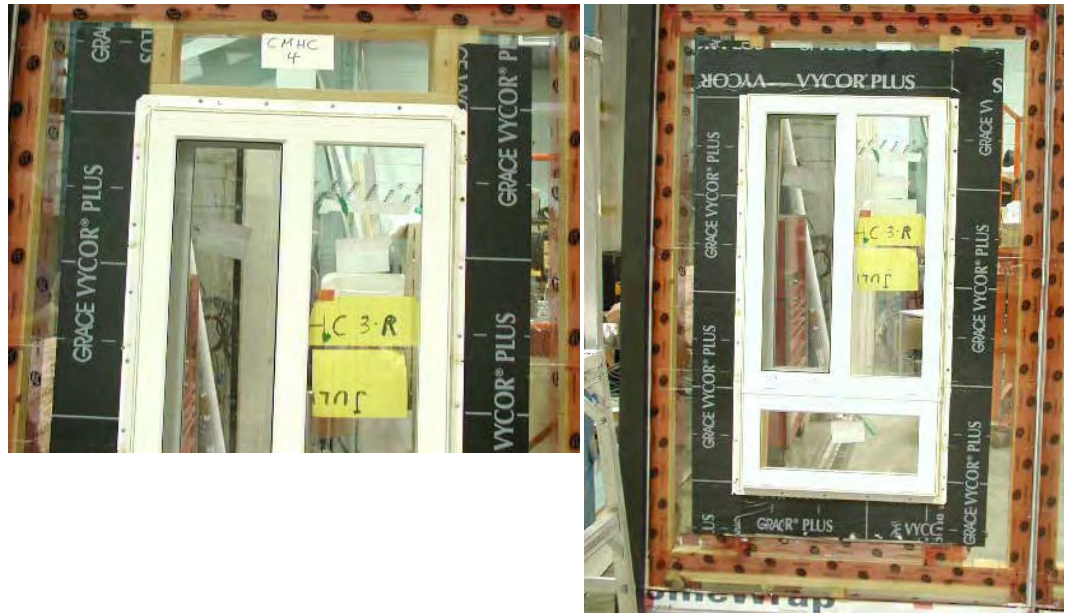
Figure A7-23: Modified Specimen W4 – Installation of self-adhered membrane at the window head over the window flange (the original Specimen did not have that membrane at that location)

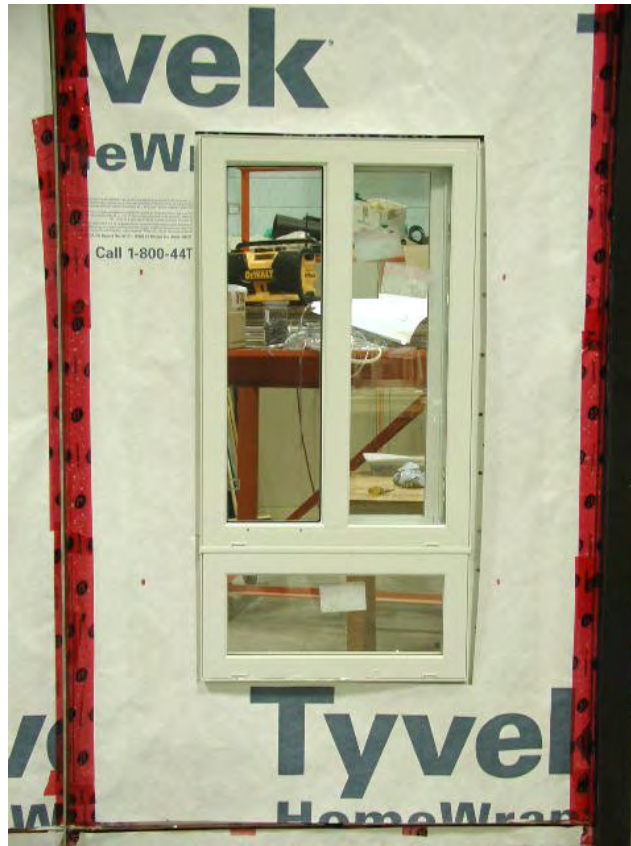
Figure A7-24: Modified Specimen W4 V-side – Installation of WRB membrane

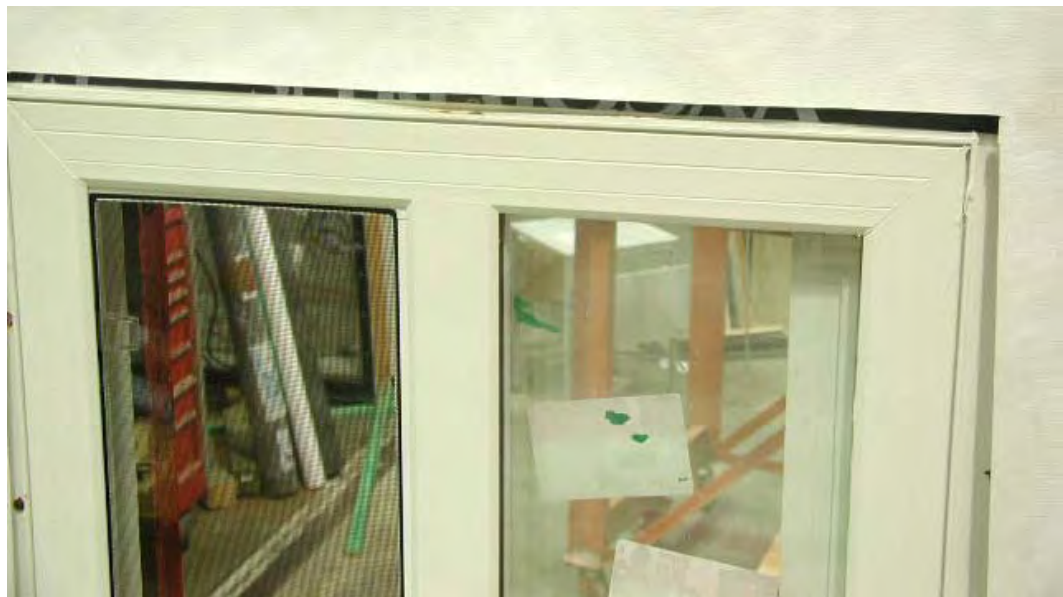
Figure A7-25: Modified Specimen W4 V-side – WRB membrane cut 6 mm short of window frame

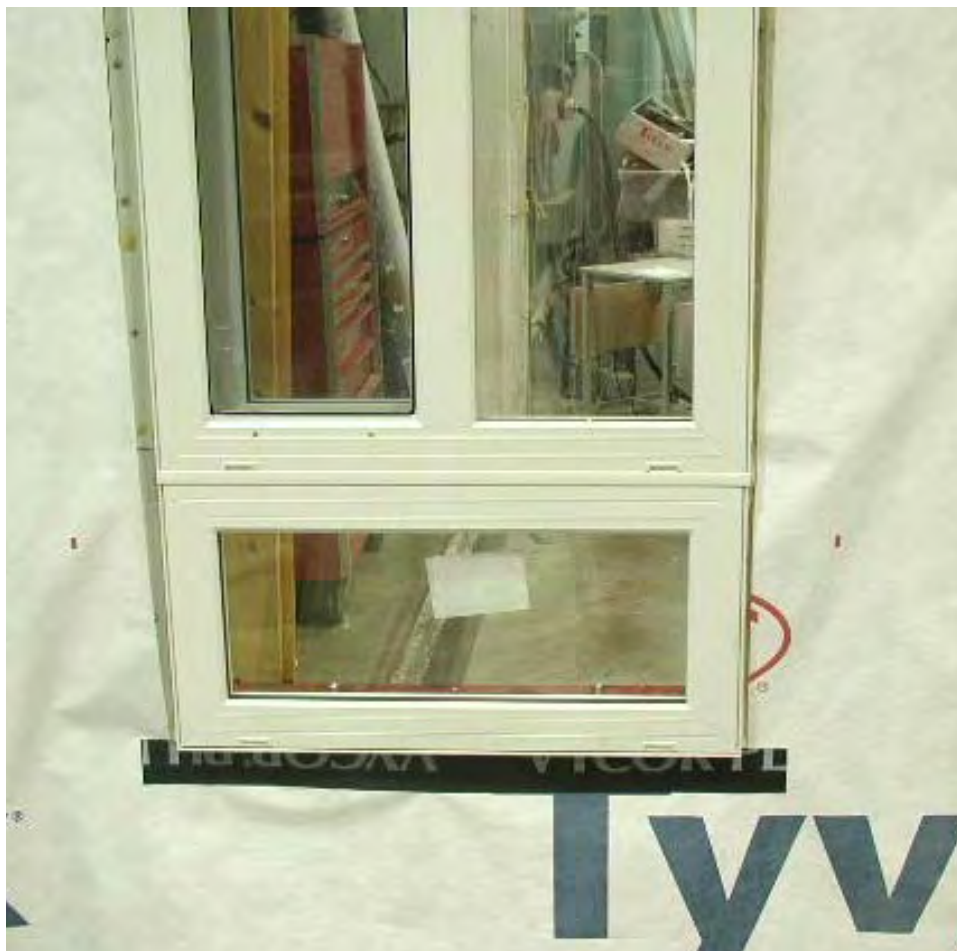
Figure A7-26: Modified Specimen W4 B-side – Self-adhered flashing membrane at sill

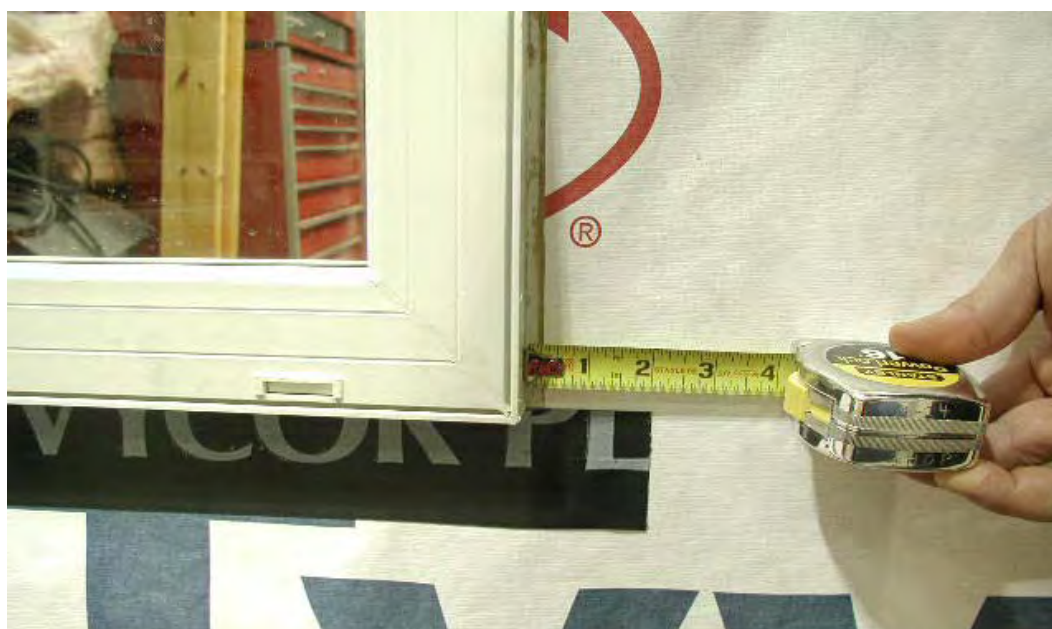
Figure A7-27: Modified Specimen W4 – B-side. Gap left between WRB membrane and window flange, to be covered later by a 50 mm wide strip of flashing membrane

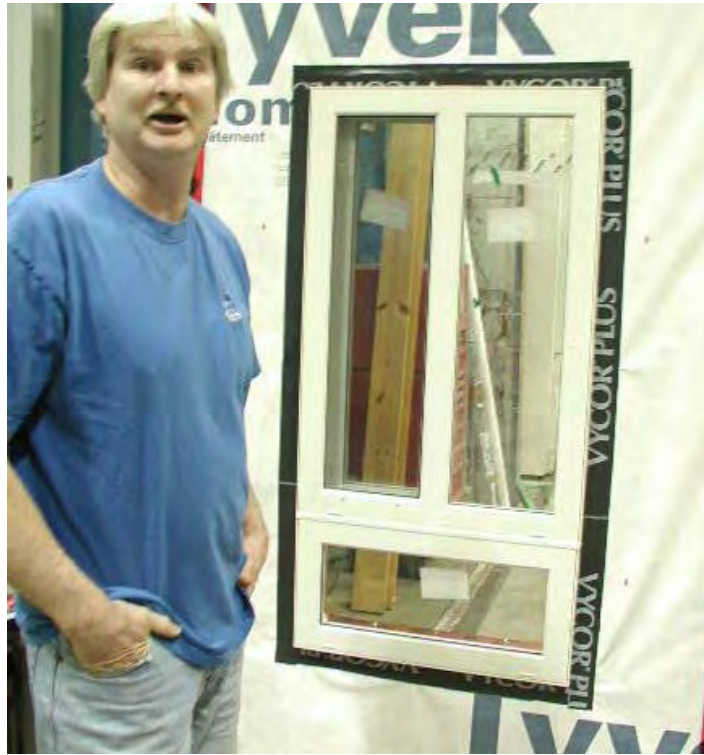
Figure A7-28: Modified Specimen W4 – B-side self-adhered membrane installed at the perimeter of the joint between the WRB membrane and the window flange

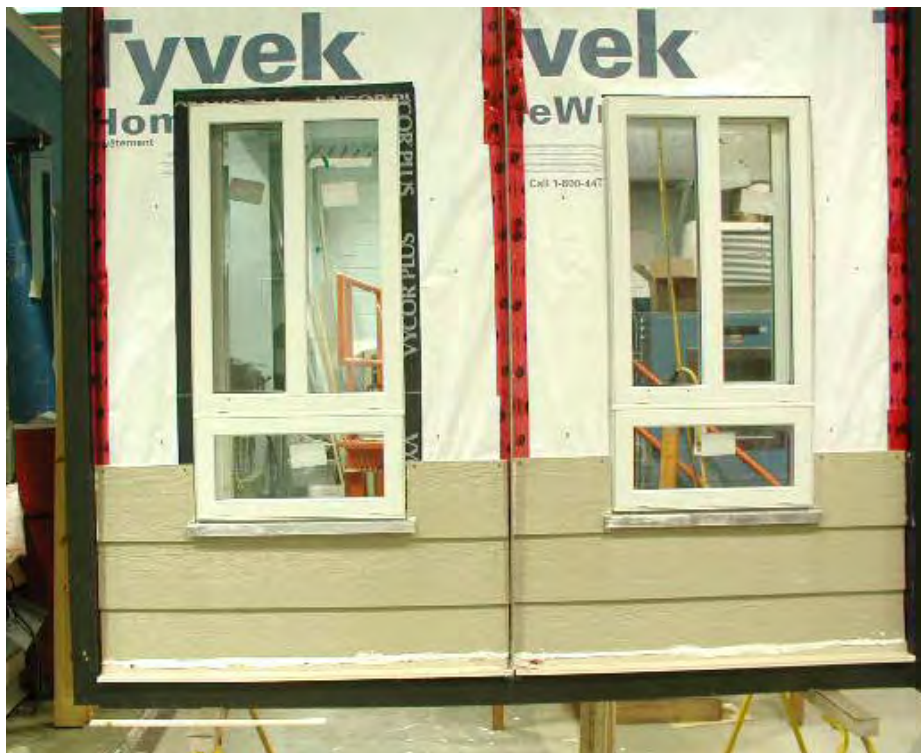
Figure A7-29: Modified Specimen W4. Siding installation (b-side on the left and V-side on the right)

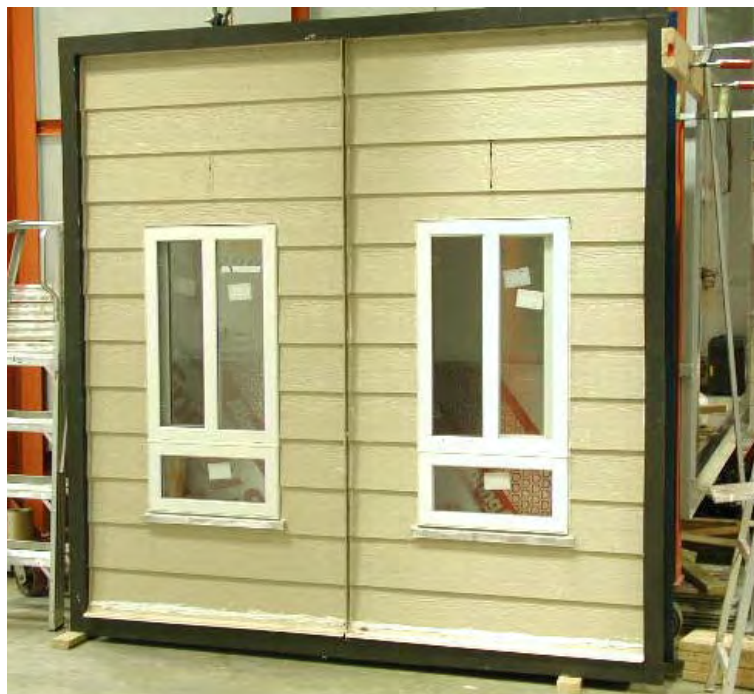
Figure A7-30: Modified Specimen W4 Siding installation completed

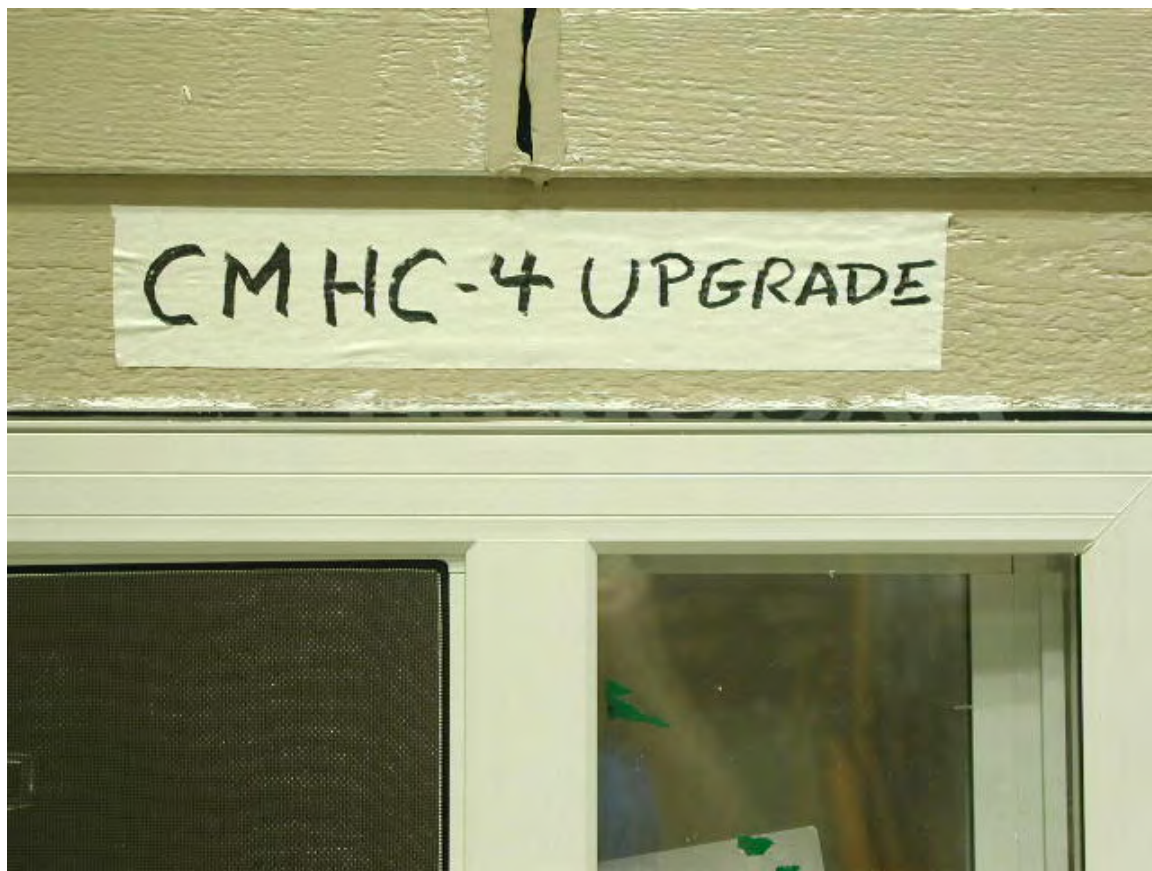
Figure A7-31: Modified Specimen W4. Detail at the window head: no drip cap flashing and gap left open
