Construction Technology Update; no. 22, 1998-12-01

Control of Floor Vibration

by *D.E. Allen and G. Pernica*

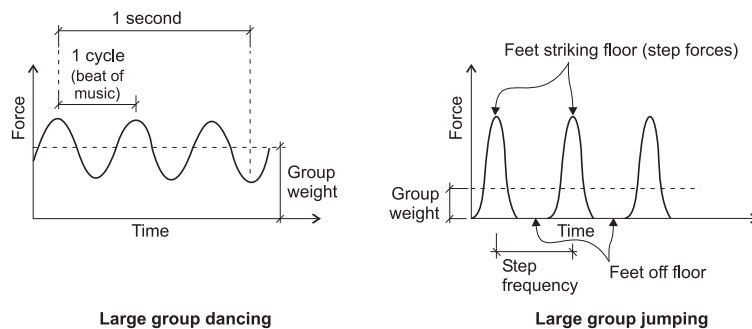
Figure 1. Repetitive forces produced by human activities

The main factor underlying most vibration problems is resonance, which occurs when a load is exerted on a floor at a particular frequency. For example, a group of people dancing applies a cyclic force (their footsteps) to the floor at the frequency corresponding to the beat of the music (see Figure 1). The cyclic force produces a maximum floor acceleration, which depends on the ratio of the natural frequency of the floor structure to the cyclic frequency of the applied force (see Figure 2). When the natural frequency of the floor coincides with, or is close to, the forcing frequency, resonance occurs and the consequences are most severe. During each cycle of loading, more energy is fed into the system and the magnitude of vibration grows, until a maximum is reached. This maximum is dependent on the amount of damping in the floor.

If the repeated force has an impact component, as is the case for aerobics in which everyone jumps at the same time (see Figure 1), then resonance can occur not only at the step frequency, but also at multiples, or harmonics, of this frequency. For example, an aerobics class jumping to a beat of 2.5 Hz (the step frequency) will produce harmonic vibrations at multiples of 2.5 Hz — i.e., at 2.5 Hz (first harmonic), 5 Hz (second harmonic), and 7.5 Hz (third harmonic). Since the natural frequencies of most floors are greater than 3 Hz (they often fall between 4 Hz and 8 Hz), problems are most likely to occur as a result of the second and third harmonics. However, the lower the harmonic the larger the vibration produced by resonance.

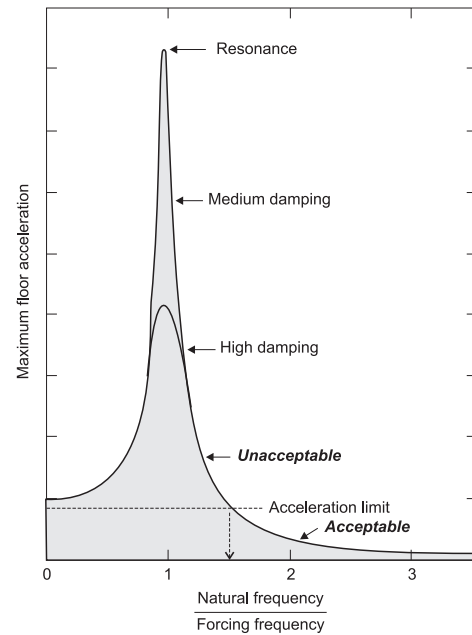
Figure 2. Floor acceleration due to a cyclic force for a range of natural frequencies

Increased damping. Damping of the floor system (increasing the rate of removal of vibrational energy) reduces resonance vibration (see Figure 2) and thus annoyance. It depends primarily on the presence of non-structural components such as partitions, ceilings, mechanical services and furnishings. Full-height partitions are most effective in adding damping to the floor system.³

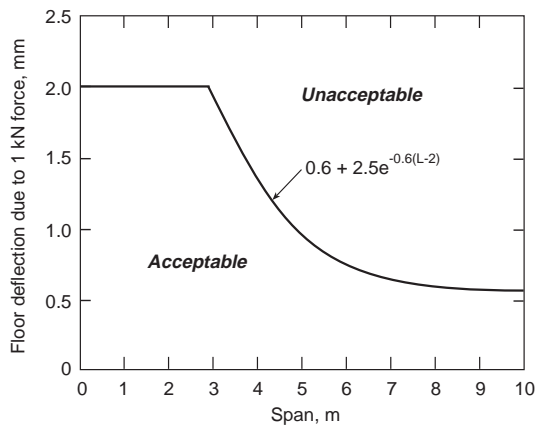
Figure 3. Design criterion for light-frame floors

Deflection criterion. When walking vibration is likely to be an issue, e.g., in a house or multi-family dwelling, light-frame floors should be designed to meet the deflection criterion for a 1 kN concentrated force (as shown in Figure 3). This decrease in allowable deflection with increase in span is due to a number of factors described in Reference 4.

The most practical approach for designing light-frame floors to minimize the effects of walking is to develop span tables based on calculations that satisfy the Figure 3 criterion, e.g., those contained in Part 9 of the NBC. To evaluate floor systems not covered by the NBC span tables, see Reference 4.
