## **Field investigation and laboratory testing of exposed poly(vinyl chloride) roof systems**

**Whelan, B.J.; Graveline, S.P.; Delgado, A.H.;  
Liu, K.K.Y.; Paroli, R.M.**

**NRCC-47700**

**A version of this document is published in / Une version de ce document se trouve dans:  
CIB World Building Congress 2004, Toronto, ON., May 2-7, 2004, pp. 1-14**

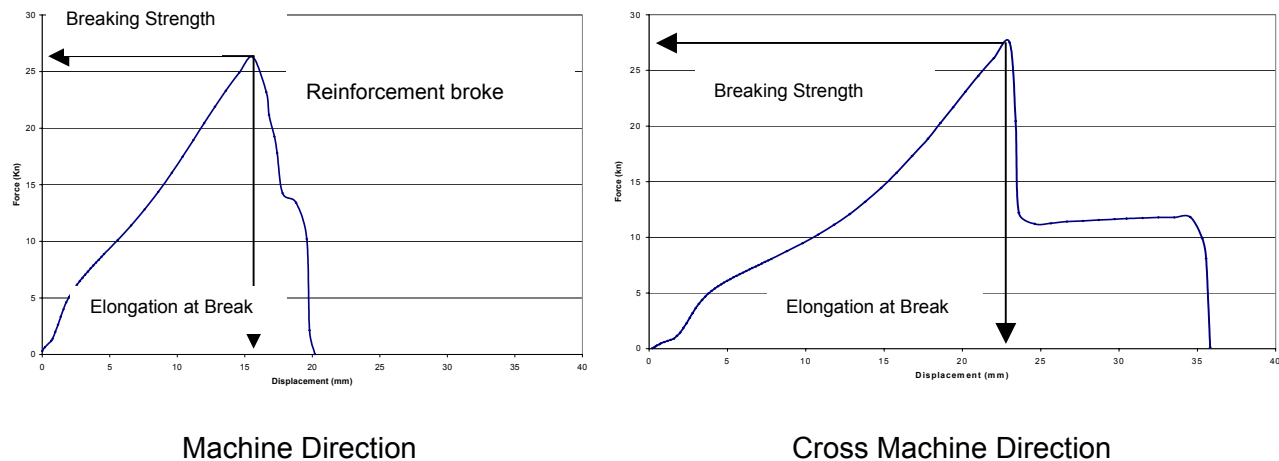
**Figure 1** Typical Force displacement curve for tensile test of polyester reinforced roof membrane (Sample 21C) in the machine (MD) and cross directions (CD)

Typical force-displacement curves for the tensile testing of the polyester reinforced roofing membrane are displayed in Figure 1. The load increased with displacement almost linearly at the beginning as the specimen stretched until the reinforcement broke, which caused an abrupt drop in load. No delamination was observed between the polyester fibre and the PVC matrix.

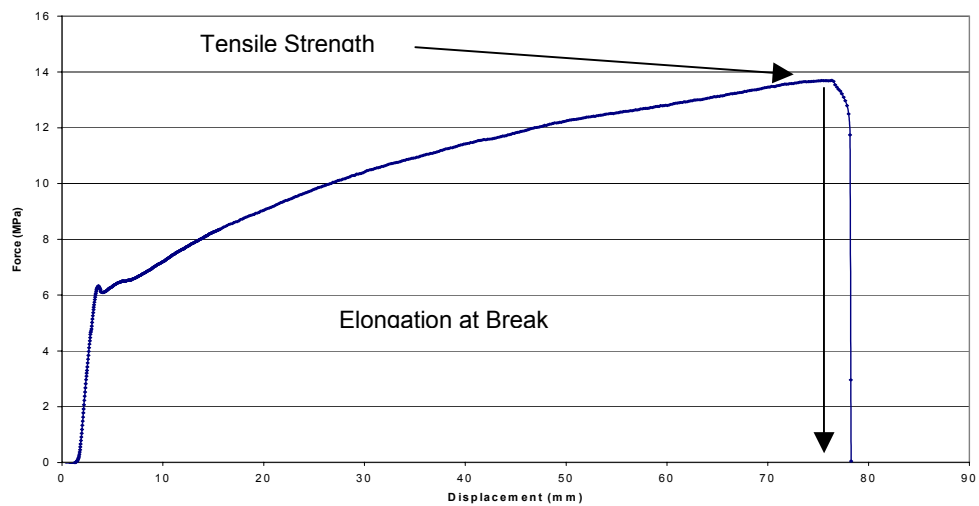
**Figure 2** Typical Force displacement curve tensile test for fibreglass reinforced roofing membrane Sample 18A).

Figure 2 shows a typical force-displacement curve for the tensile testing of the fiberglass reinforced roofing membranes. The load increased linearly with displacement at the beginning. The specimen then started to yield and neck as indicated by the change in slope in the force-displacement curve. It stretched to a high degree (over 100% in general) and finally broke with a snap. No delamination was observed between the fiberglass reinforcement and the PVC matrix.

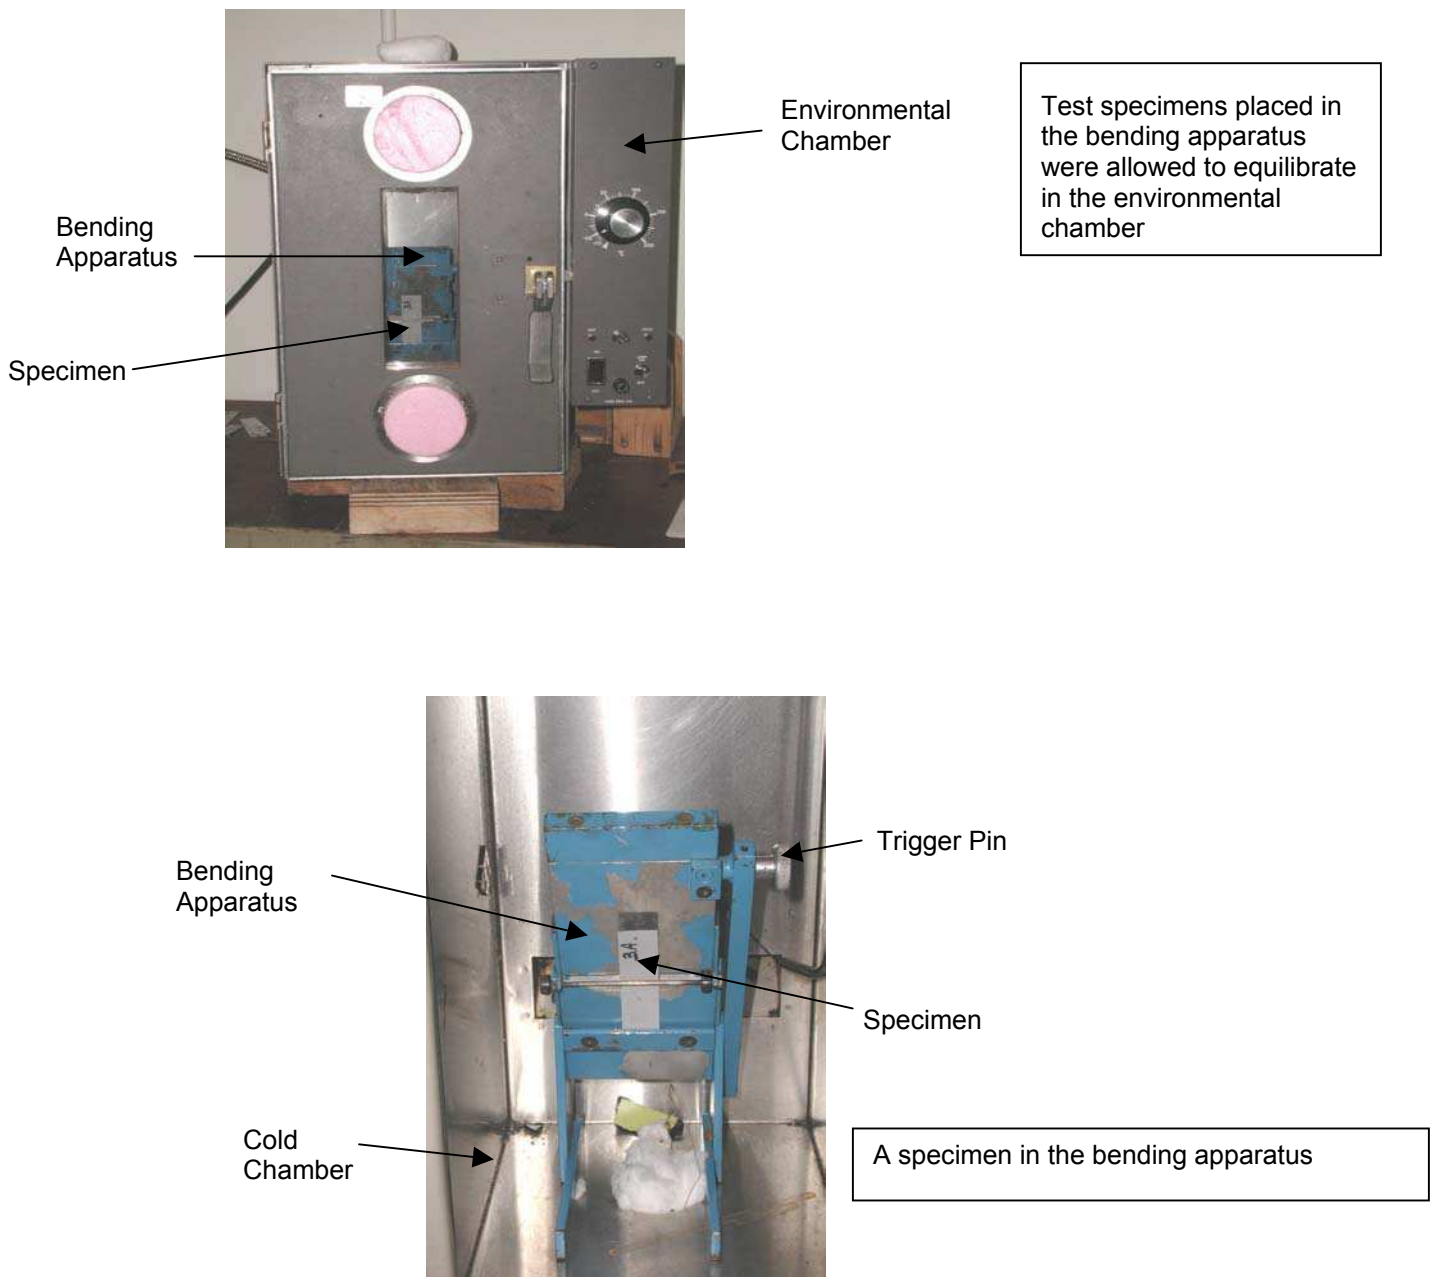
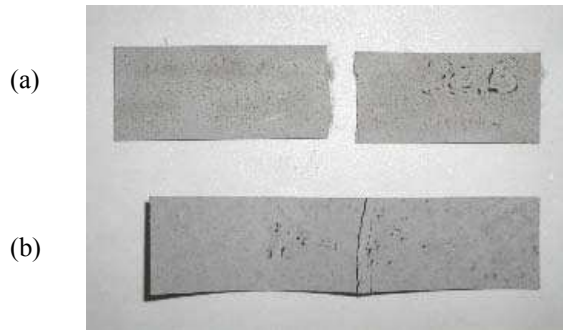
**Figure 3** Typical failed specimens showing (a) fracture, (b) surface crack

After three specimens had been tested, they were removed from the environmental chamber and examined for surface cracks using a 5X-magnifying glass. During the inspection, each specimen was folded 180° in the same direction as the specimen was bent during the test. If all three specimens showed no cracks in the coating and no fractures, then the sample was considered to have passed. If all three specimens displayed cracks or fracture, the sample failed. However, if only one or two specimens showed cracks, three additional specimens were tested. If any of these exhibited coating cracks or fractures, then the material failed; otherwise, it passed. Typical failed and passed specimens are shown in Figures 3 and 4, respectively.

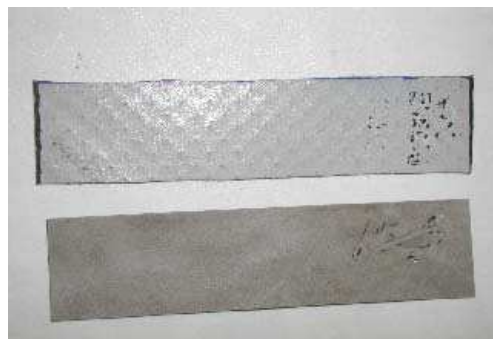
**Figure 4** Typical passed specimens

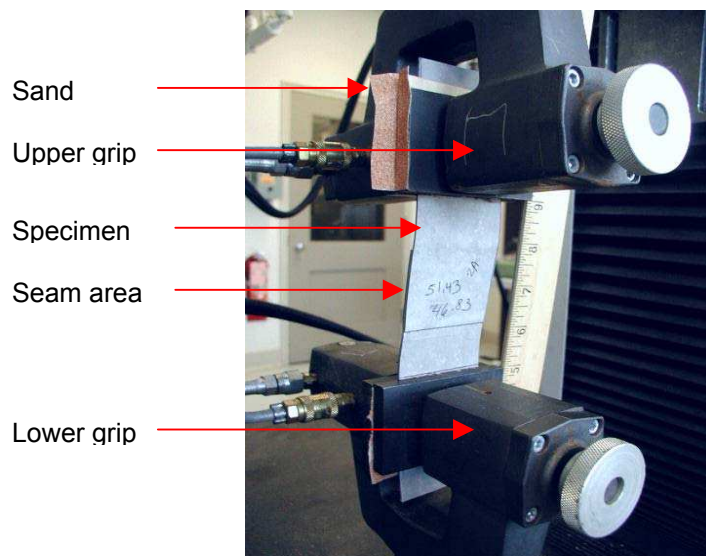
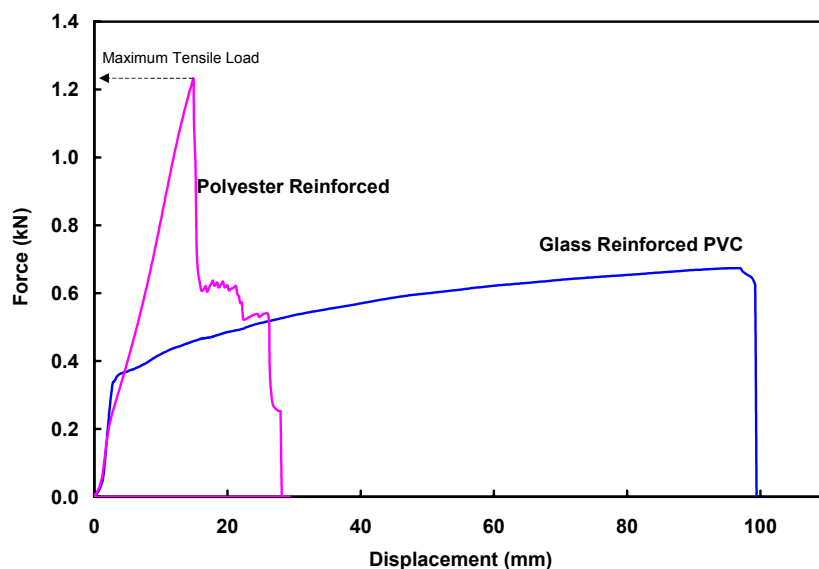
**Figure 5**

Typical force-displacement curves for the seam test of the reinforced PVC roofing membrane samples.

Typical force-displacement curves for the seam test of the glass and polyester reinforced roofing membrane samples are displayed in Figure 5. The load increased with displacement as the specimen stretched. The slope of the curve then decreased slightly as the stretched zone started to neck and the surrounding material was drawn into this zone. The membrane stretched further and finally broke, which caused an abrupt drop in load. Both the glass and the polyester reinforced PVC membranes failed in similar manner. However, the glass samples stretched and necked to a higher extent because the random short glass fibres moved more freely with the PVC matrix.

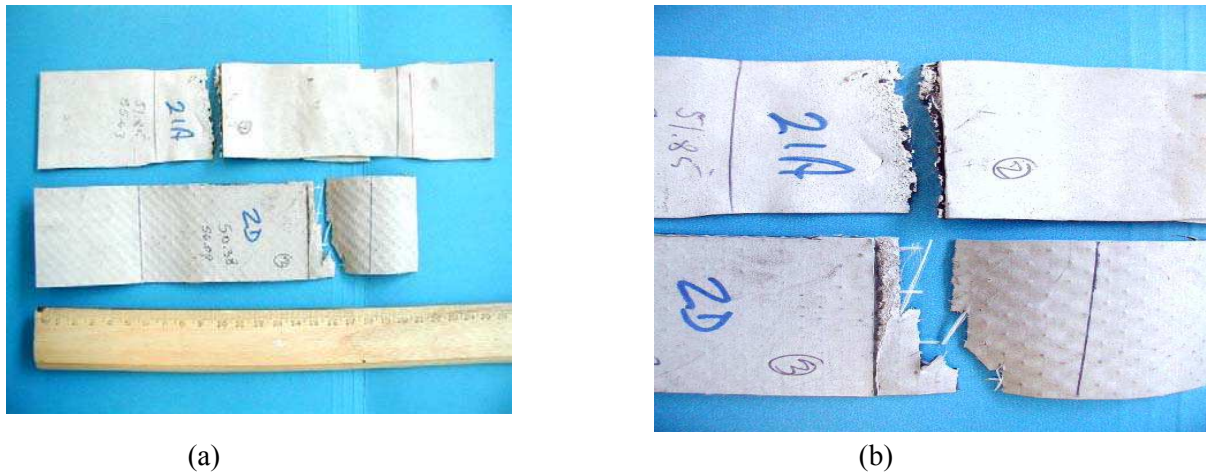
Figure 6 Typical failed glass and polyester reinforced seam test specimens (a) failure occurred in the membrane outside the seam area while the seam remained intact (b) close up at area of failure.

The failure of all specimens occurred in the membrane outside the seam area with the seam remained intact (Figure 6). This indicated that the seam did not deteriorate after the membranes had been in-service for various periods of time and that the seam strength was governed by the tensile strength of the membrane.
